Prestons Park Subdivision GEOTECHNICAL REPORT FOR LOT 1042 CDL Land NZ Limited

5 August 2022 Revision: 1 Reference: 235361

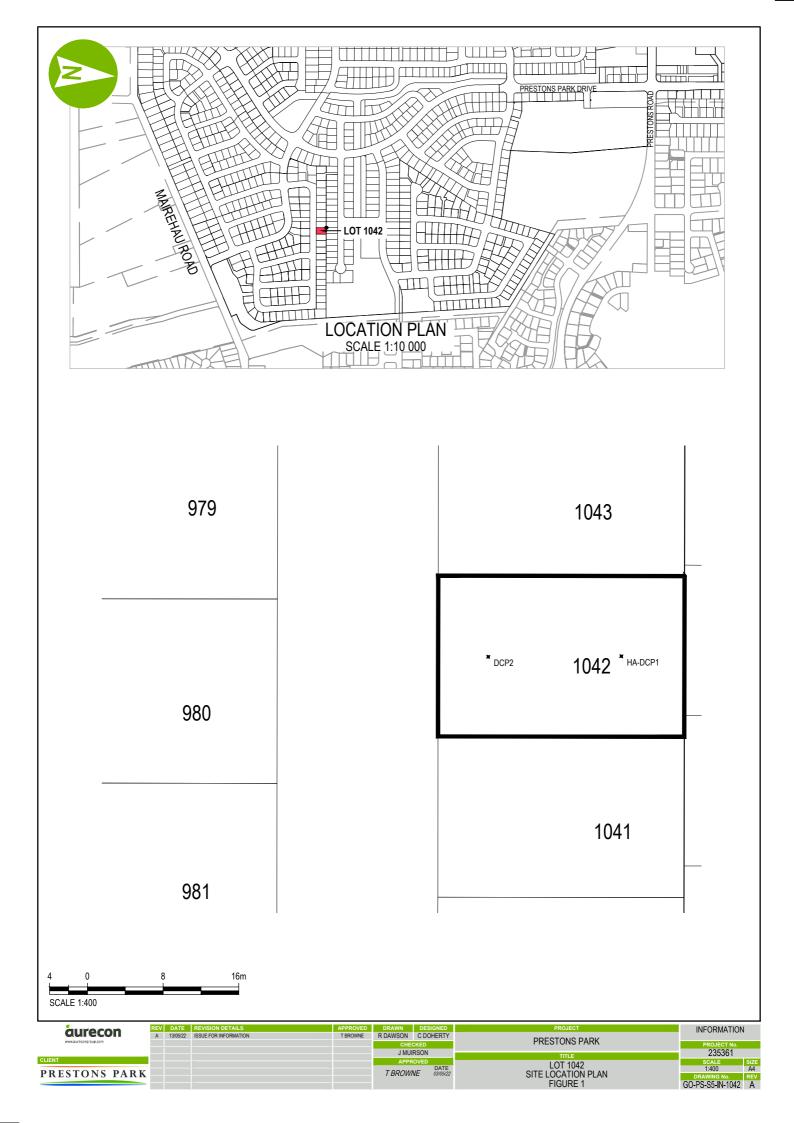
This building consent report is for Lot 1042 which is located in Stage 5 of the Prestons Park Subdivision development (refer Figure 1 in Appendix A). The lot is bordered by residential lots to the north, east and west, with an access road to the north.

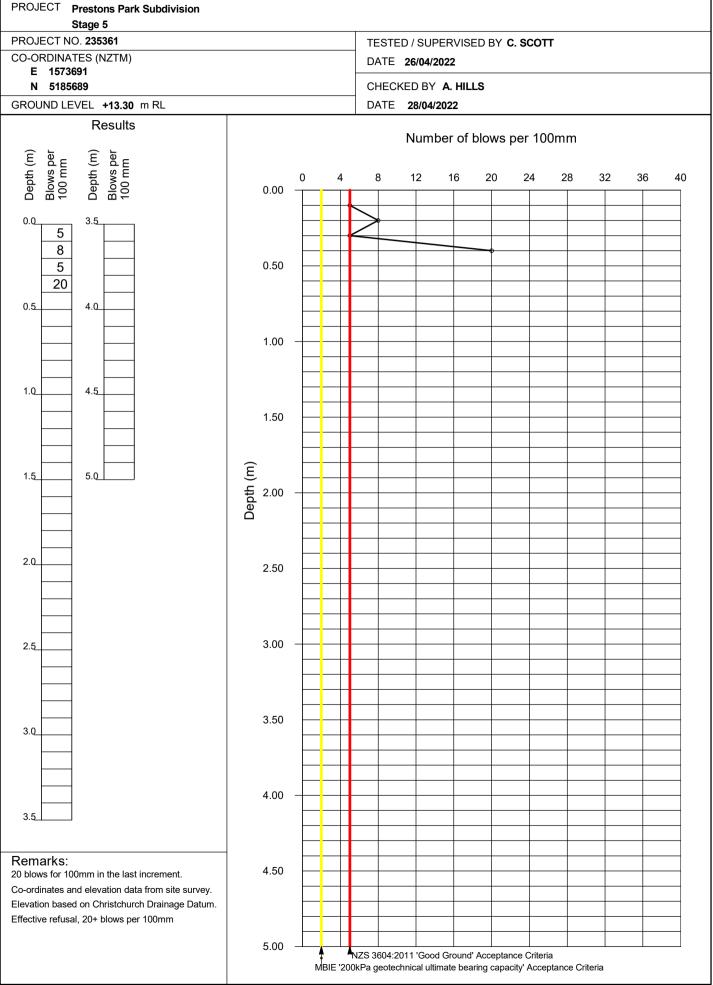
Lot 1042 - DCP1

DCP logs indicate 5 blows per 100mm penetration, which is equivalent to an ultimate bearing capacity of 300kPa, was consistently encountered from a shallow depth.

Based on our understanding of the site works and the investigation results, we recommend that NZS3604:2011 compliant foundations are embedded a minimum depth of 0.35m below current ground level.
