Prestons Park Subdivision GEOTECHNICAL REPORT FOR LOT 1047 CDL Land NZ Limited

3 August 2022 Revision: 1 Reference: 235361

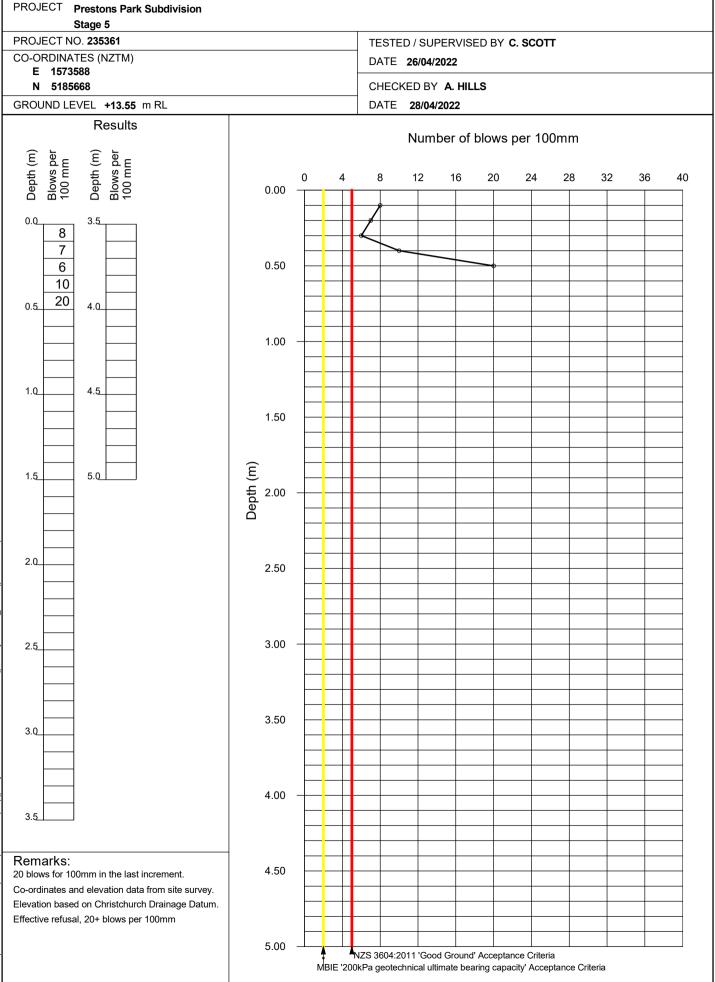
Lot 1047 - DCP1

DCP logs indicate 5 blows per 100mm penetration, which is equivalent to an ultimate bearing capacity of 300kPa, was consistently encountered from a shallow depth.

It is recommended that residential structures that are built on Lot 1047 are founded on standard NZS3604:2011 compliant foundations. These foundations require a minimum geotechnical ultimate bearing capacity of at least 300kPa. The site investigation results indicate that approximately 350mm of topsoil was present, which will need to be removed and the clean subgrade exposed for foundation construction.

Based on our understanding of the site works and the investigation results, we recommend that NZS3604:2011 compliant foundations are embedded a minimum depth of 0.35m below current ground level.
