Prestons Park Subdivision GEOTECHNICAL REPORT FOR LOT 1048 CDL Land NZ Limited

3 August 2022 Revision: 1 Reference: 235361

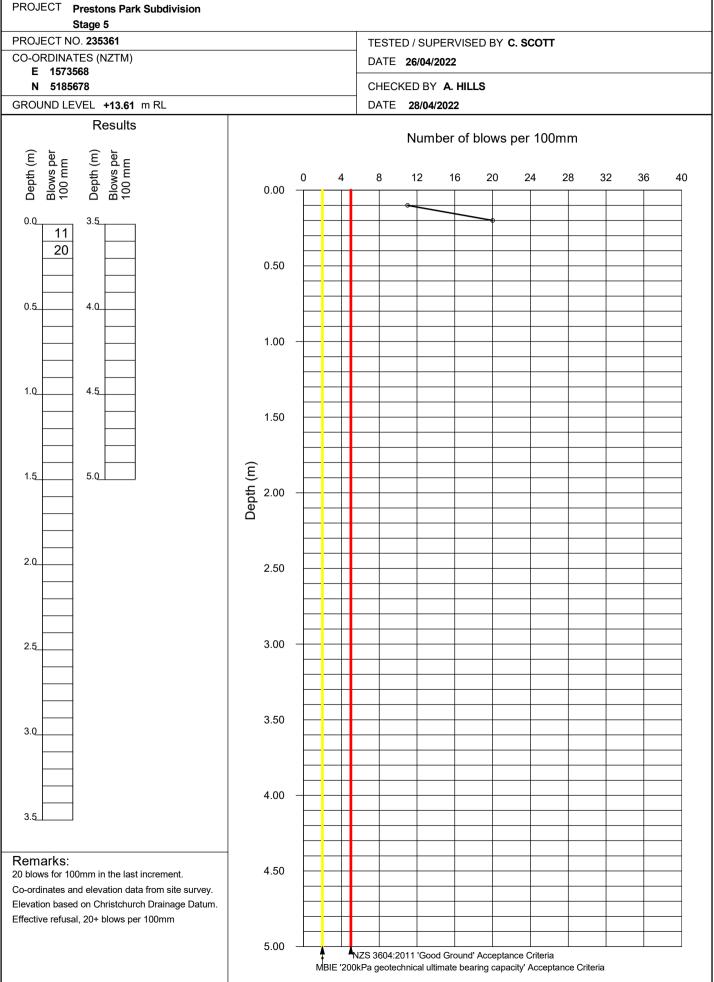
Lot 1048 - DCP1

DCP logs indicate 5 blows per 100mm penetration, which is equivalent to an ultimate bearing capacity of 300kPa, was consistently encountered from a shallow depth.

Based on our understanding of the site works and the investigation results, we recommend that NZS3604:2011 compliant foundations are embedded a minimum depth of 0.4m below current ground level.
