Prestons Park Subdivision
GEOTECHNICAL REPORT FOR LOT 937
CDL Land NZ Limited

26 June 2023 Revision: 1 Reference: 235361

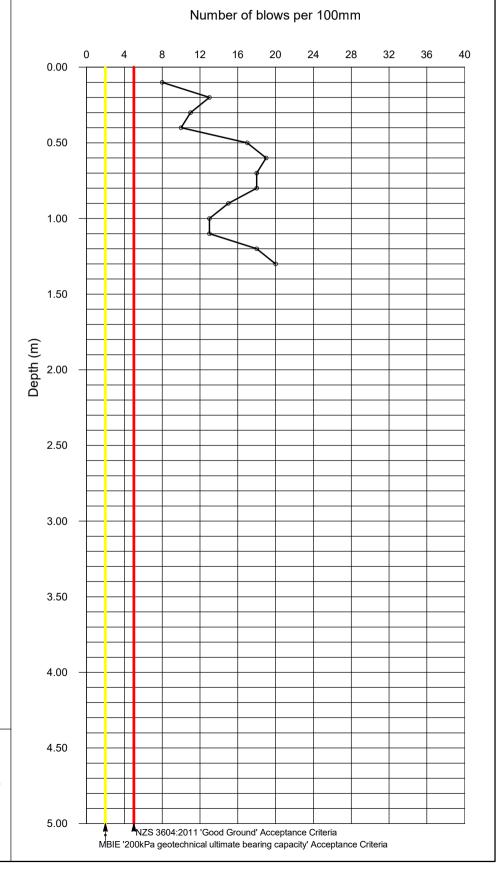
Lot 937 - DCP1

DCP logs indicate two blows per 100mm penetration, which is equivalent to an ultimate bearing capacity of 200kPa, was consistently encountered from a shallow depth.

# Results Blows per 100 mm Depth (m) 0.0 3.5 8 13 11 10 17 4.0\_ 0.5 19 18 18 15 13 1.0 4.5\_ 13 18 20 5.Q\_ 2.0 2.5

20 blows for 100mm in the last increment.

Effective refusal, 20+ blows per 100mm
