Prestons Park Subdivision
GEOTECHNICAL REPORT FOR LOT 939
CDL Land NZ Limited

26 June 2023 Revision: 1 Reference: 235361

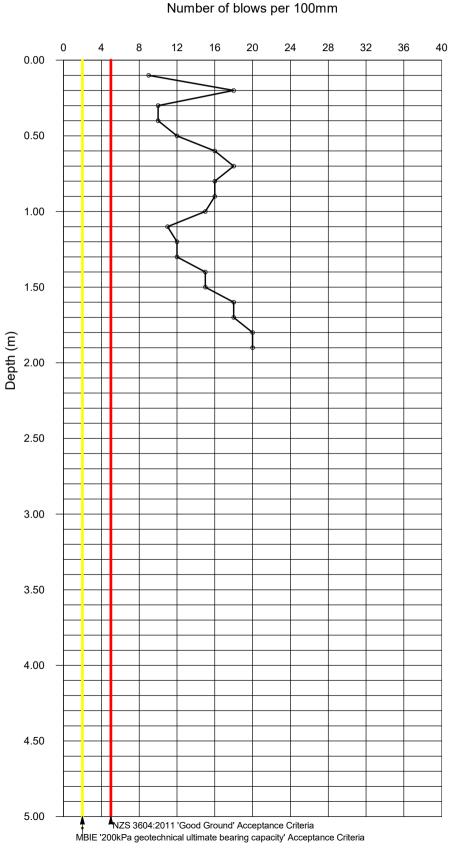
Lot 939 - DCP1

DCP logs indicate two blows per 100mm penetration, which is equivalent to an ultimate bearing capacity of 200kPa, was consistently encountered from a shallow depth.

GROUND LEVEL +13.03 m RL Results Blows per 100 mm Blows per 100 mm Depth (m) 0.0 3.5 9 18 10 10 12 4.0_ 0.5 16 18 16 16 15 1.0 4.5_ 11 12 12 15 15 5.Q_ 18 18 20 20 2.0 2.5

20 blows for 100mm in the last increment.

Effective refusal, 20+ blows per 100mm
