**Prestons Subdivision**  
**GEOTECHNICAL REPORT FOR LOT 871**  
**CDL Land NZ Limited**

**23 April 2021**  
**Revision: 1**  
**Reference: 235361**

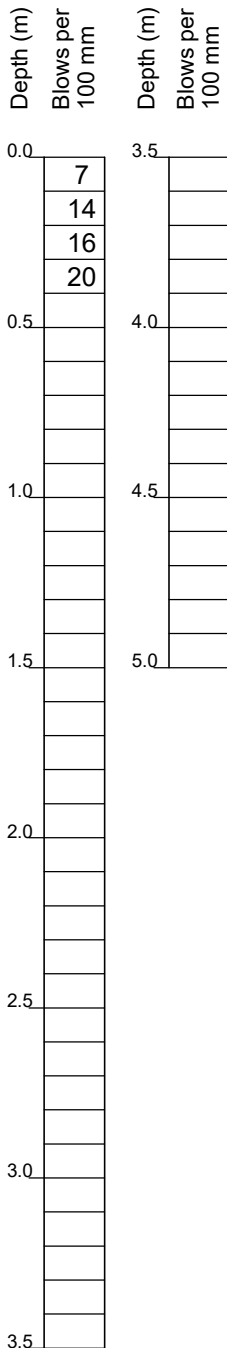
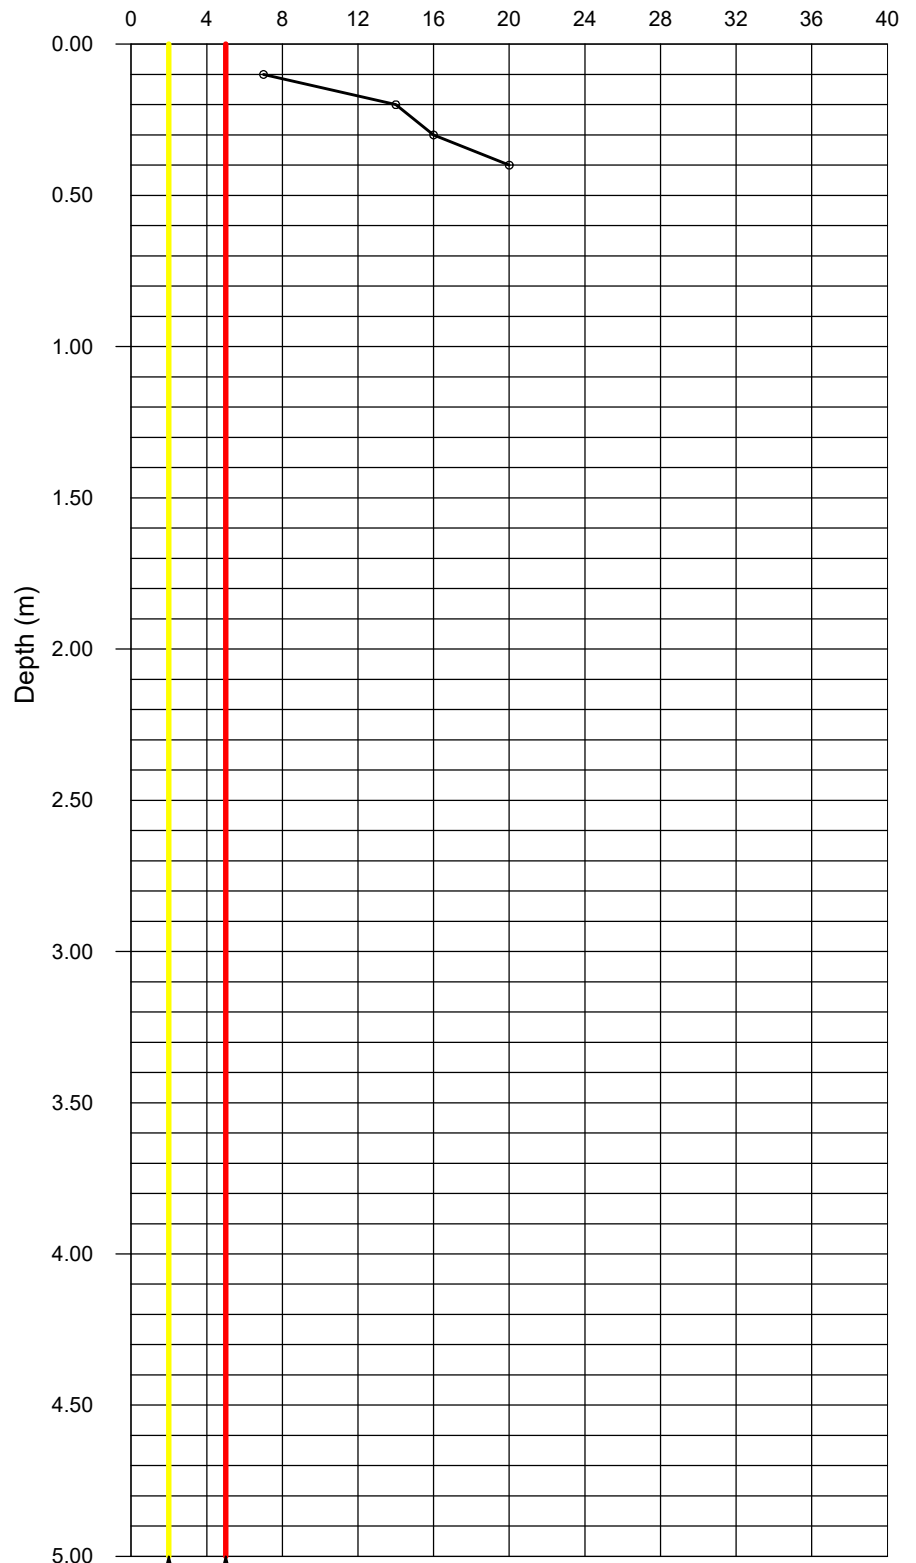
20 blows for 100mm in the last increment.  
Co-ordinates and elevation data from site survey.  
Elevation based on Christchurch Drainage Datum.  
Effective refusal on gravel, 20+ blows per 100mm

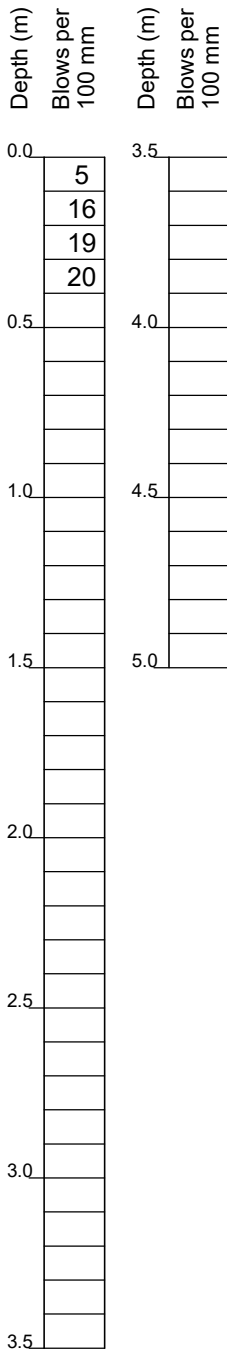
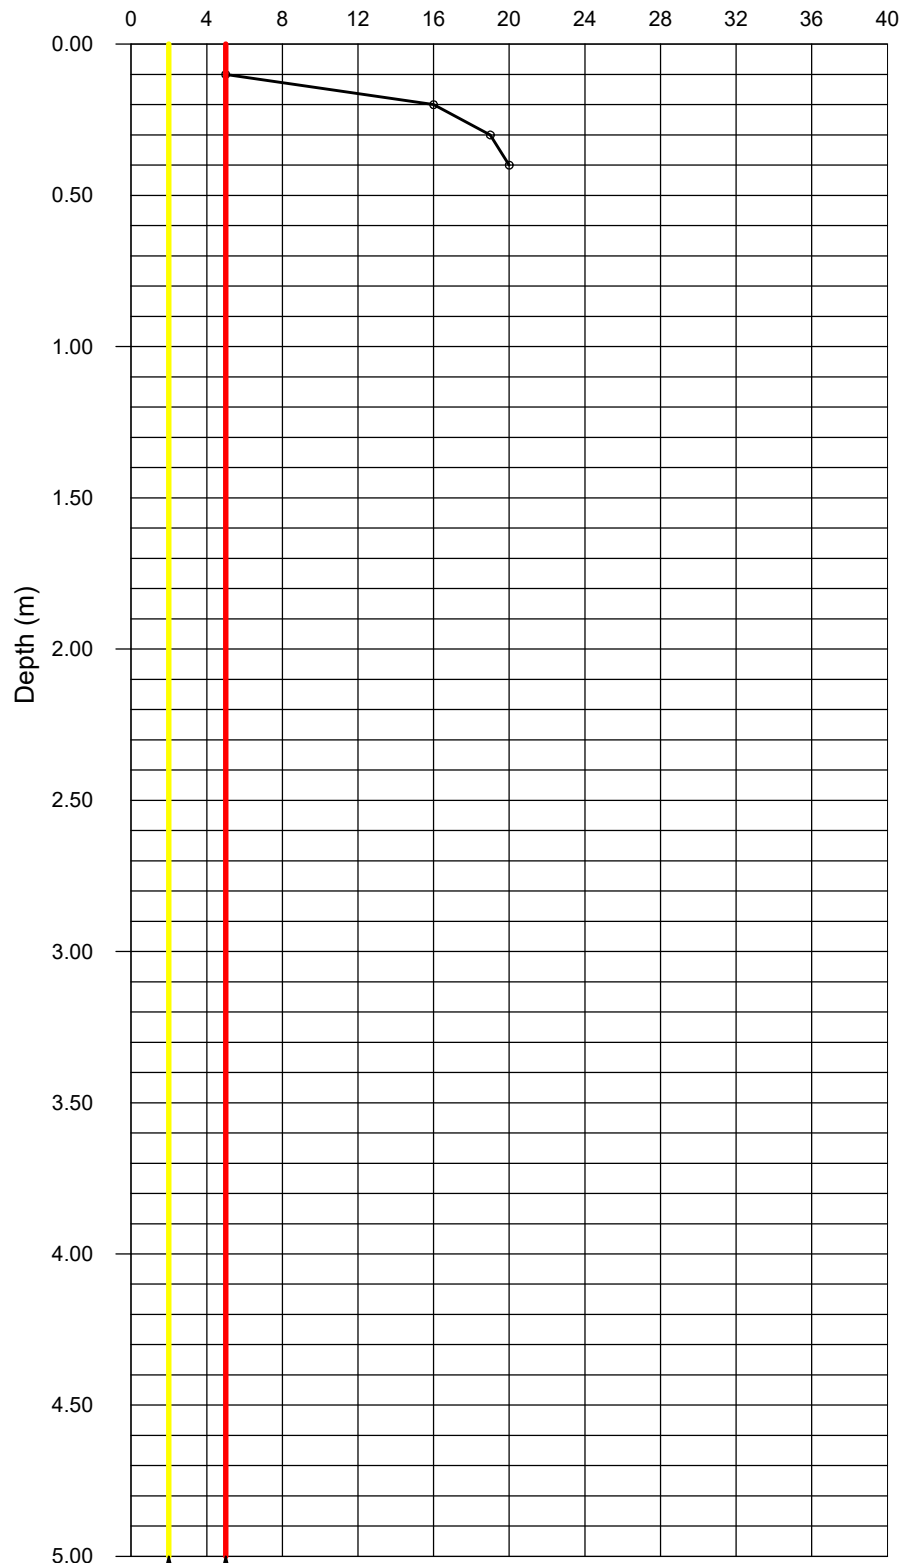
20 blows for 100mm in the last increment.  
Co-ordinates and elevation data from site survey.  
Elevation based on Christchurch Drainage Datum.  
Effective refusal on gravel, 20+ blows per 100mm
