Prestons Subdivision GEOTECHNICAL REPORT FOR LOT 872 CDL Land NZ Limited

23 April 2021 Revision: 1 Reference: 235361

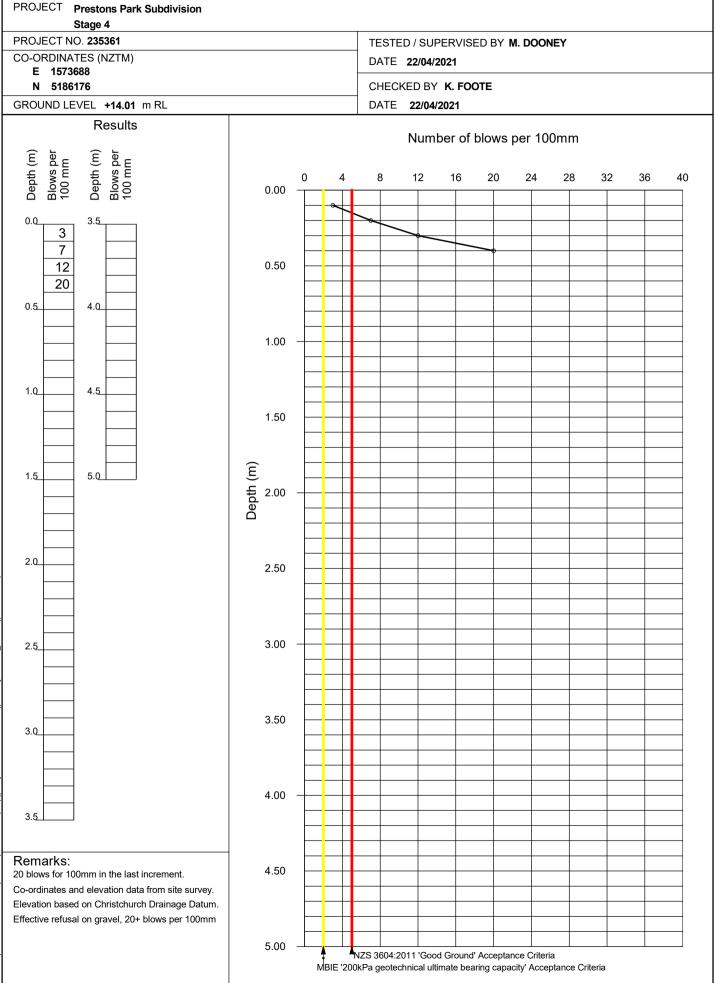
Lot 872 - DCP1

DCP logs indicate 5 blows per 100mm penetration, which is equivalent to an ultimate bearing capacity of 300kPa, was consistently encountered from a shallow depth.

Based on our understanding of the site works and the investigation results, we recommend that NZS3604:2011 compliant foundations are embedded a minimum depth of 0.4m below current ground level.
