**Prestons Subdivision**  
**GEOTECHNICAL REPORT FOR LOT 874**  
**CDL Land NZ Limited**

**30 April 2021**  
**Revision: 1**  
**Reference: 235361**

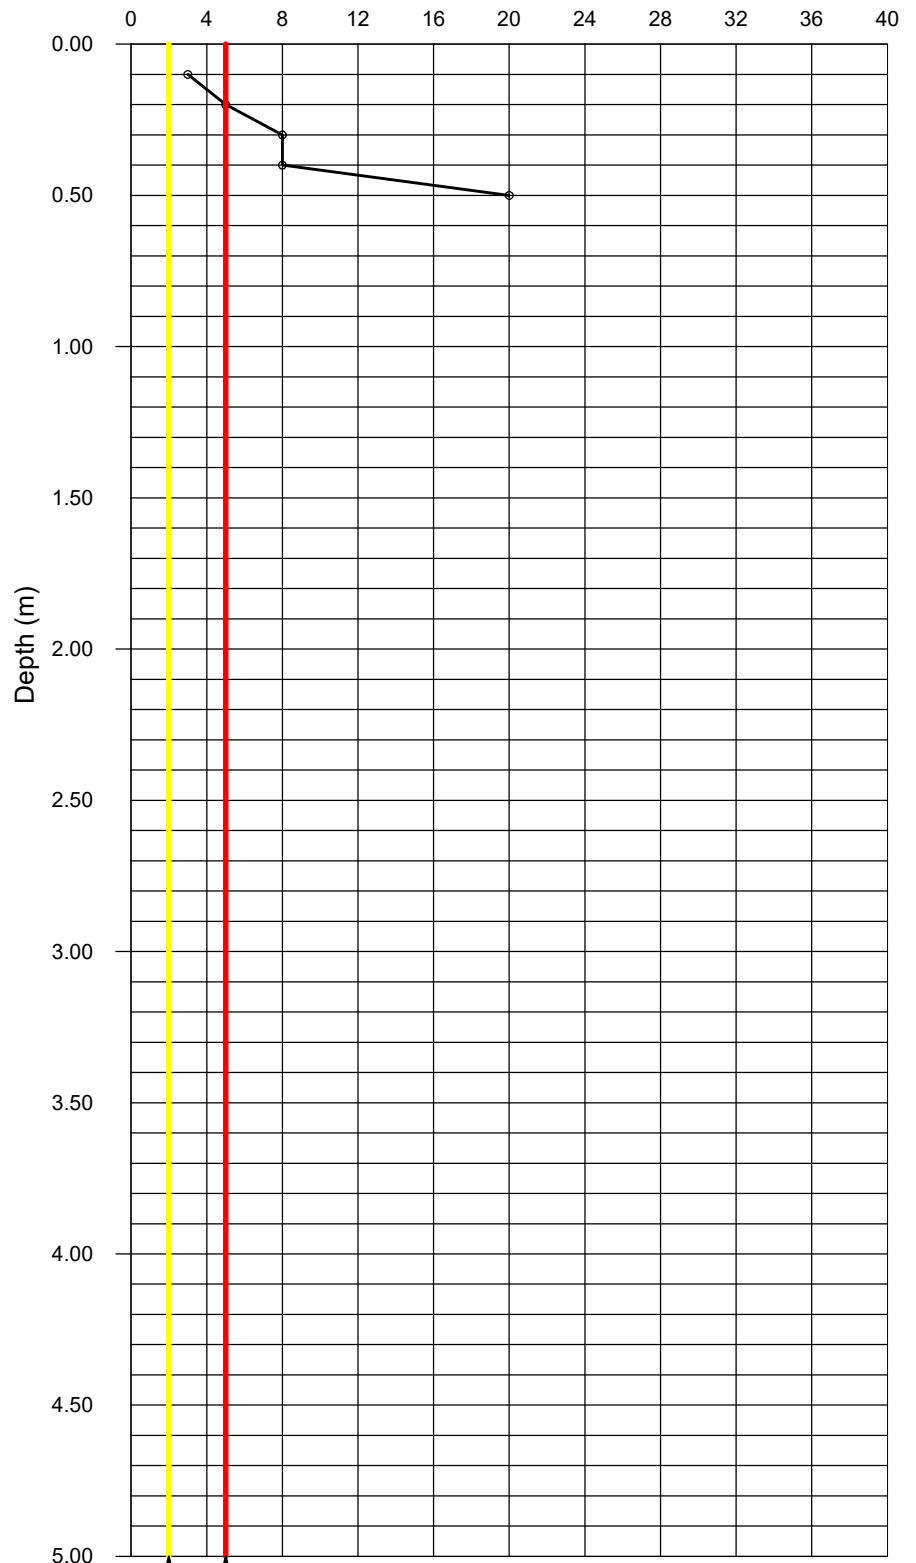
Depth (m)	Blows per 100 mm	Depth (m)	Blows per 100 mm
0.0	3	3.5	
0.1	5		
0.2	8		
0.3	8		
0.4	20		
0.5		4.0	
1.0		4.5	
1.5		5.0	
2.0			
2.5			
3.0			
3.5

20 blows for 100mm in the last increment.  
Co-ordinates and elevation data from site survey.  
Elevation based on Christchurch Drainage Datum.  
Effective refusal on gravel, 20+ blows per 100mm

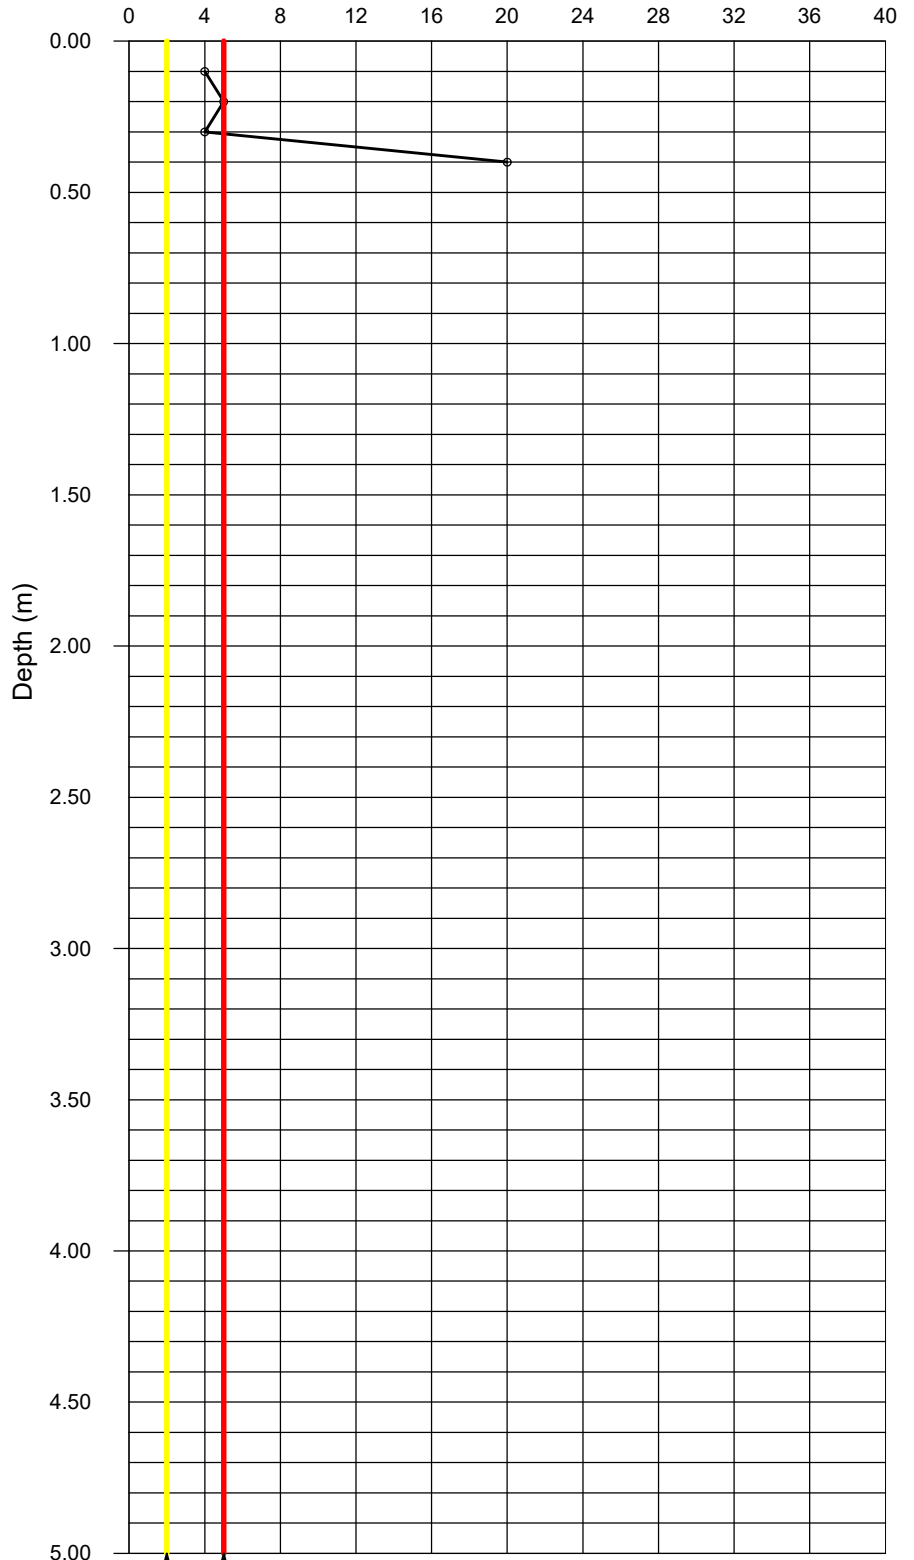
Depth (m)	Blows per 100 mm	Depth (m)	Blows per 100 mm
0.0	4	3.5	
0.1	5		
0.2	4		
0.3	20		
0.4		4.0	
0.5			
1.0		4.5	
1.5		5.0	
2.0			
2.5			
3.0			
3.5

20 blows for 100mm in the last increment.  
Co-ordinates and elevation data from site survey.  
Elevation based on Christchurch Drainage Datum.  
Effective refusal on gravel, 20+ blows per 100mm
