Prestons Subdivision
GEOTECHNICAL REPORT FOR LOT 914
CDL Land NZ Limited

30 April 2021 Revision: 1 Reference: 235361

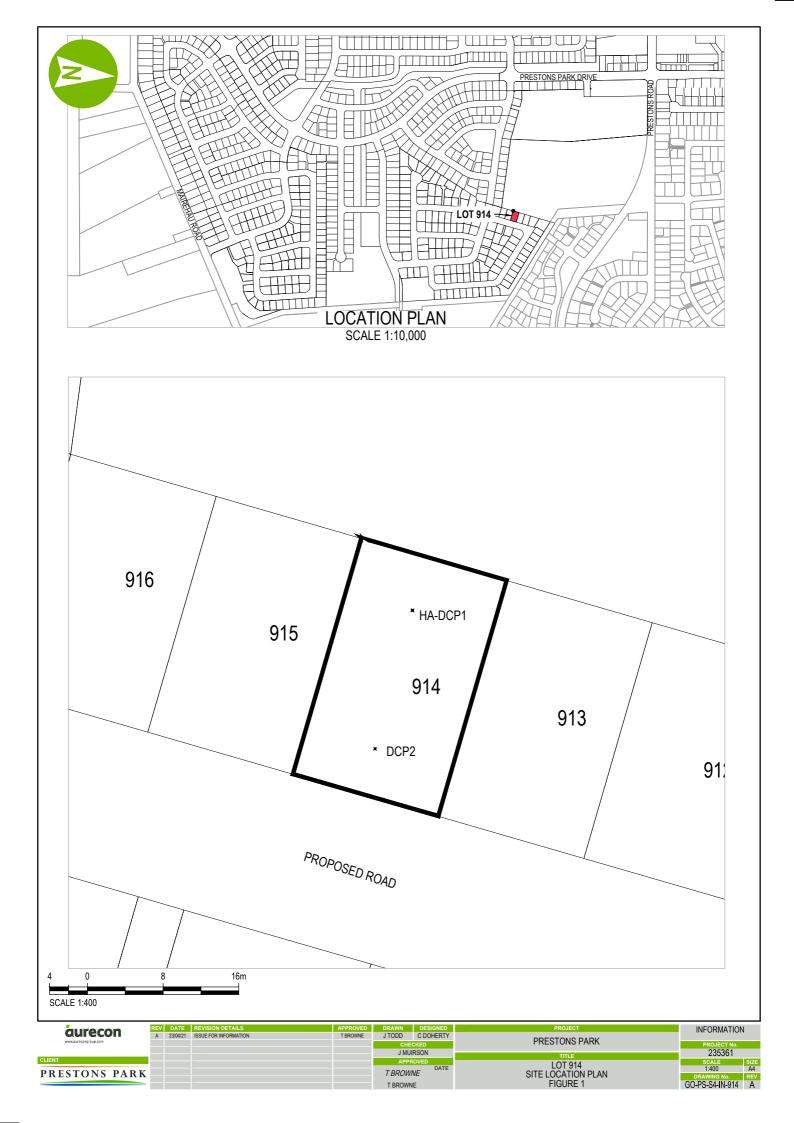
This building consent report is for Lot 914 which is located in Stage 4 of the Prestons South Subdivision development (refer Figure 1 in Appendix A). The lot is bordered by residential lots to the north and south, an access road to the east and the Alpine View Retirement Village to the west.

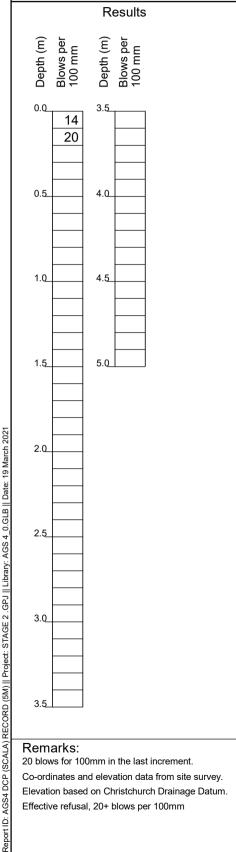
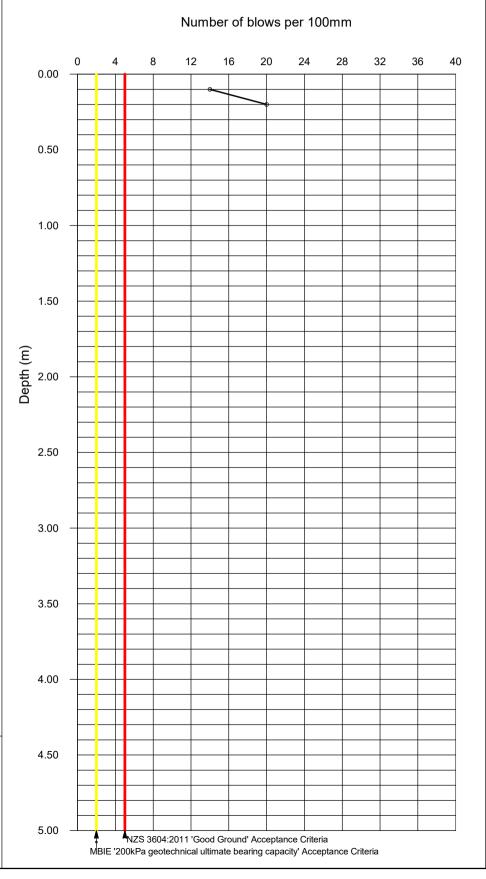
Lot 914 - DCP1

DCP logs indicate 5 blows per 100mm penetration, which is equivalent to an ultimate bearing capacity of 300kPa, was consistently encountered from a shallow depth.

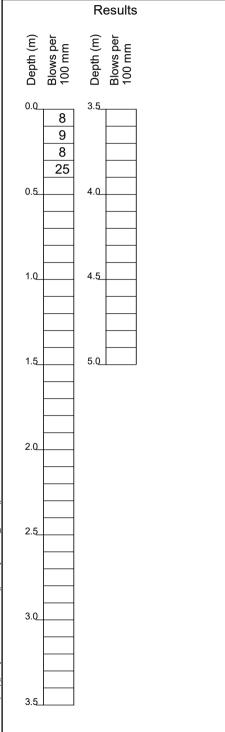
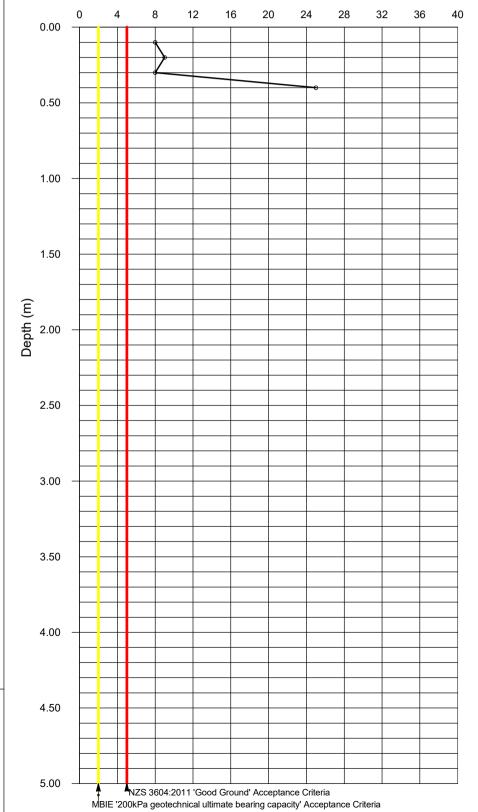
Lot 914 - DCP2

25 blows for 100mm in the last increment.

Effective refusal, 20+ blows per 100mm
