Prestons Park Subdivision GEOTECHNICAL REPORT FOR LOT 889 CDL Land NZ Limited

23 April 2021 Revision: 1 Reference: 235361

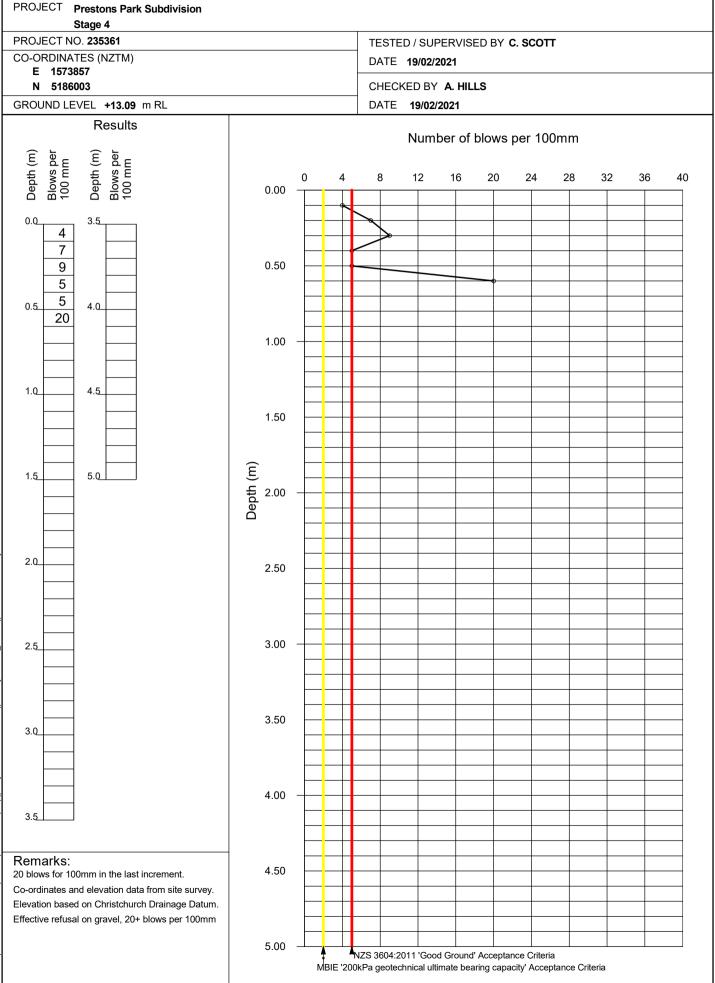
Lot 889 - DCP1

DCP logs indicate two blows per 100mm penetration, which is equivalent to an ultimate bearing capacity of 200kPa, was consistently encountered from a shallow depth.
