Prestons Park Subdivision GEOTECHNICAL REPORT FOR LOT 890 CDL Land NZ Limited

23 April 2021 Revision: 1 Reference: 235361

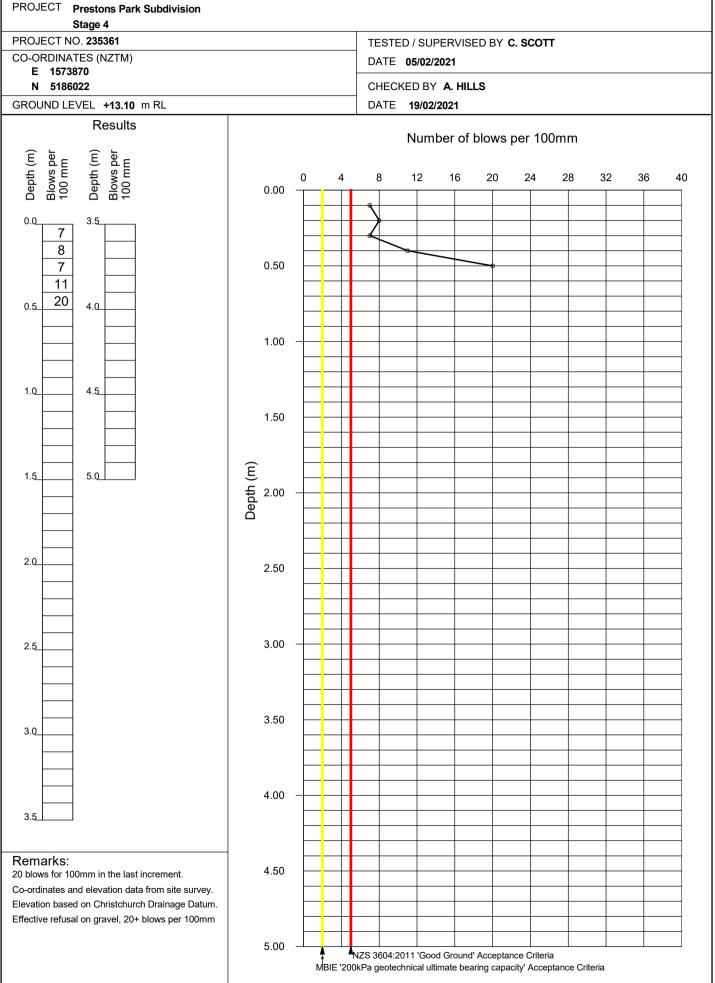
Lot 890 - DCP1

DCP logs indicate two blows per 100mm penetration, which is equivalent to an ultimate bearing capacity of 200kPa, was consistently encountered from a shallow depth.
