**Prestons Park Subdivision**  
**GEOTECHNICAL REPORT FOR LOT 891**  
**CDL Land NZ Limited**

**23 April 2021**  
**Revision: 1**  
**Reference: 235361**

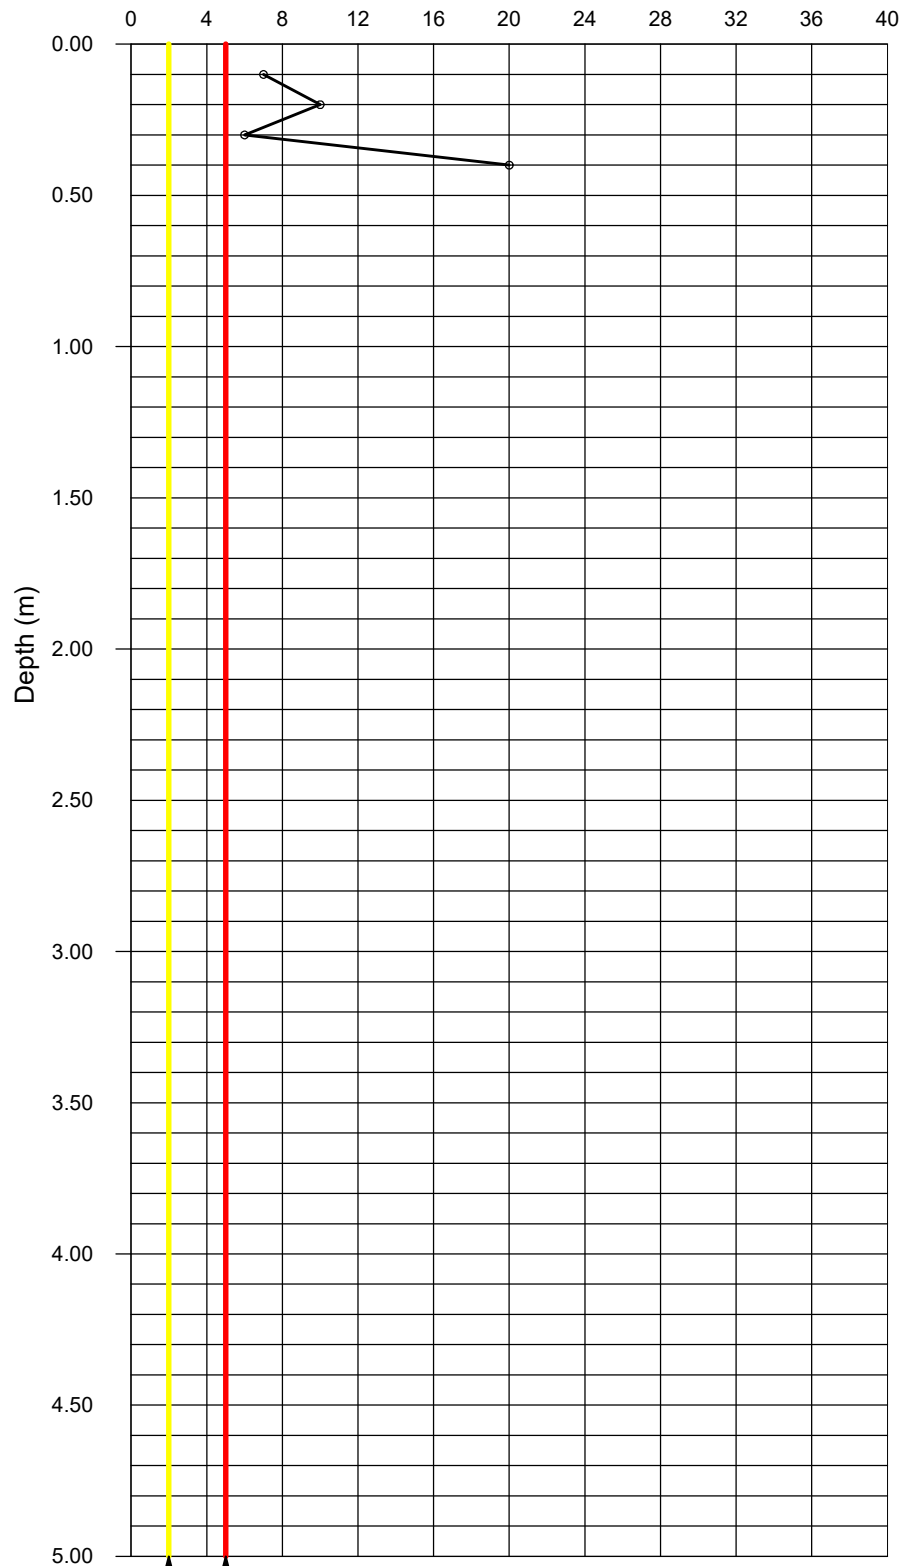
DCP logs indicate two blows per 100mm penetration, which is equivalent to an ultimate bearing capacity of 200kPa, was consistently encountered from a shallow depth.

20 blows for 100mm in the last increment.  
Co-ordinates and elevation data from site survey.  
Elevation based on Christchurch Drainage Datum.  
Effective refusal on gravel, 20+ blows per 100mm

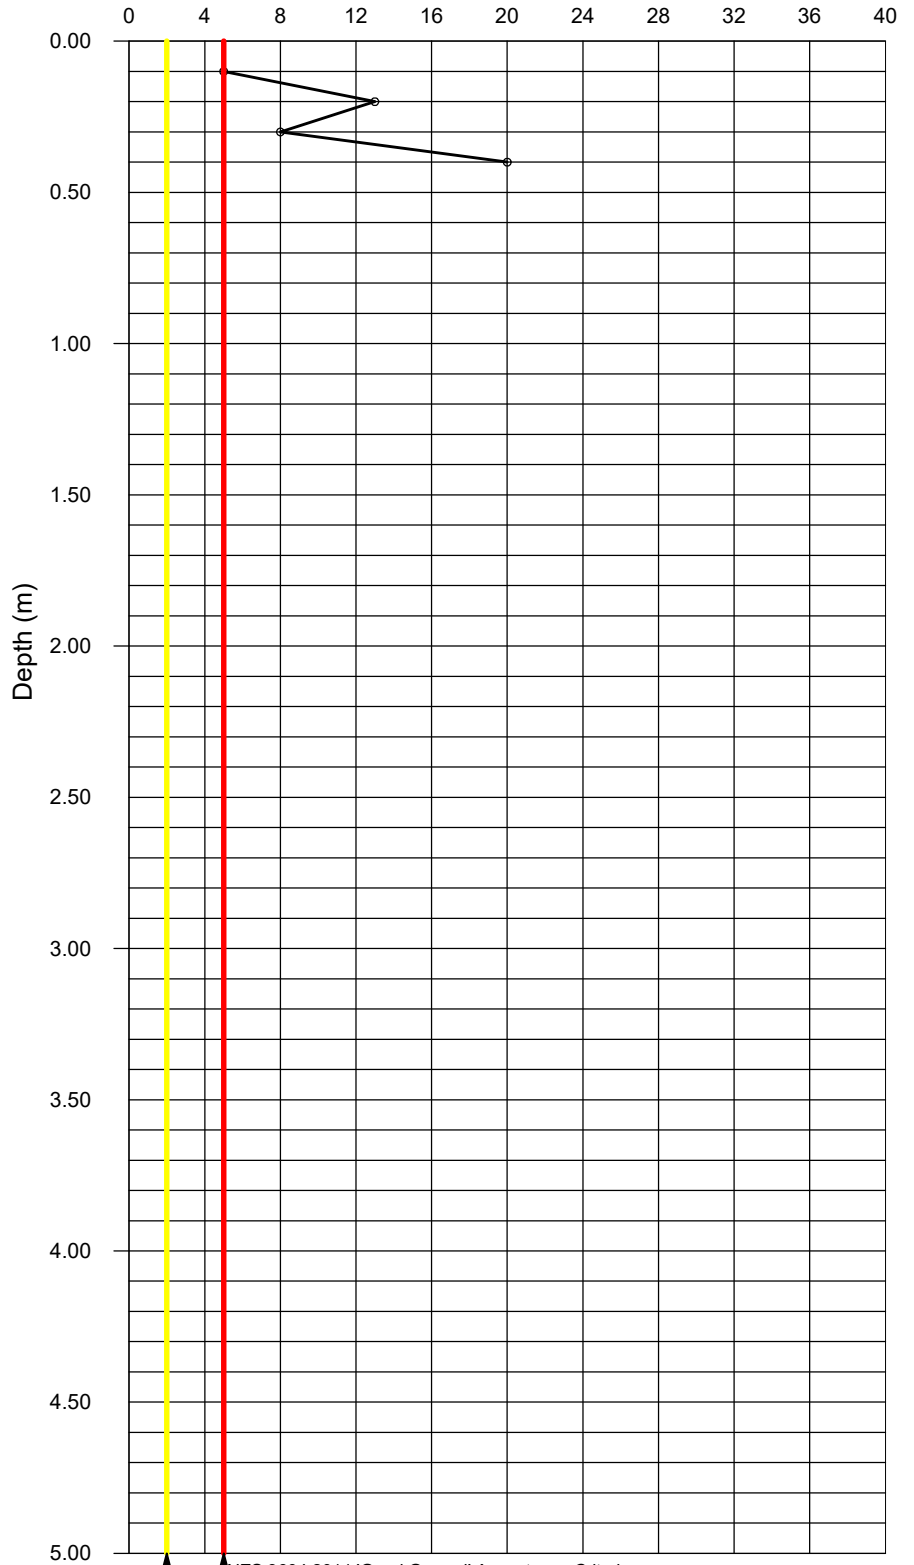
20 blows for 100mm in the last increment.  
Co-ordinates and elevation data from site survey.  
Elevation based on Christchurch Drainage Datum.  
Effective refusal on gravel, 20+ blows per 100mm
