Prestons Park Subdivision
GEOTECHNICAL REPORT FOR LOT 893
CDL Land NZ Limited

23 April 2021
Revision: 1
Reference: 235361

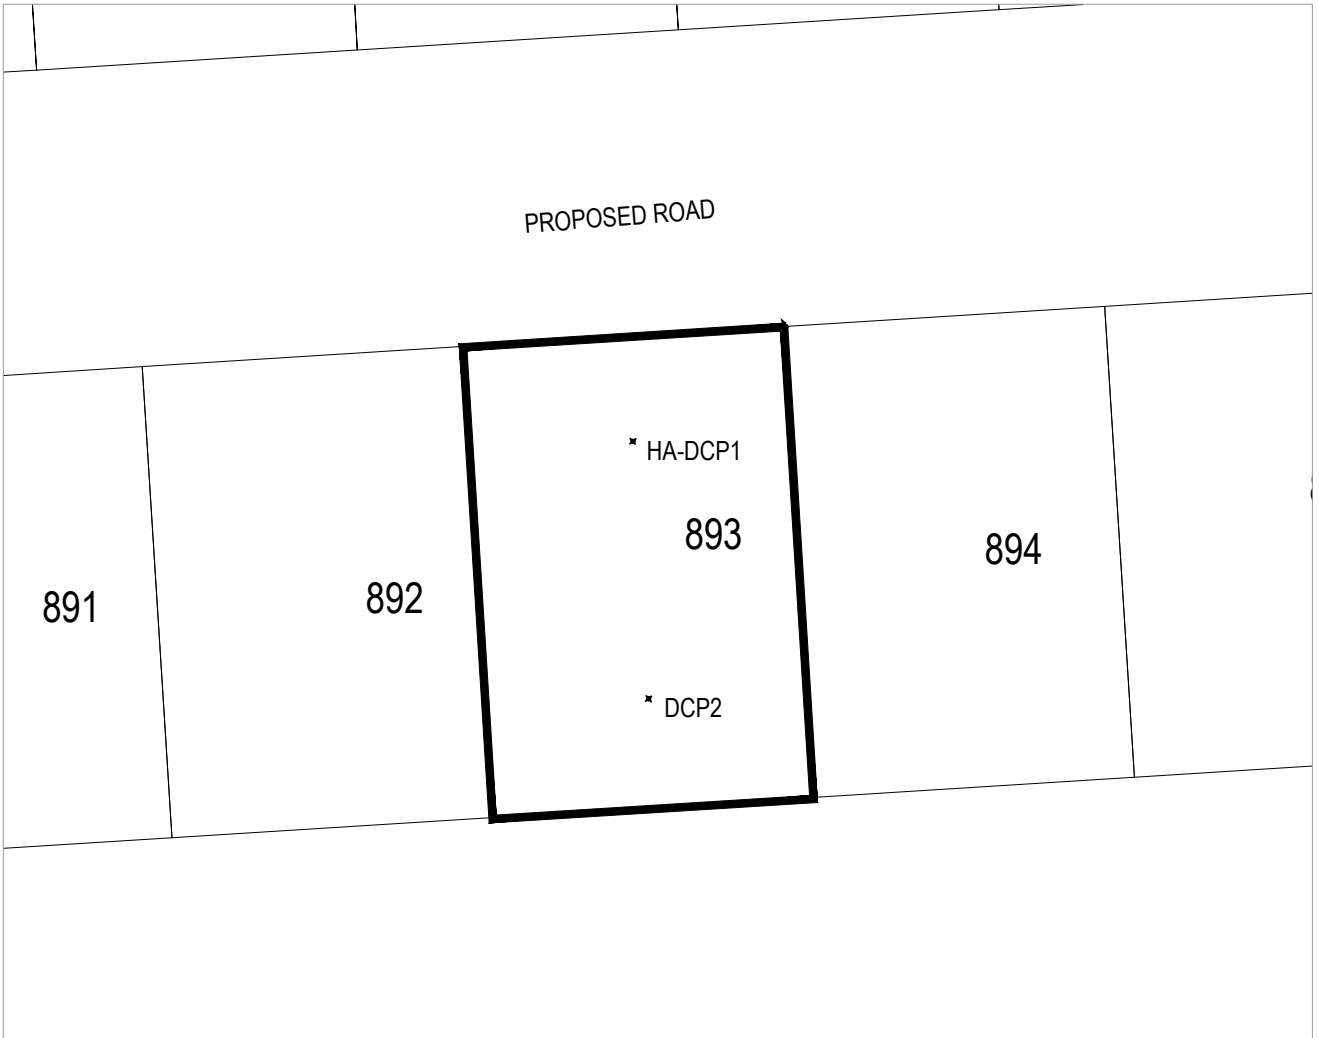
PROJECT	
PRESTONS PARK	
TITLE	
LOT 893	
SITE LOCATION PLAN	
FIGURE 1

This building consent report is for Lot 893 which is located in Stage 4 of the Prestons South Subdivision development (refer Figure 1 in Appendix A). The lot is bordered by residential lots to the north and south, an access road to the west and a storm water channel to the east.

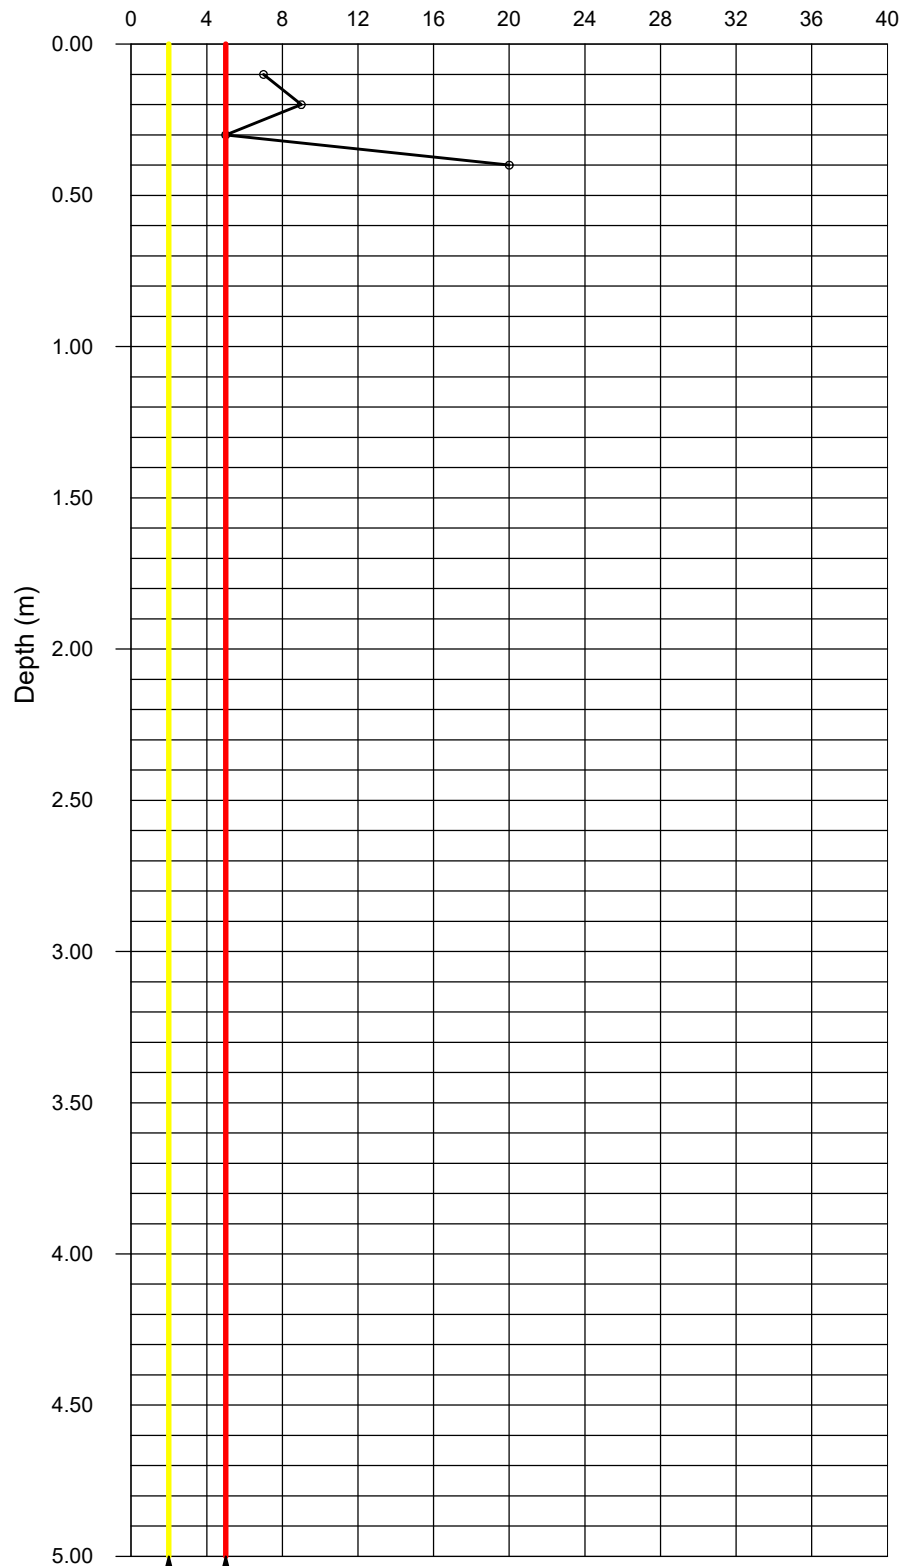
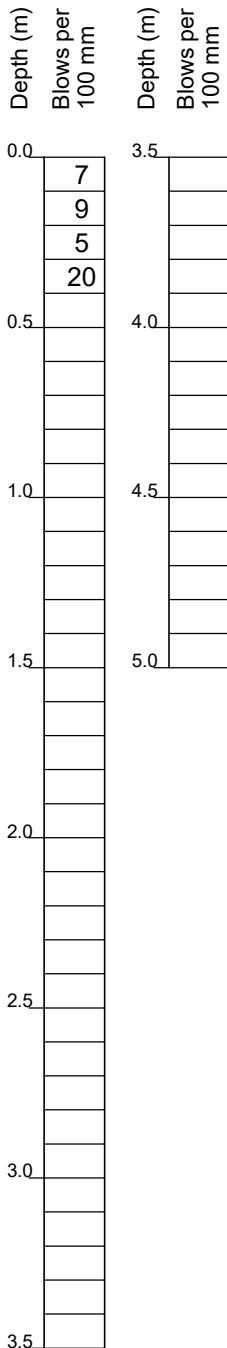
DCP logs indicate two blows per 100mm penetration, which is equivalent to an ultimate bearing capacity of 200kPa, was consistently encountered from a shallow depth.

20 blows for 100mm in the last increment.
Co-ordinates and elevation data from site survey.
Elevation based on Christchurch Drainage Datum.
Effective refusal on gravel, 20+ blows per 100mm

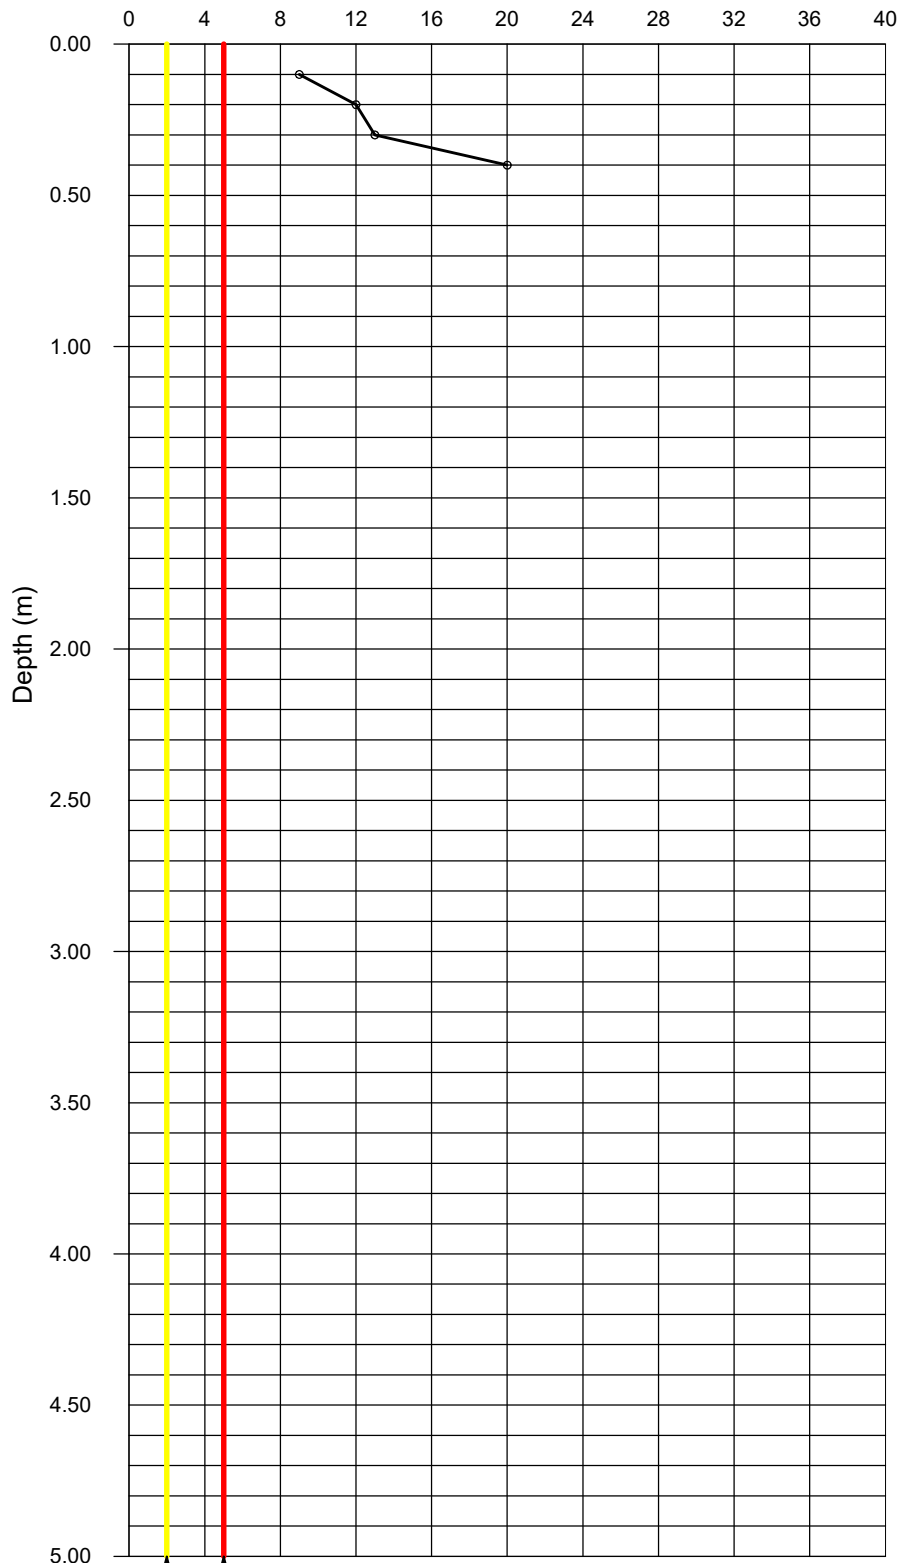
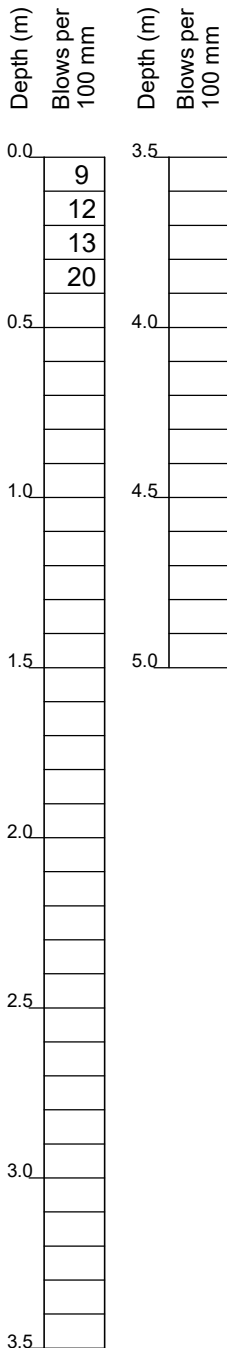
20 blows for 100mm in the last increment.
Co-ordinates and elevation data from site survey.
Elevation based on Christchurch Drainage Datum.
Effective refusal on gravel, 20+ blows per 100mm
