**Prestons Park Subdivision GEOTECHNICAL REPORT FOR LOT 894 CDL Land NZ Limited**

23 April 2021 Revision: 1 Reference: 235361

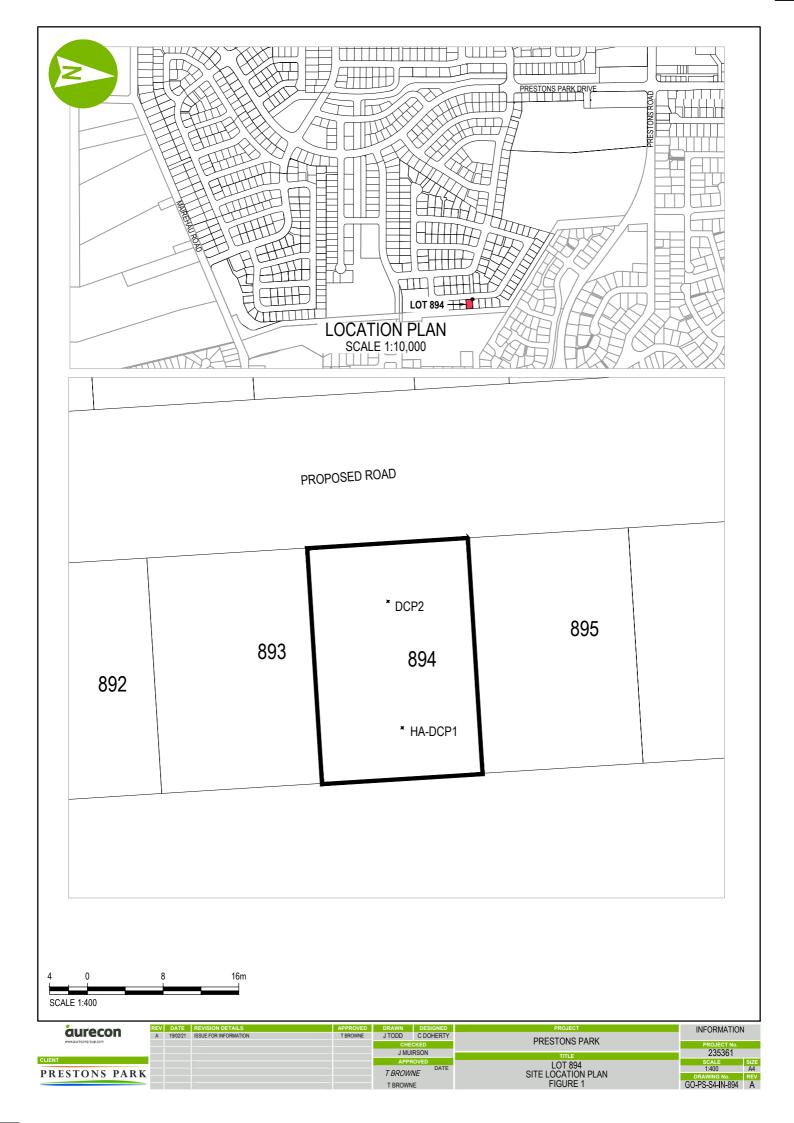
This building consent report is for Lot 894 which is located in Stage 4 of the Prestons South Subdivision development (refer Figure 1 in Appendix A). The lot is bordered by residential lots to the north and south, an access road to the west and a storm water channel to the east.
