Prestons Park Subdivision
GEOTECHNICAL REPORT FOR LOT 896
CDL Land NZ Limited

23 April 2021 Revision: 1 Reference: 235361

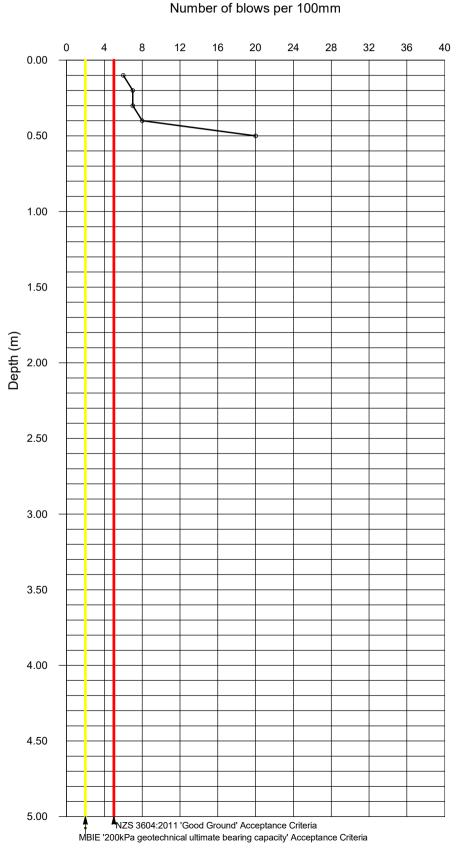
Lot 896 - DCP1

DCP logs indicate two blows per 100mm penetration, which is equivalent to an ultimate bearing capacity of 200kPa, was consistently encountered from a shallow depth.

Blows per 100 mm Depth (m) 0.0 3.5 6 7 7 8 20 4.0 0.5 1.0 4.5 5.0_ Report ID: AGS4 DCP (SCALA) RECORD (5M) || Project: STAGE 4.GPJ || Library: AGS 4 0.GLB || Date: 25 February 2021 2.0 2.5

20 blows for 100mm in the last increment. Co-ordinates and elevation data from site survey. Elevation based on Christchurch Drainage Datum. Effective refusal on gravel, 20+ blows per 100mm
