Prestons Park Subdivision
GEOTECHNICAL REPORT FOR LOT 908
CDL Land NZ Limited

21 October 2021
Revision: 1
Reference: 235361

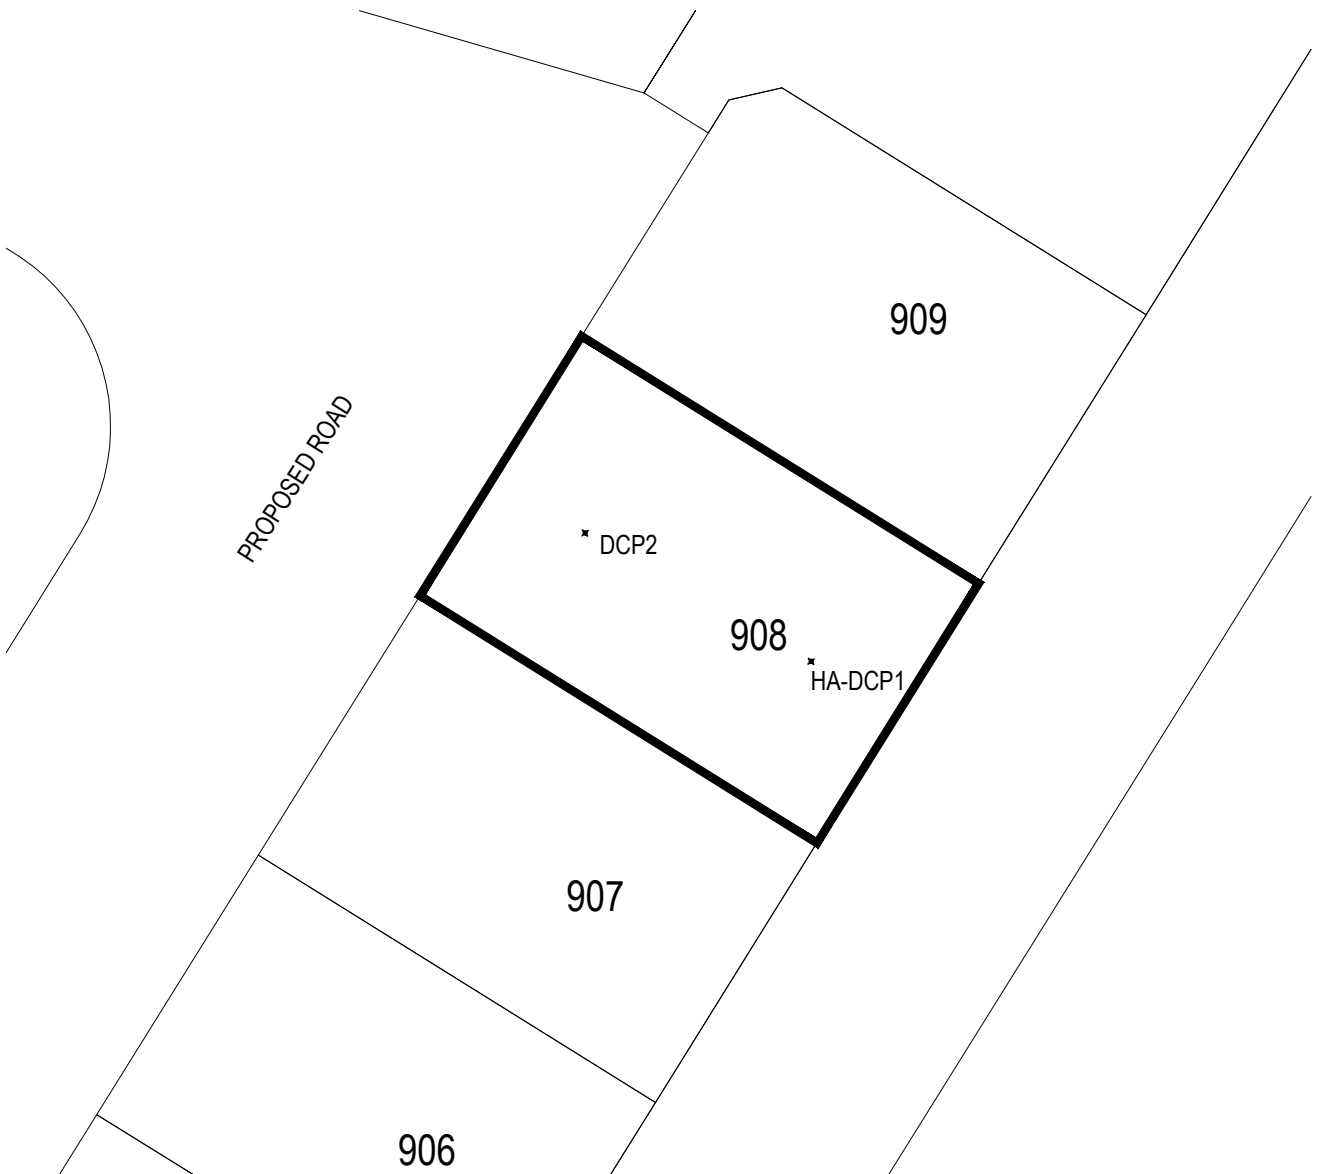
This building consent report is for Lot 908 which is located in Stage 4 of the Prestons South Subdivision development (refer Figure 1 in Appendix A). The lot is bordered by residential lots to the east and west, an access road to the south and a local purpose reserve (utility) to the north.

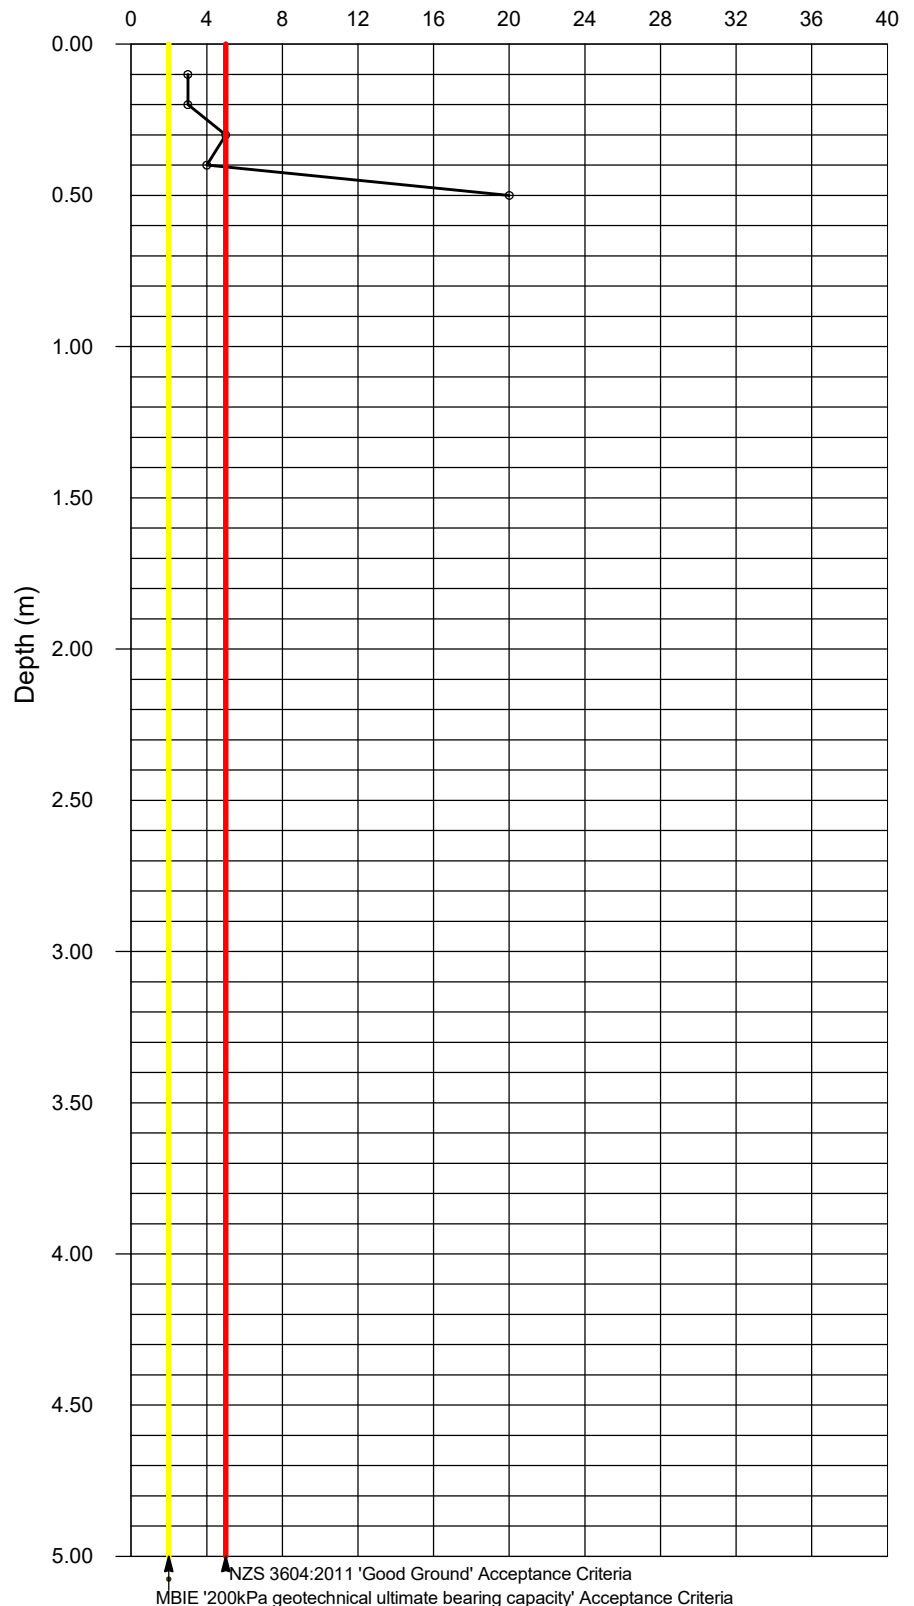
DCP logs indicate two blows per 100mm penetration, which is equivalent to an ultimate bearing capacity of 200kPa, was consistently encountered from a shallow depth.

20 blows for 100mm in the last increment.

Effective refusal on gravel, 20+ blows per 100mm

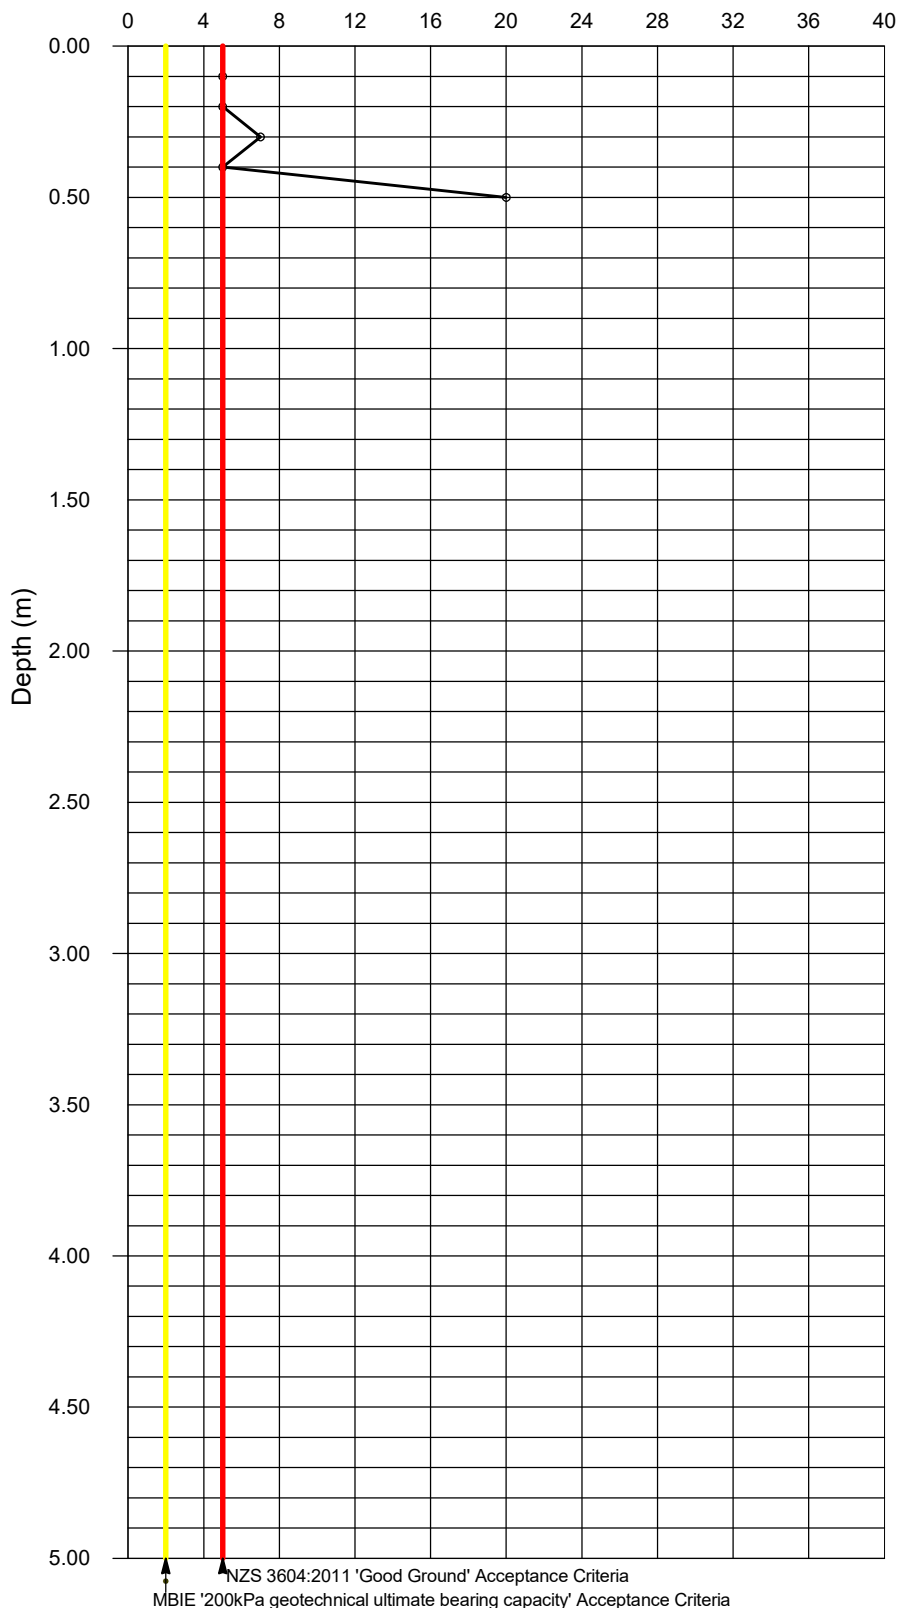
20 blows for 100mm in the last increment.
Co-ordinates and elevation data from site survey.
Elevation based on Christchurch Drainage Datum.
Effective refusal on gravel, 20+ blows per 100mm
