Prestons Subdivision GEOTECHNICAL REPORT FOR LOT 4001 CDL Land NZ Limited

26 August 2021 Revision: 1

Reference: 235361

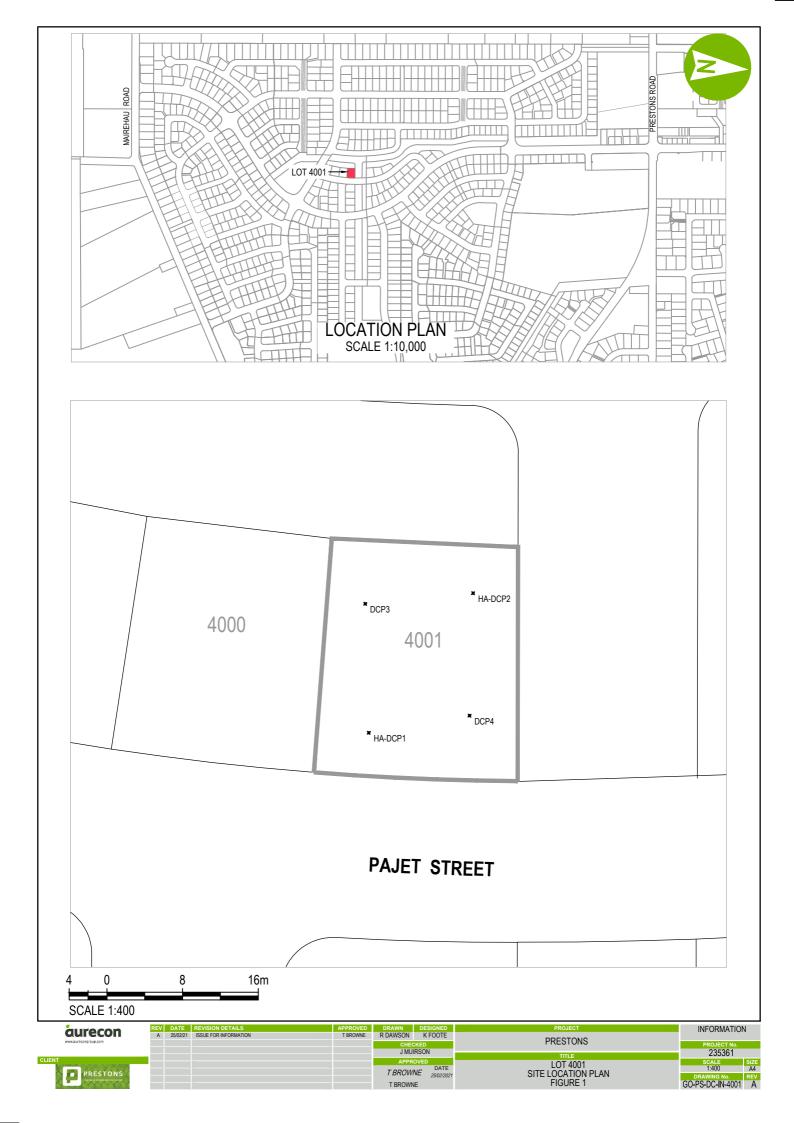
This building consent report is for Lot 4001 which is located in Stage 2 of the Prestons South Subdivision development (refer Figure 1 in Appendix A). The lot is bordered by a residential lot to the south, an access road to the east and an open storm water channel to the west and north.

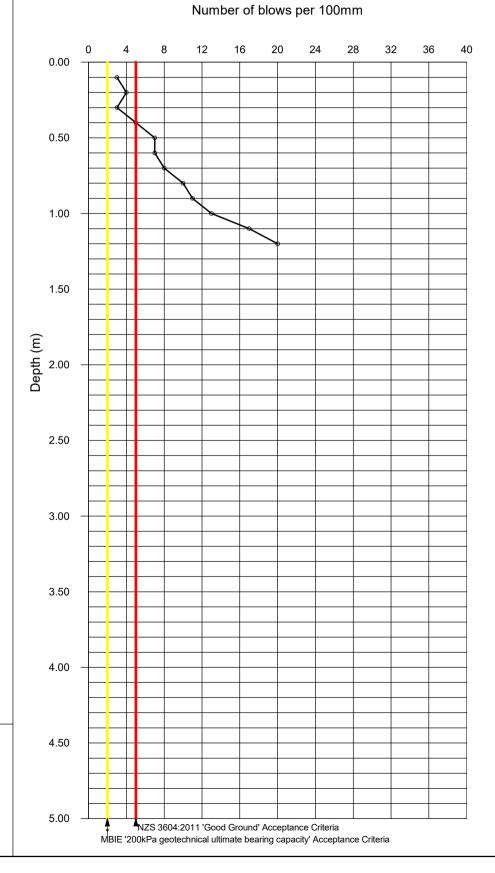
Lot 4001 DCP1

DCP logs indicate 5 blows per 100mm penetration, which is equivalent to an ultimate bearing capacity of 300kPa, was consistently encountered from a shallow depth.

Results Depth (m) Blows per 100 mm Blows per 100 mm 0.0 3.5 3 4 3 5 7 4.0 0.5 7 8 10 11 13 1.0 4.5_ 17 20 5.0_ 2.0 2.5

Effective refusal, 20+ blows per 100mm penetration.
