Prestons Subdivision
GEOTECHNICAL REPORT FOR LOT 1052
CDL Land NZ Limited

25 August 2021
Revision: 1
Reference: 235361

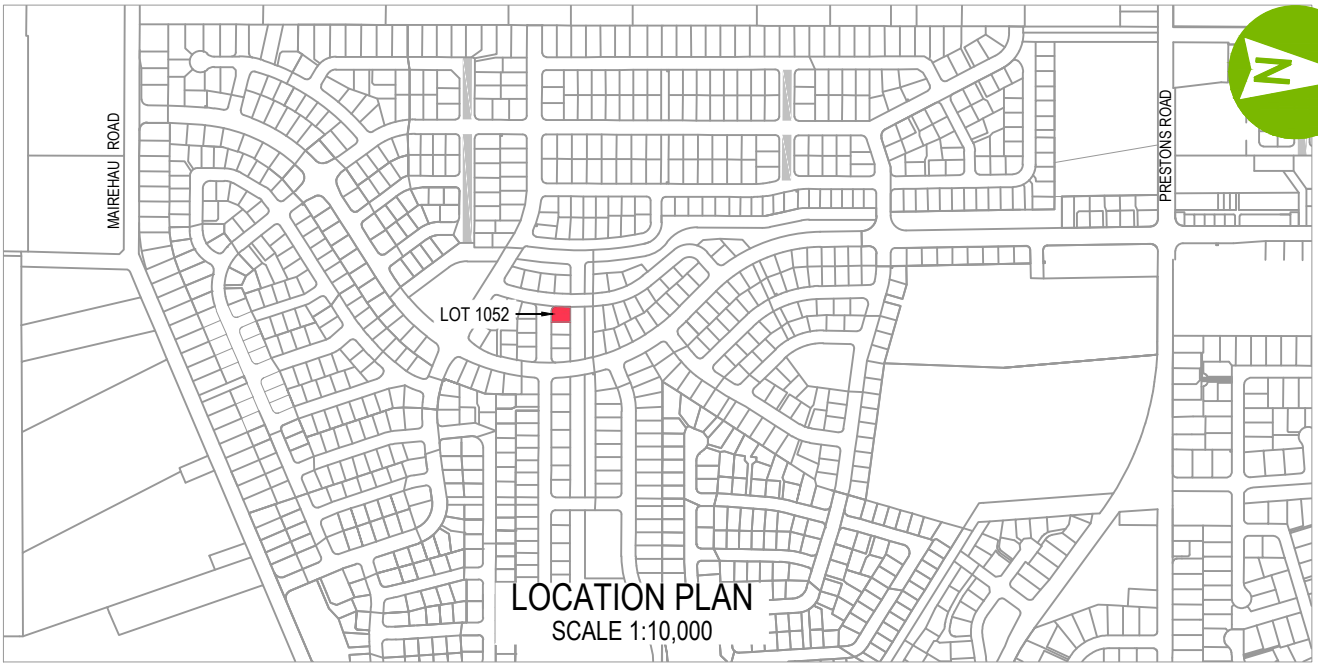
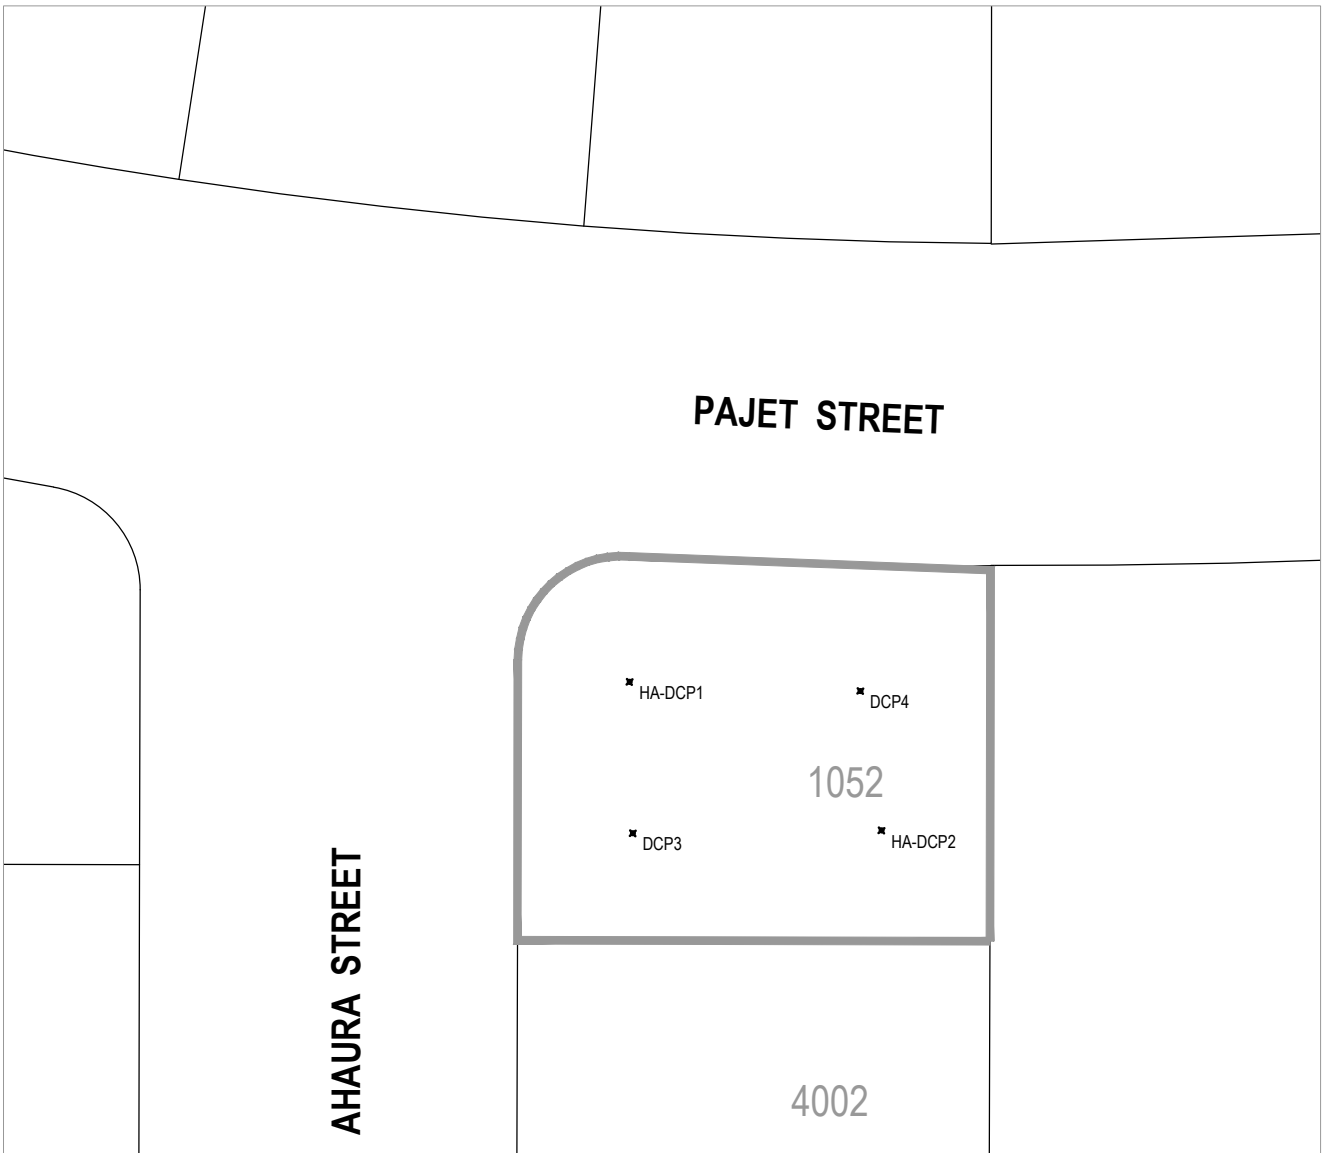
PROJECT
PRESTONS
TITLE
LOT 1052 SITE LOCATION PLAN FIGURE 1

This building consent report is for Lot 1052 which is located in Stage 2 of the Prestons South Subdivision development (refer Figure 1 in Appendix A). The lot is bordered by a residential lot to the east, access roads to the south and west, and an open storm water channel to the north.

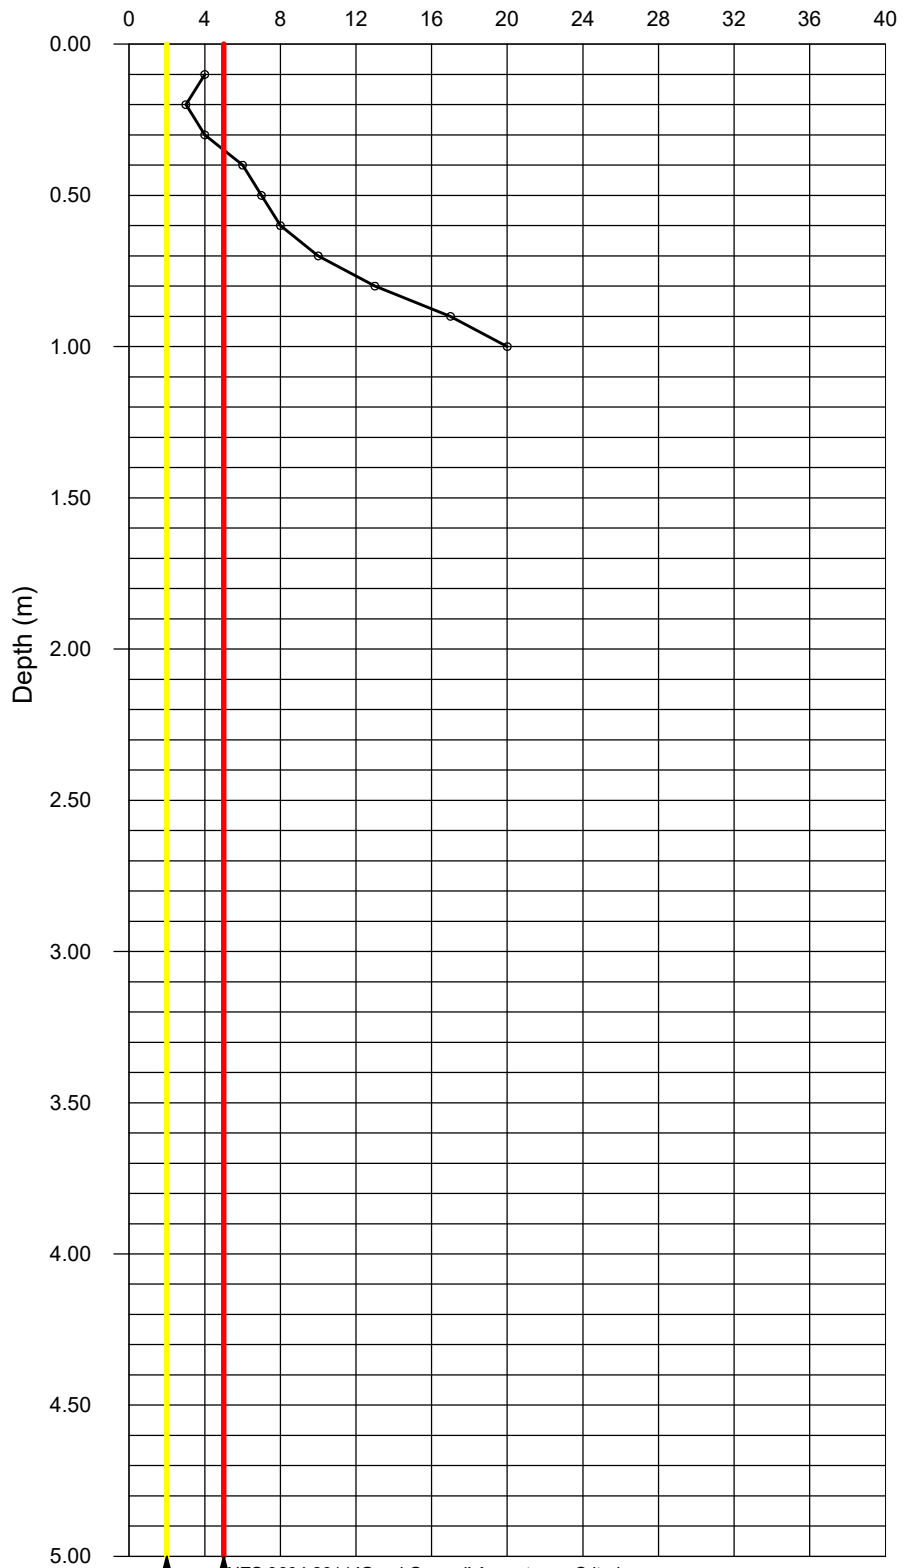
DCP logs indicate 5 blows per 100mm penetration, which is equivalent to an ultimate bearing capacity of 300kPa, was consistently encountered from a shallow depth.

20 blows for 100mm in the last increment.
Co-ordinates and elevation data from site survey.
Elevation based on Lyttelton Vertical Datum.
Effective refusal, 20+ blows per 100mm penetration.

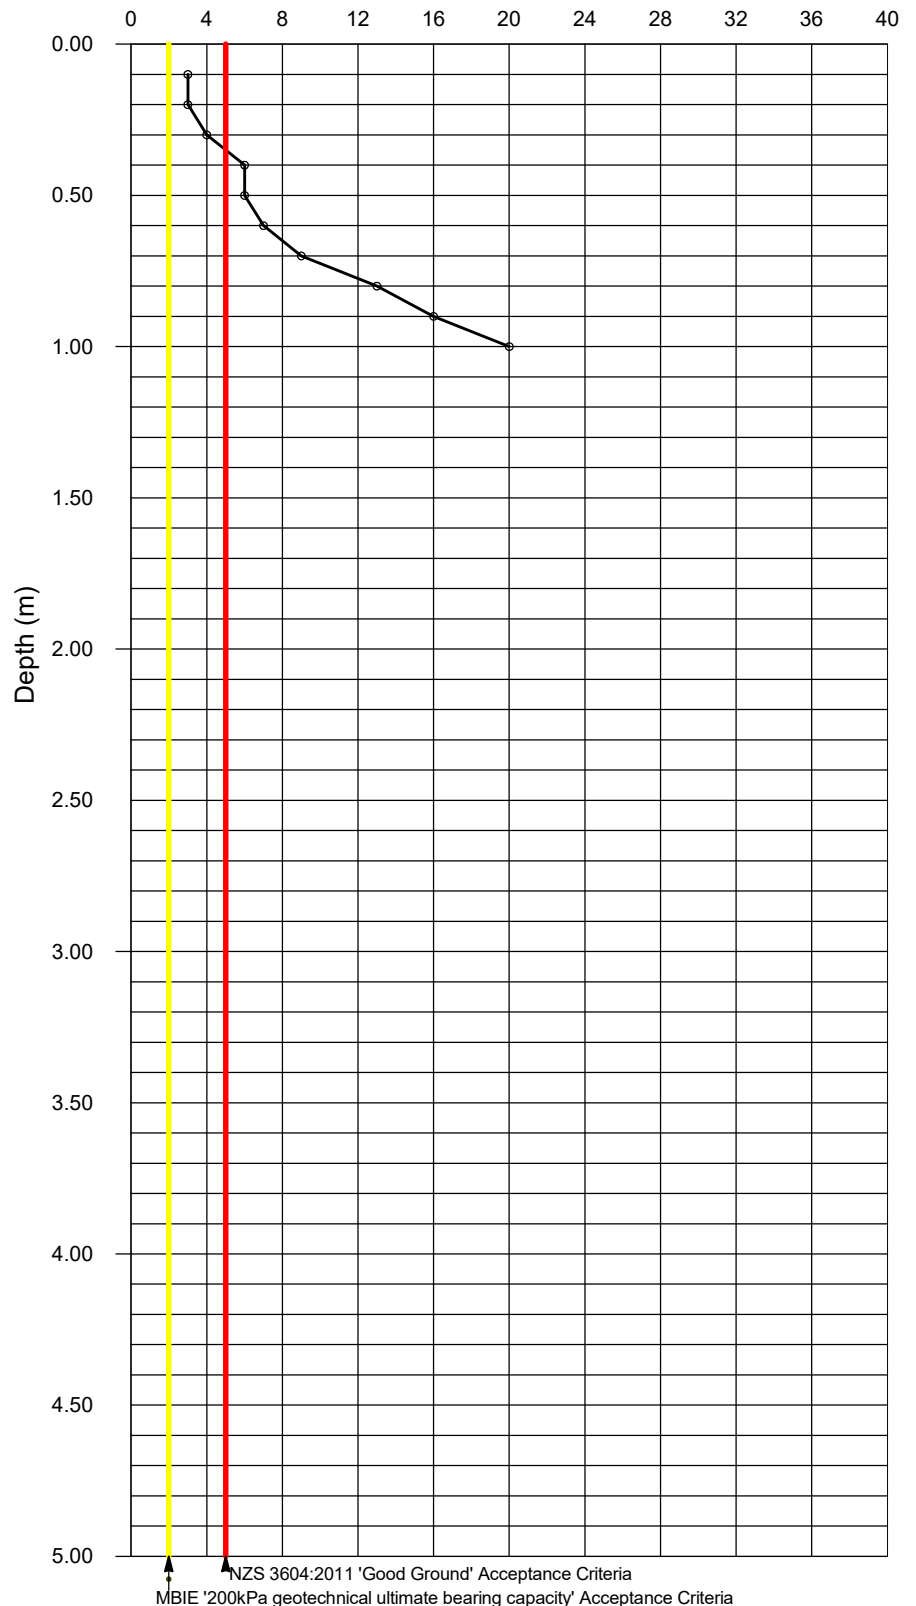
20 blows for 100mm in the last increment.
Co-ordinates and elevation data from site survey.
Elevation based on Lyttelton Vertical Datum.
Effective refusal, 20+ blows per 100mm penetration.

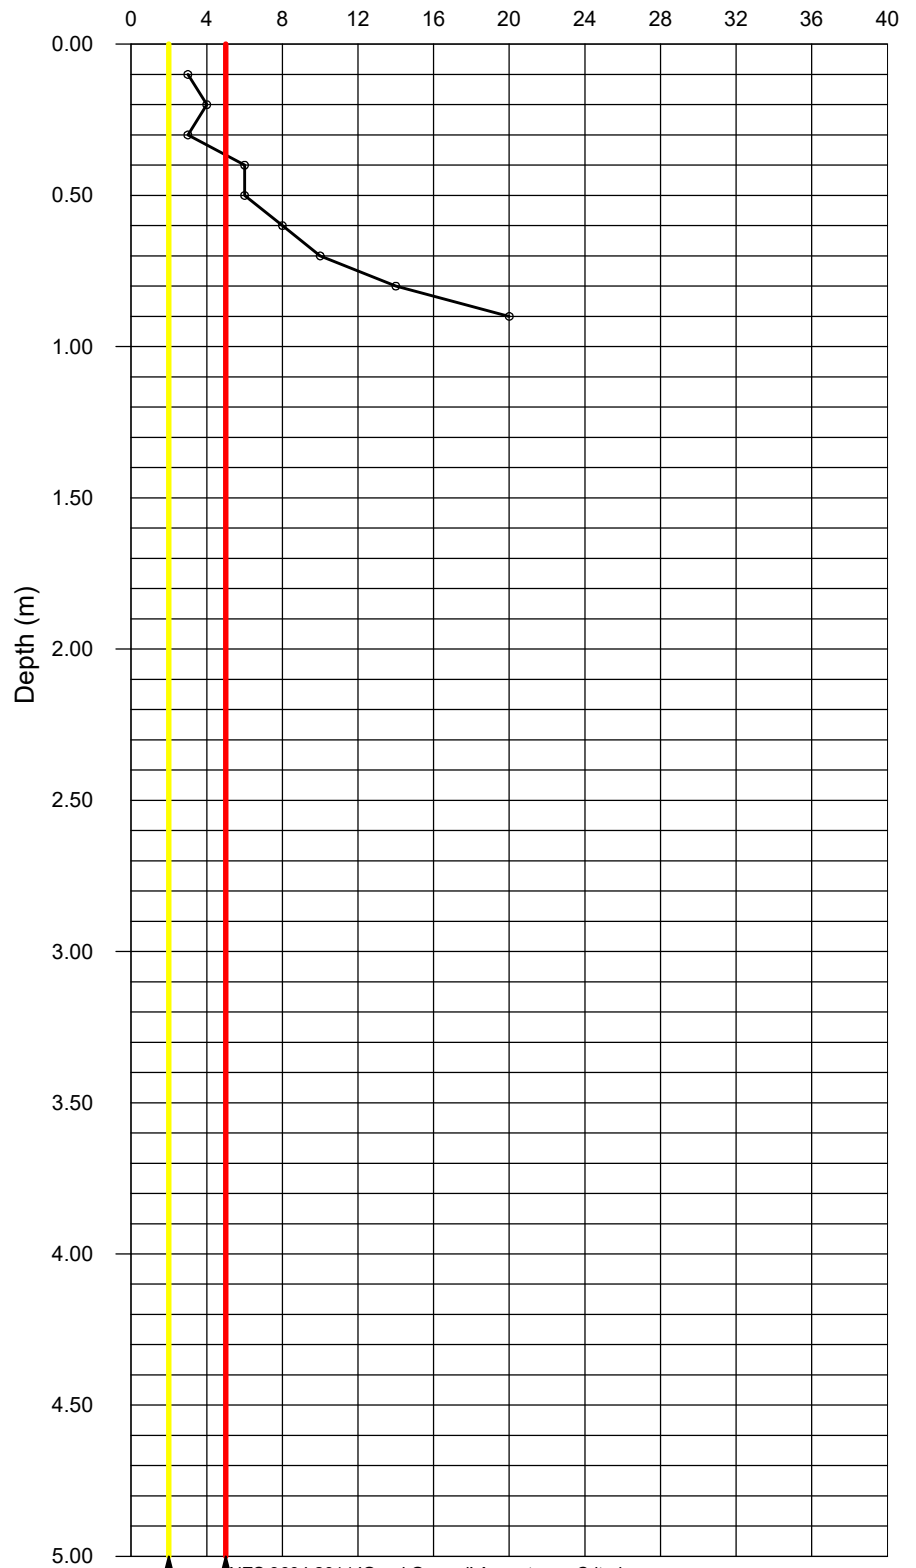
blows for 100mm in the last increment.
Co-ordinates and elevation data from site survey.
Elevation based on Lyttelton Vertical Datum.
Effective refusal, 20+ blows per 100mm penetration.
