Prestons Subdivision
GEOTECHNICAL REPORT FOR LOT 4002
CDL Land NZ Limited

26 August 2021
Revision: 1
Reference: 235361

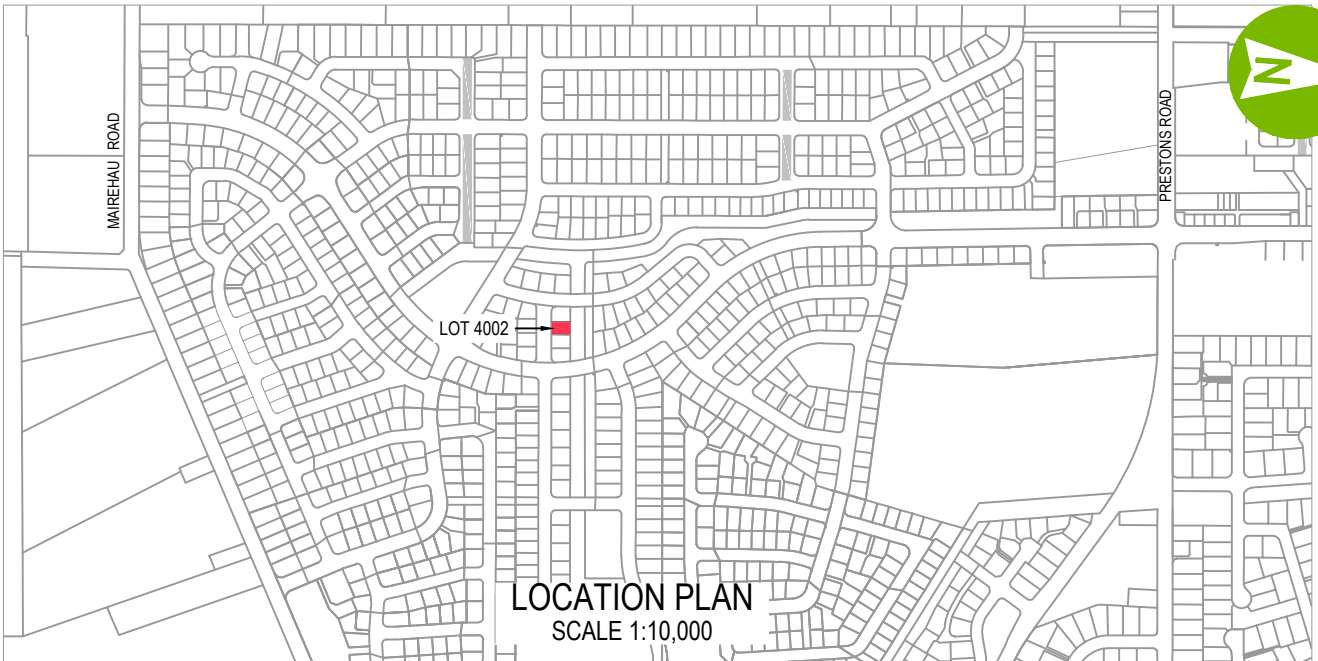
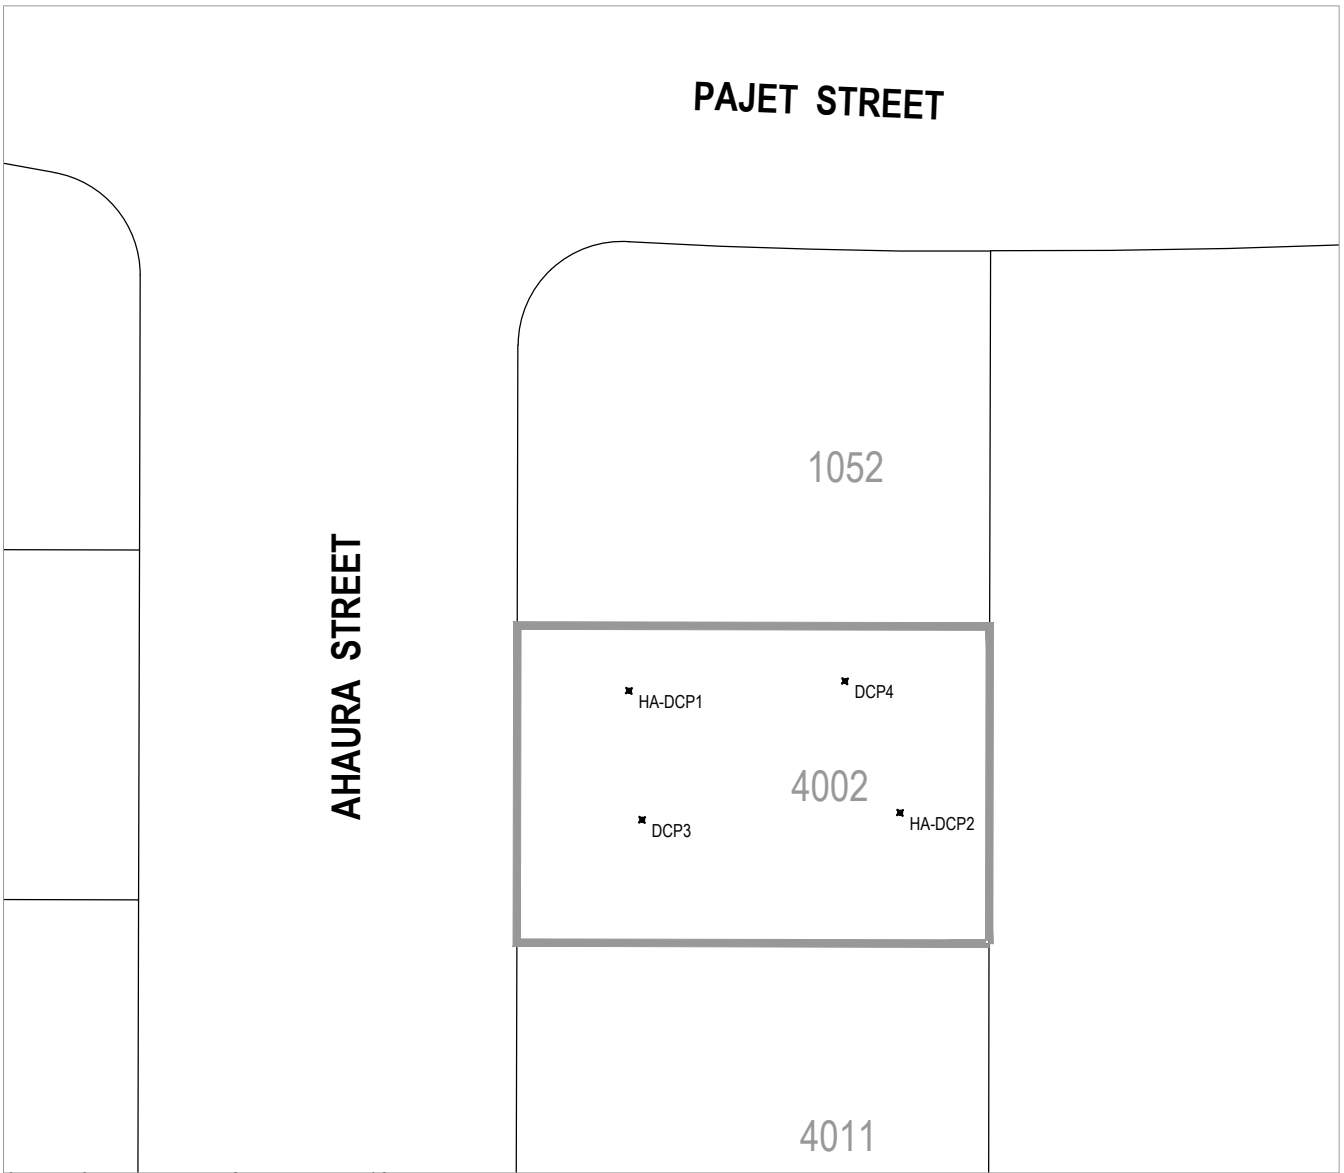
CHECKED		TITLE LOT 4002 SITE LOCATION PLAN FIGURE 1	DRAWING No.	REV	
					J MUIRSON			GO-PS-DC-IN-4002	A	
					APPROVED					
					T BROWNE	DATE				
						25/02/2021

This building consent report is for Lot 4002 which is located in Stage 2 of the Prestons South Subdivision development (refer Figure 1 in Appendix A). The lot is bordered by residential lots to the east and west, an access road to the south and an open storm water channel to the north.

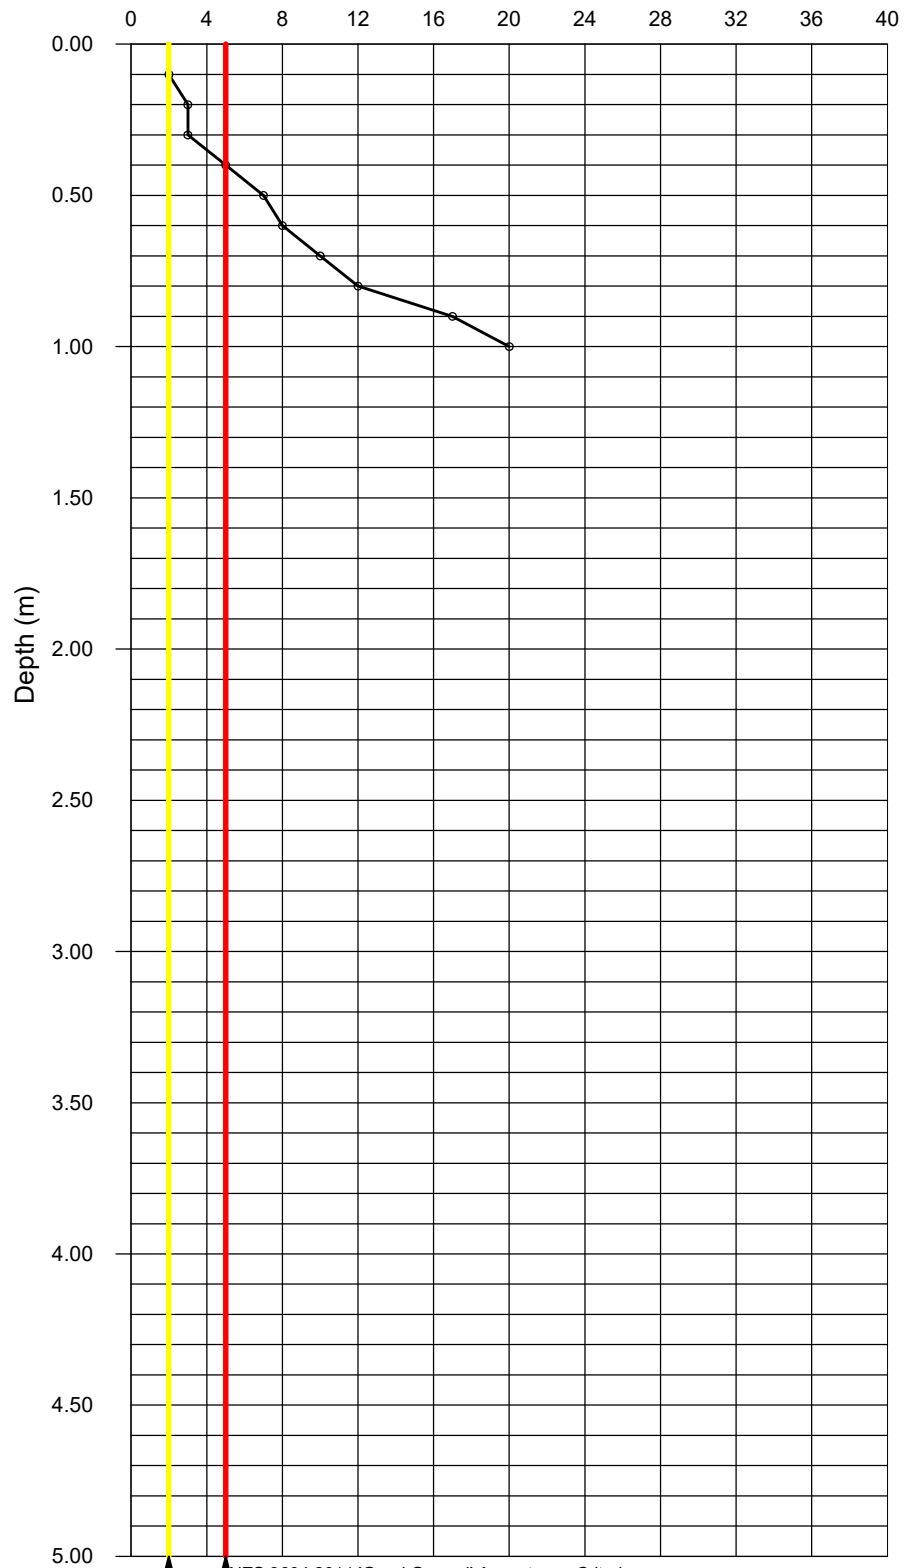
DCP logs indicate 5 blows per 100mm penetration, which is equivalent to an ultimate bearing capacity of 300kPa, was consistently encountered from a shallow depth.

20 blows for 100mm in the last increment.
Co-ordinates and elevation data from site survey.
Elevation based on Lyttelton Vertical Datum.
Effective refusal, 20+ blows per 100mm penetration.

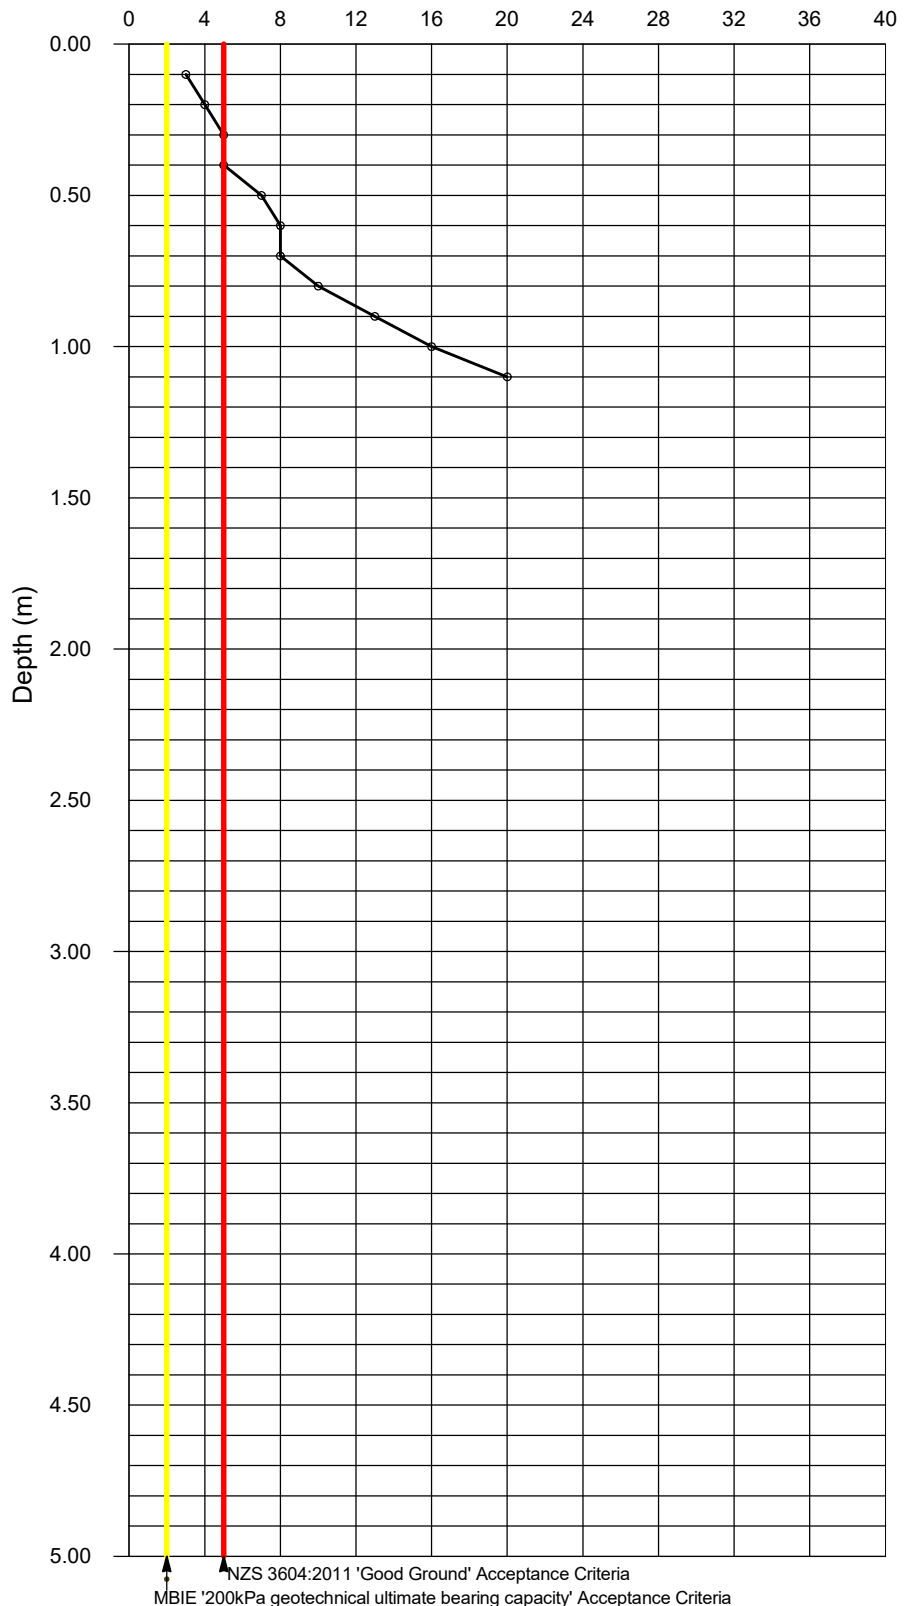
20 blows for 100mm in the last increment.
Co-ordinates and elevation data from site survey.
Elevation based on Lyttelton Vertical Datum.
Effective refusal, 20+ blows per 100mm penetration.

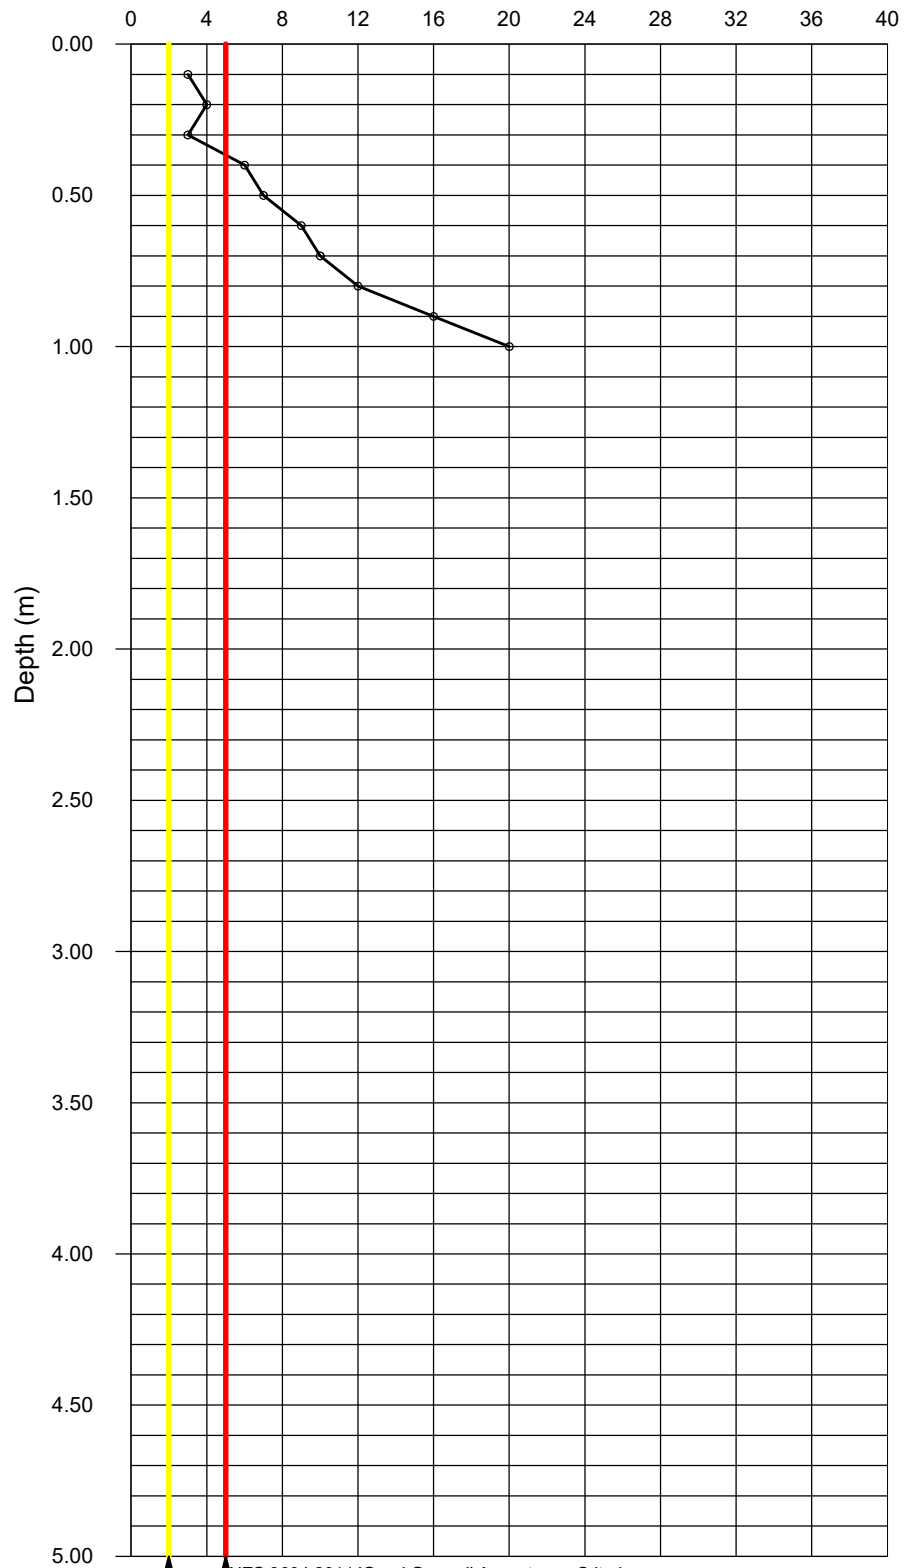
20 blows for 100mm in the last increment.
Co-ordinates and elevation data from site survey.
Elevation based on Lyttelton Vertical Datum.
Effective refusal, 20+ blows per 100mm penetration.
