Prestons Subdivision
GEOTECHNICAL REPORT FOR LOT 1056
CDL Land NZ Limited

31 August 2021
Revision: 1
Reference: 235361

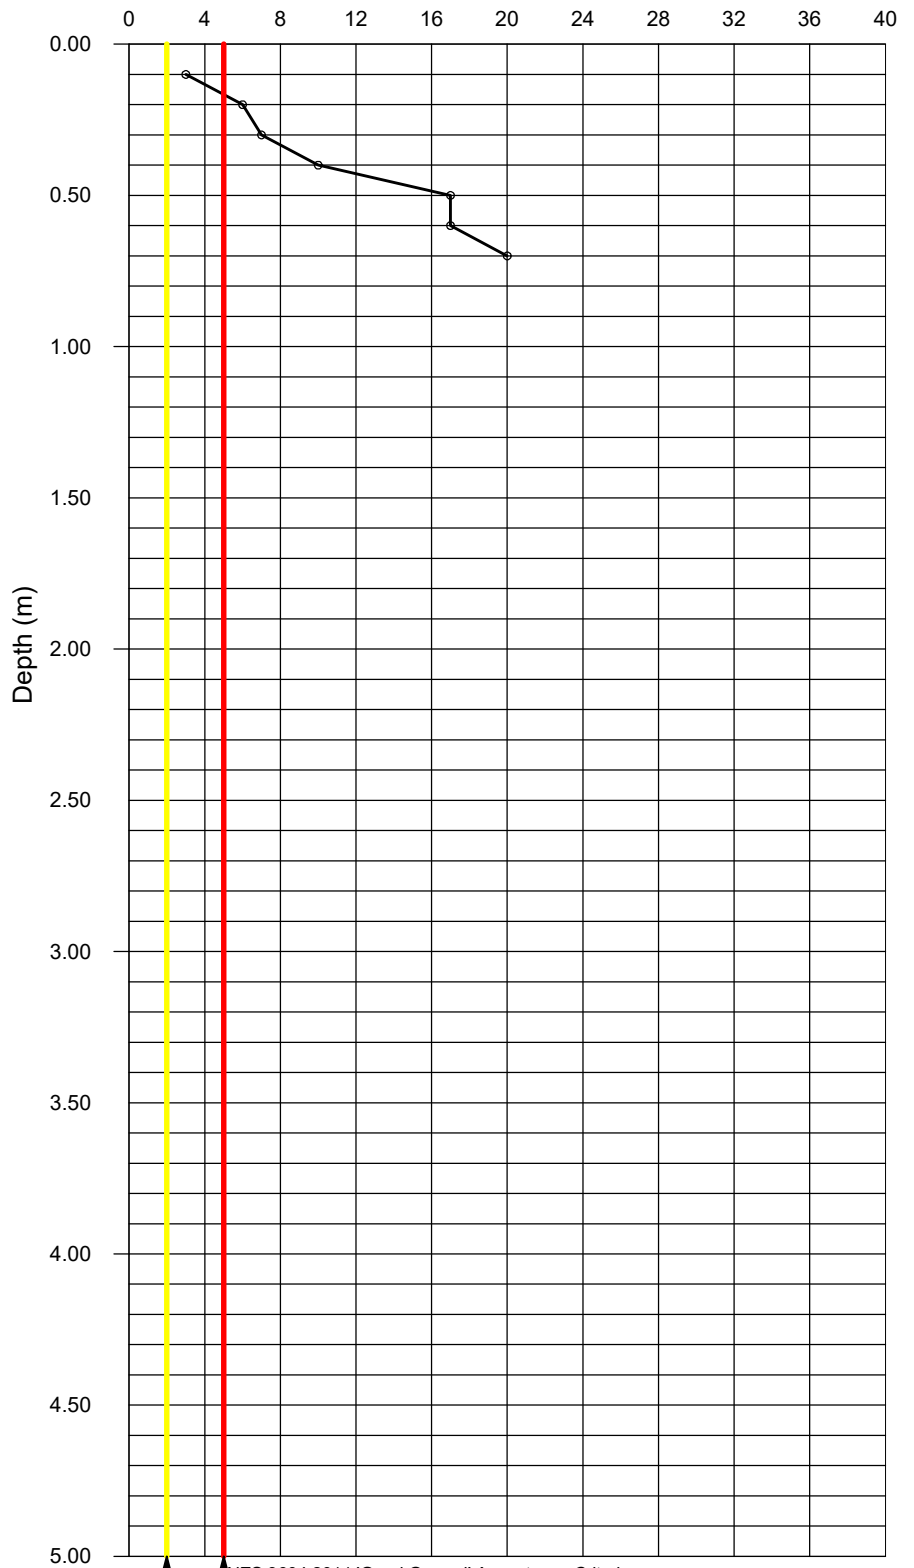
20 blows for 100mm in the last increment.
Co-ordinates and elevation data from site survey.
Elevation based on Lyttelton Vertical Datum.
Effective refusal, 20+ blows per 100mm of penetration.

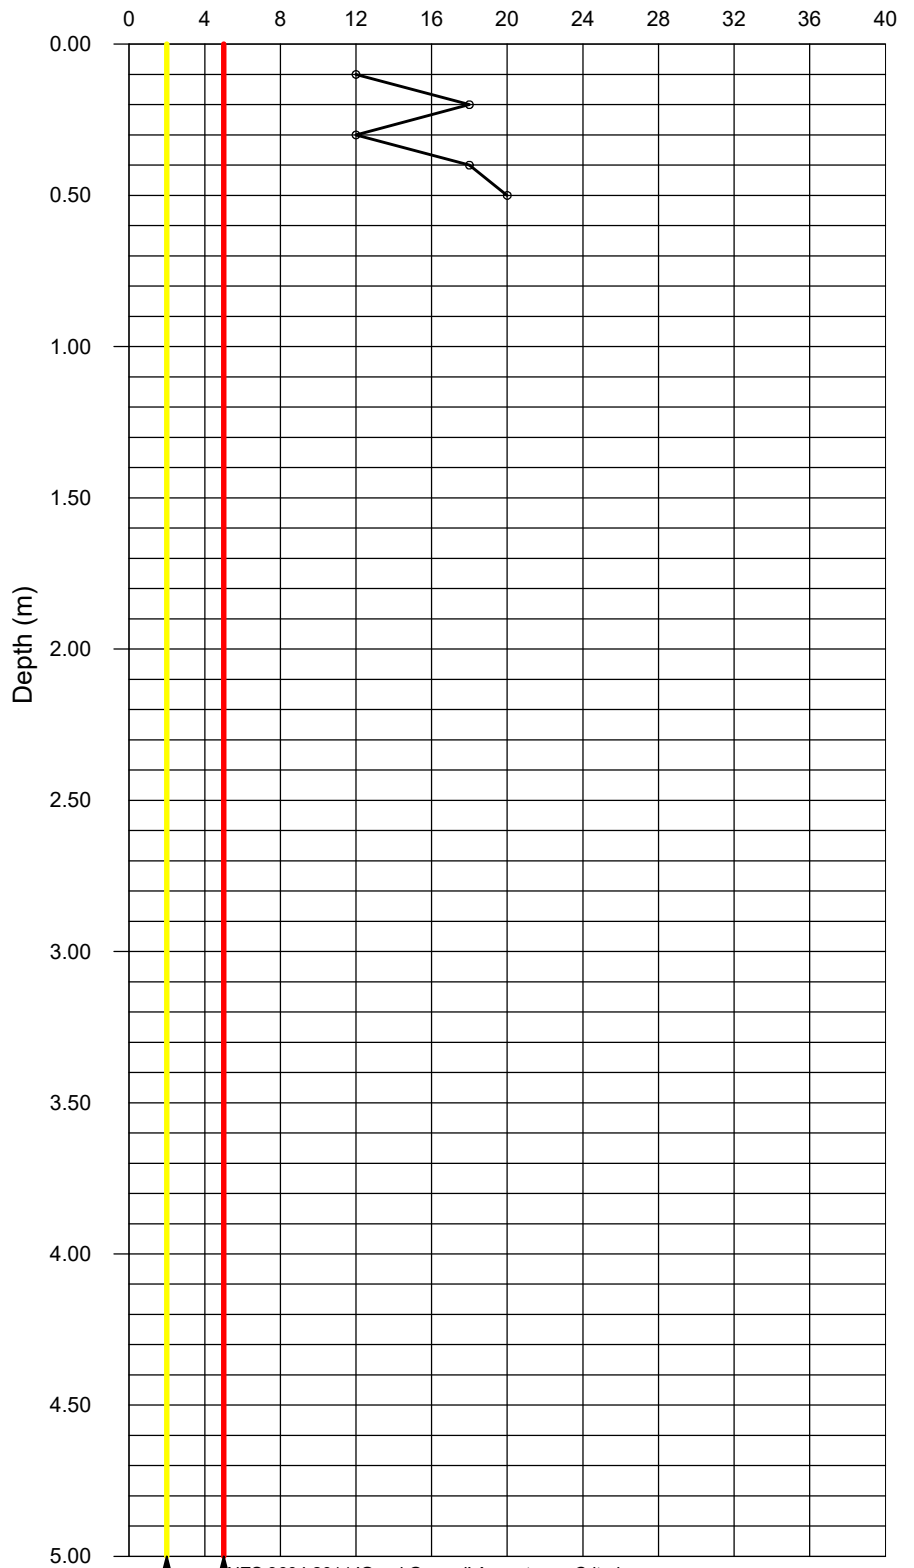
20 blows for 100mm in the last increment.
Co-ordinates and elevation data from site survey.
Elevation based on Lyttelton Vertical Datum.
Effective refusal, 20+ blows per 100mm of penetration.

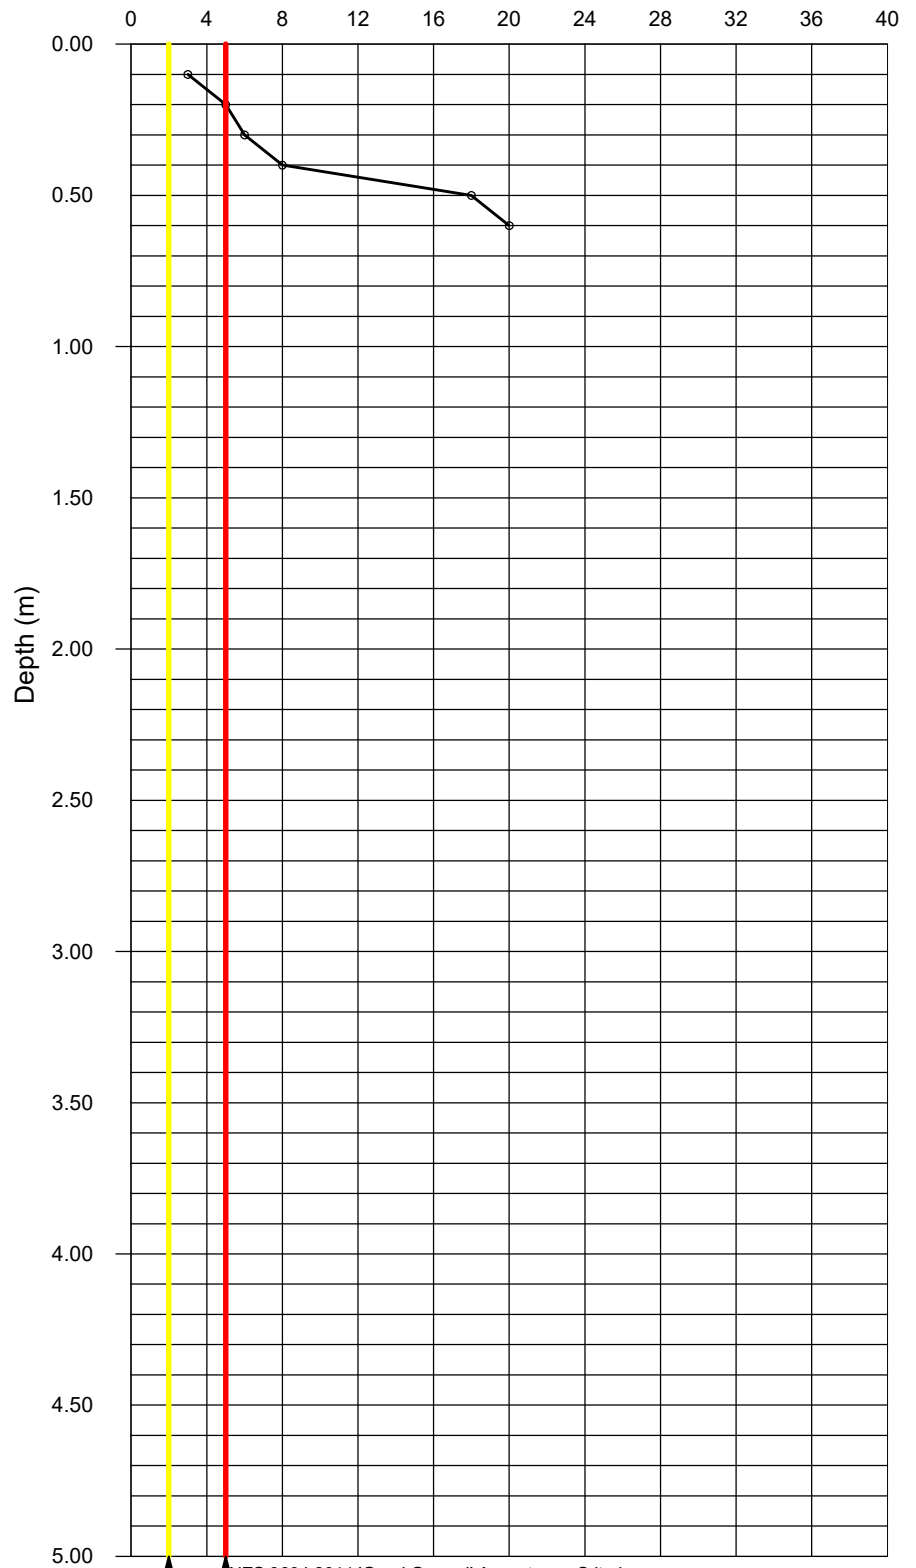
20 blows for 100mm in the last increment.
Co-ordinates and elevation data from site survey.
Elevation based on Lyttelton Vertical Datum.
Effective refusal, 20+ blows per 100mm of penetration.

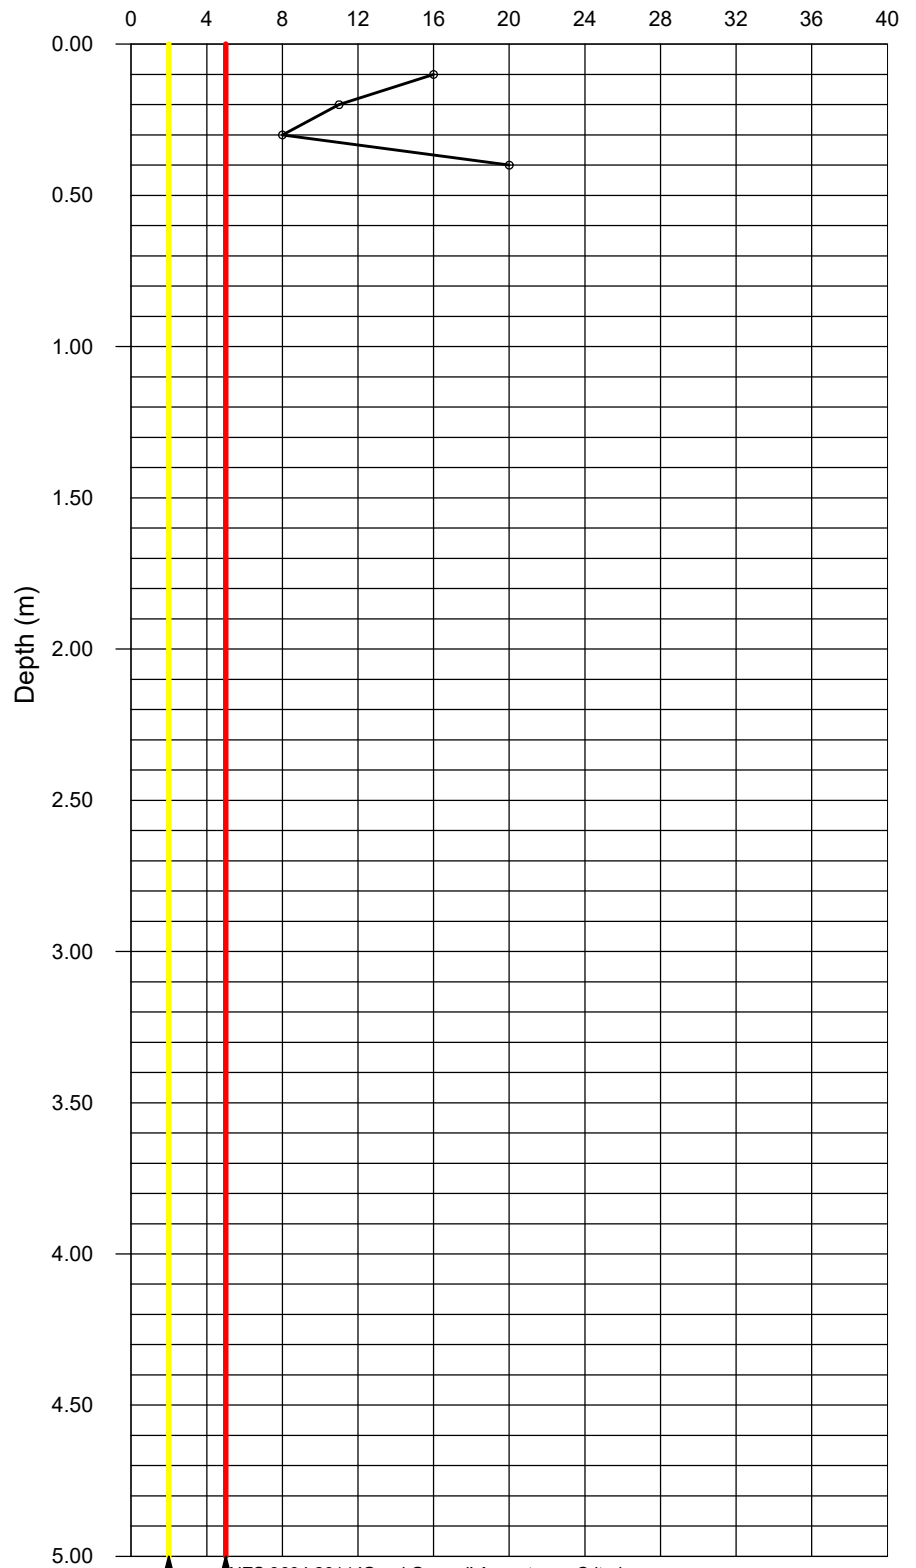
20 blows for 100mm in the last increment.
Co-ordinates and elevation data from site survey.
Elevation based on Lyttelton Vertical Datum.
Effective refusal, 20+ blows per 100mm of penetration.
