Prestons Subdivision
GEOTECHNICAL REPORT FOR LOT 4010
CDL Land NZ Limited

31 August 2021
Revision: 1
Reference: 235361

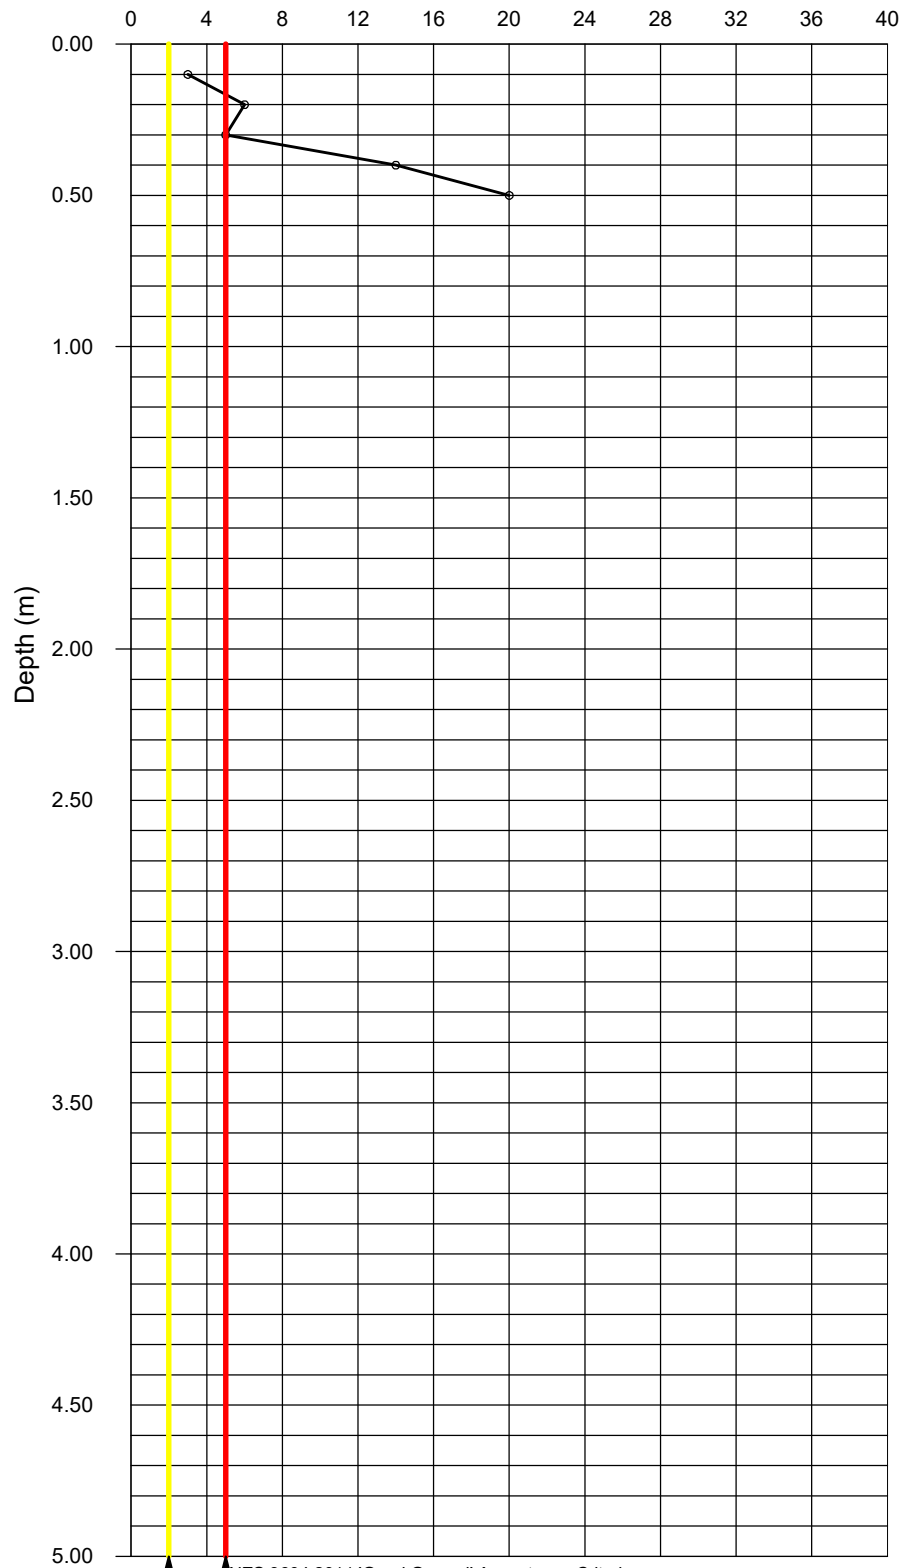
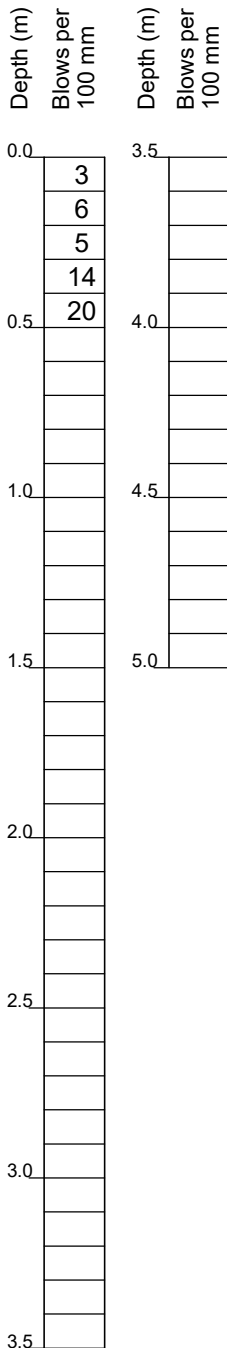
20 blows for 100mm in the last increment.
Co-ordinates and elevation data from site survey.
Elevation based on Lyttelton Vertical Datum.
Effective refusal, 20+ blows per 100mm of penetration.

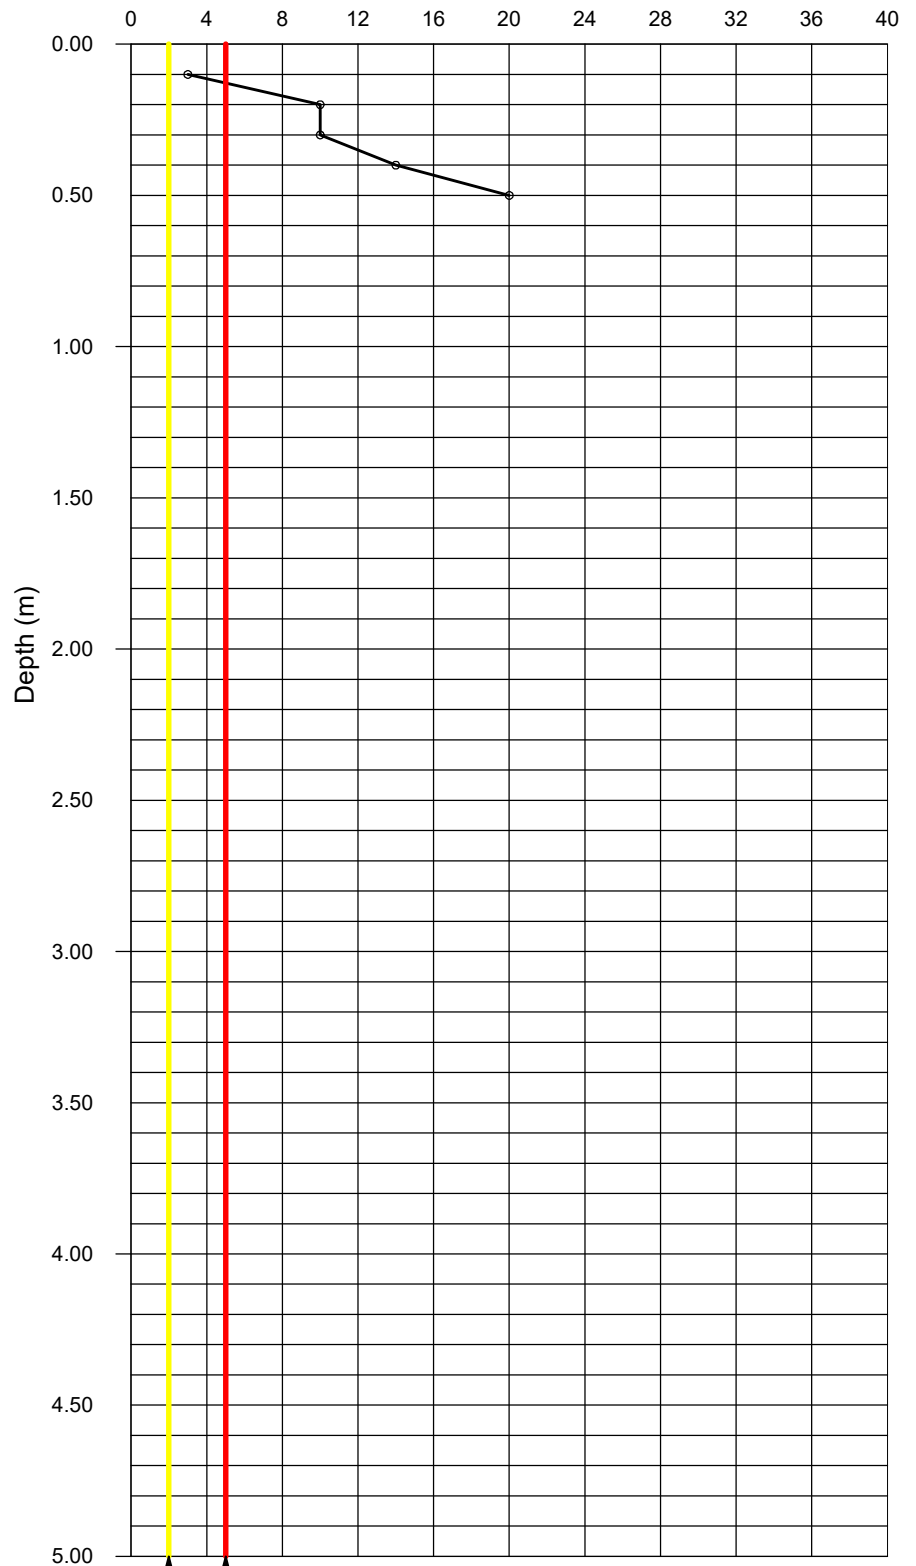
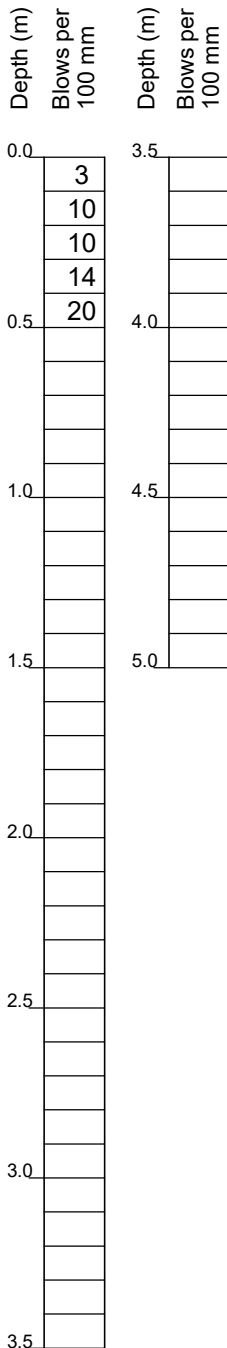
20 blows for 100mm in the last increment.
Co-ordinates and elevation data from site survey.
Elevation based on Lyttelton Vertical Datum.
Effective refusal, 20+ blows per 100mm of penetration.

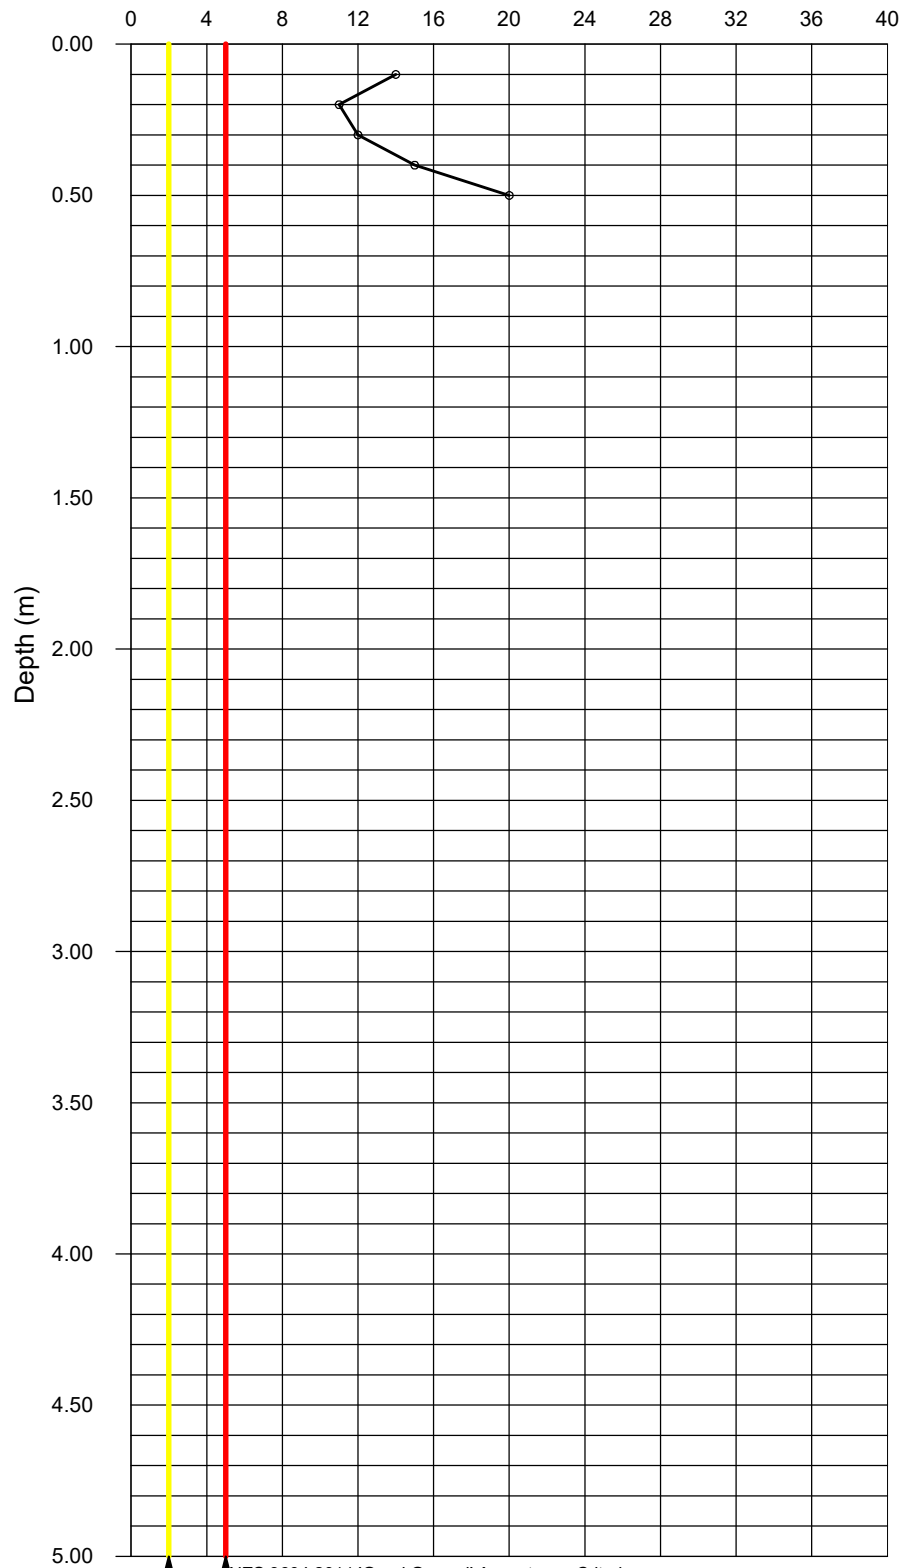
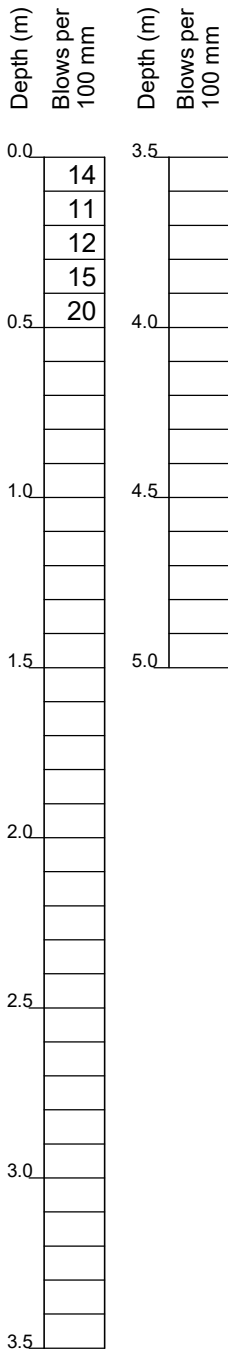
20 blows for 100mm in the last increment.
Co-ordinates and elevation data from site survey.
Elevation based on Lyttelton Vertical Datum.
Effective refusal, 20+ blows per 100mm of penetration.

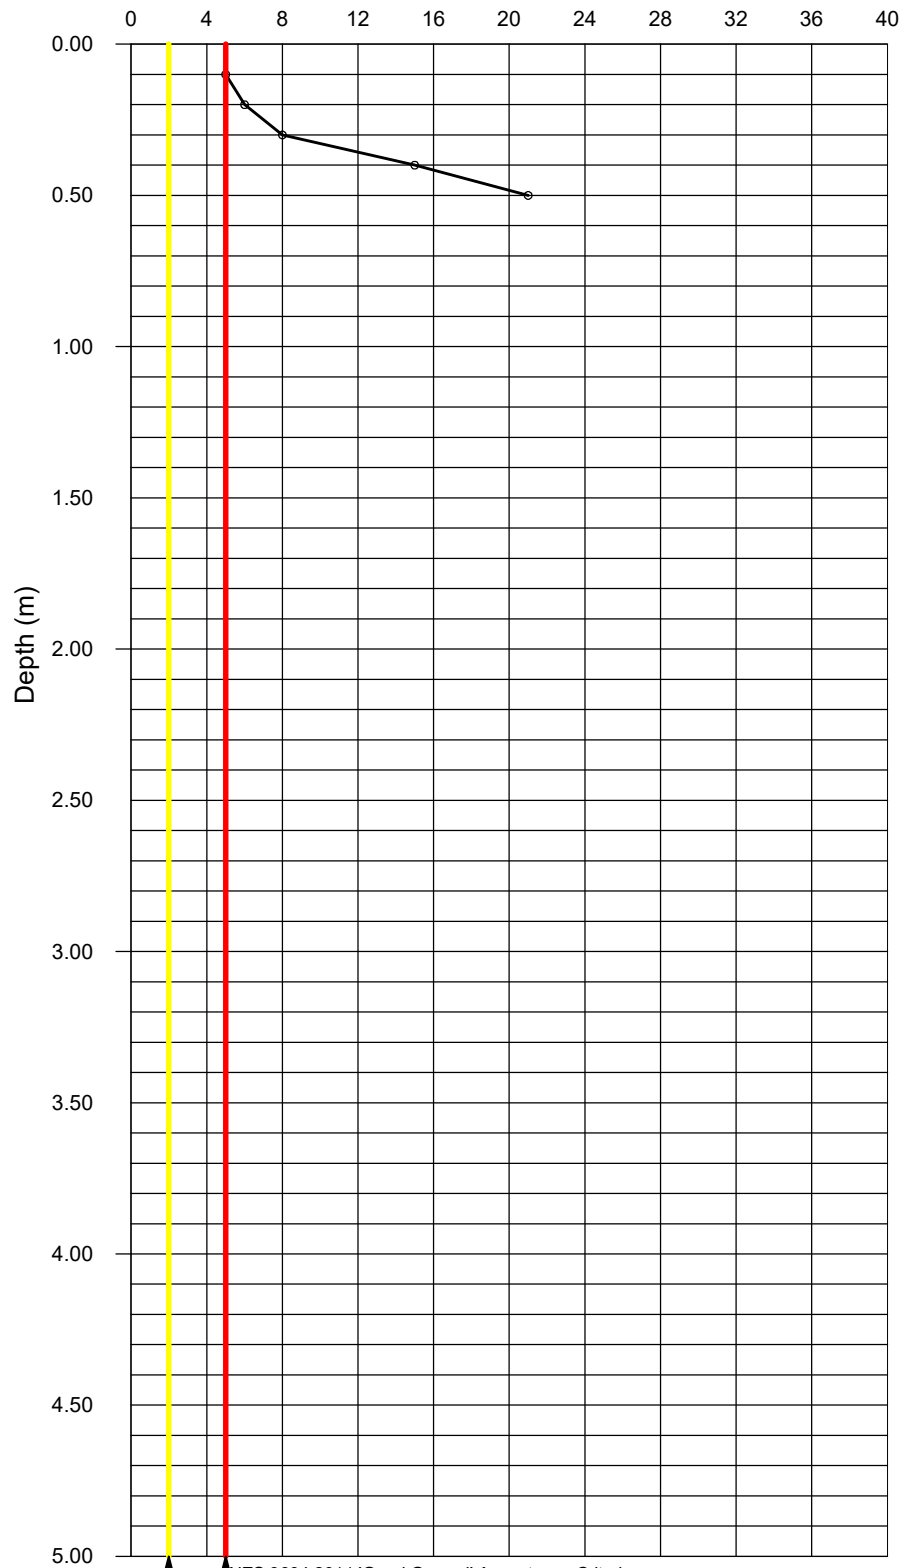
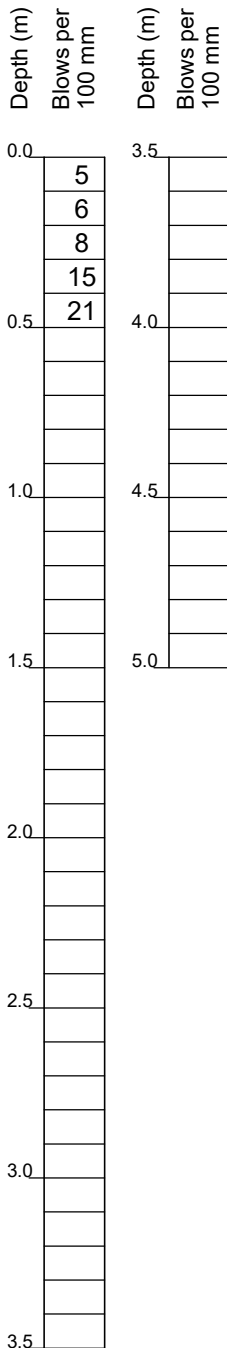
21 blows for 100mm in the last increment.
Co-ordinates and elevation data from site survey.
Elevation based on Lyttelton Vertical Datum.
Effective refusal, 20+ blows per 100mm of penetration.

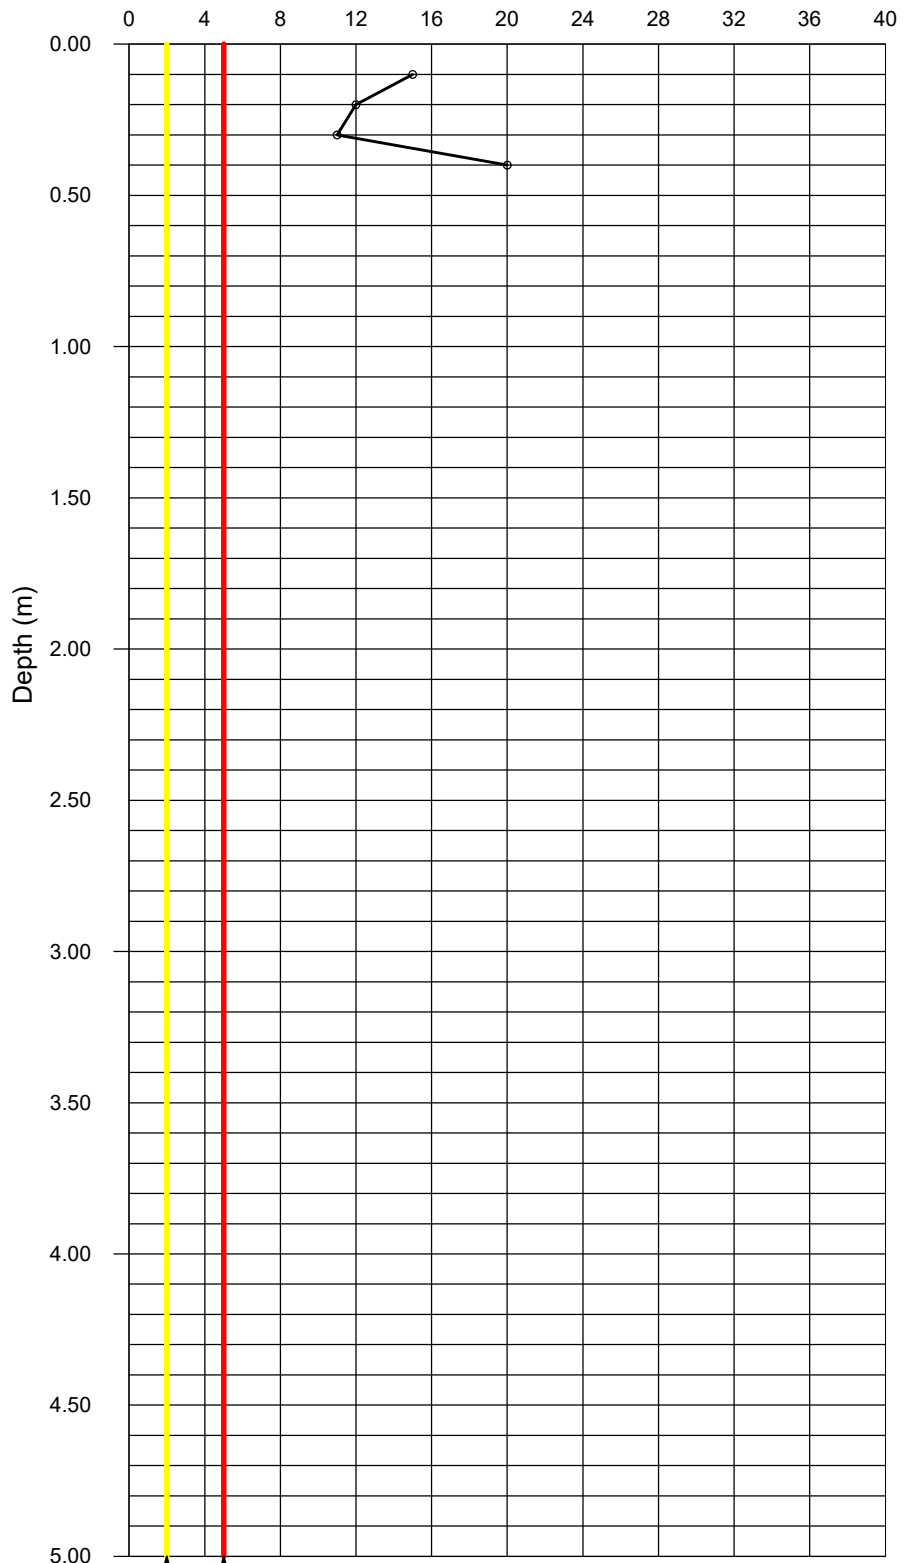
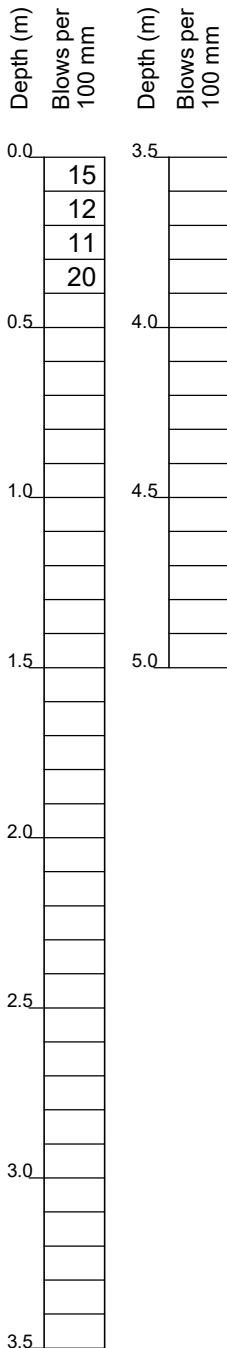
20 blows for 100mm in the last increment.
Co-ordinates and elevation data from site survey.
Elevation based on Lyttelton Vertical Datum.
Effective refusal, 20+ blows per 100mm of penetration.

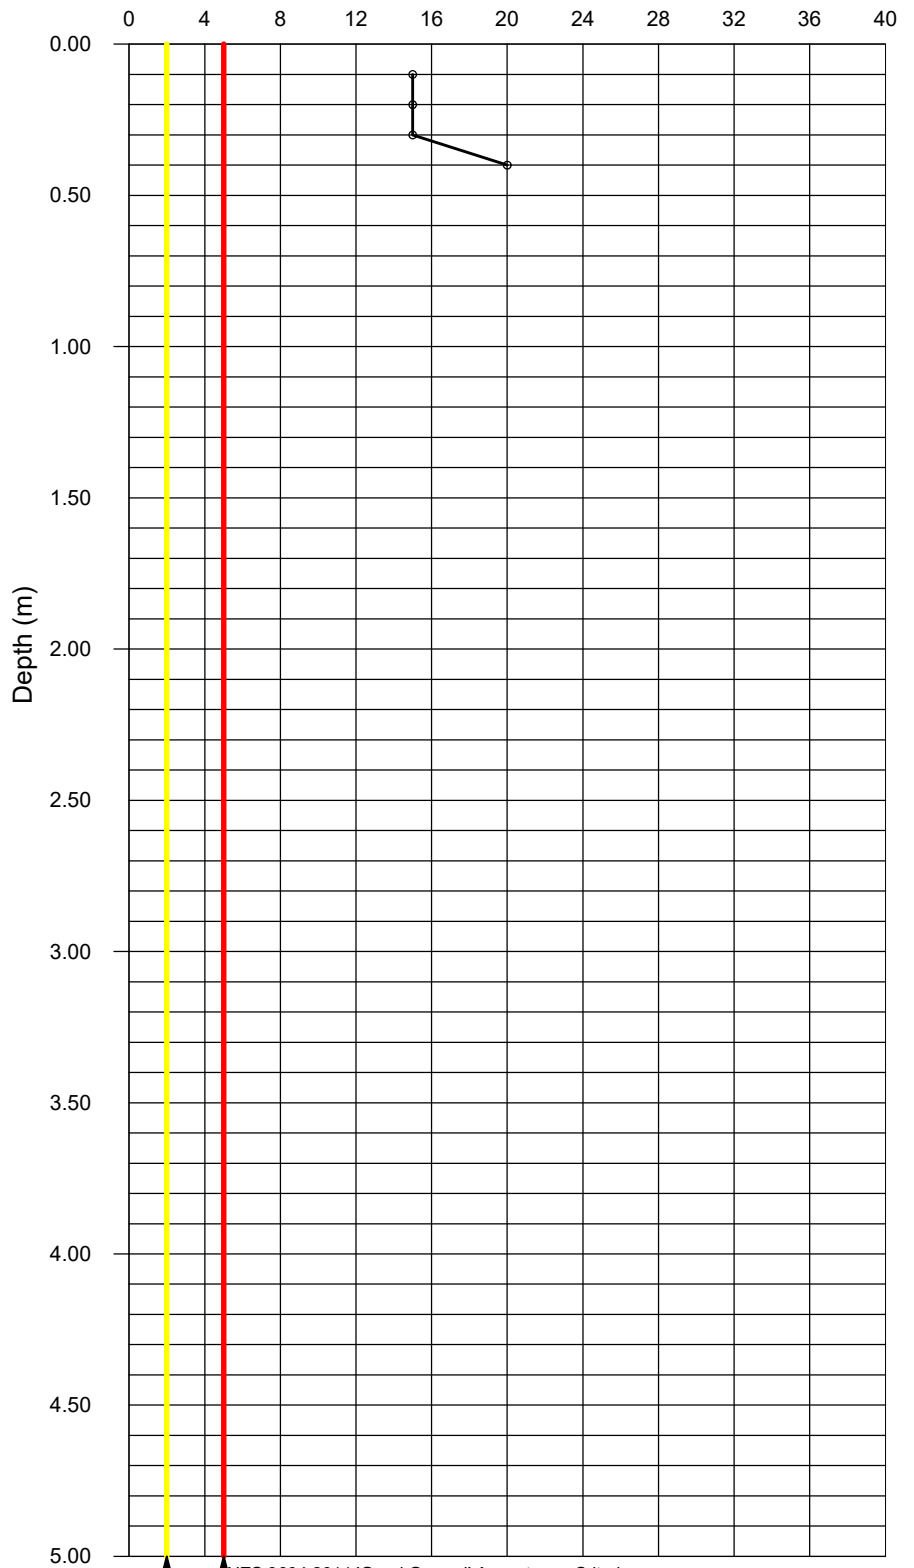
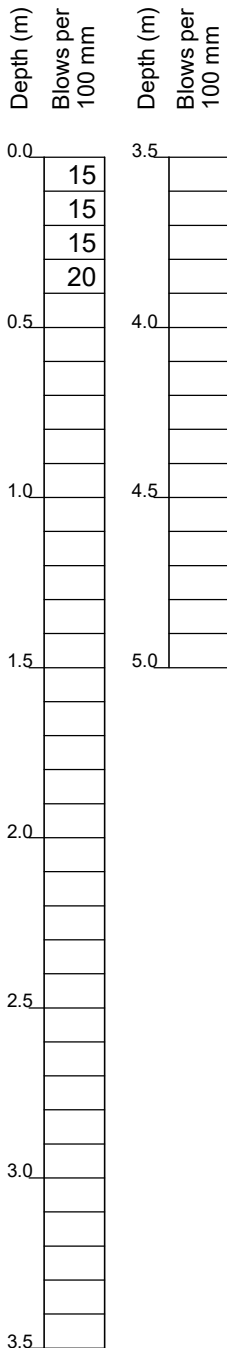
20 blows for 100mm in the last increment.
Co-ordinates and elevation data from site survey.
Elevation based on Lyttelton Vertical Datum.
Effective refusal, 20+ blows per 100mm of penetration.
