Prestons Subdivision
GEOTECHNICAL REPORT FOR LOT 4017
CDL Land NZ Limited

31 August 2021 Revision: 1

Reference: 235361

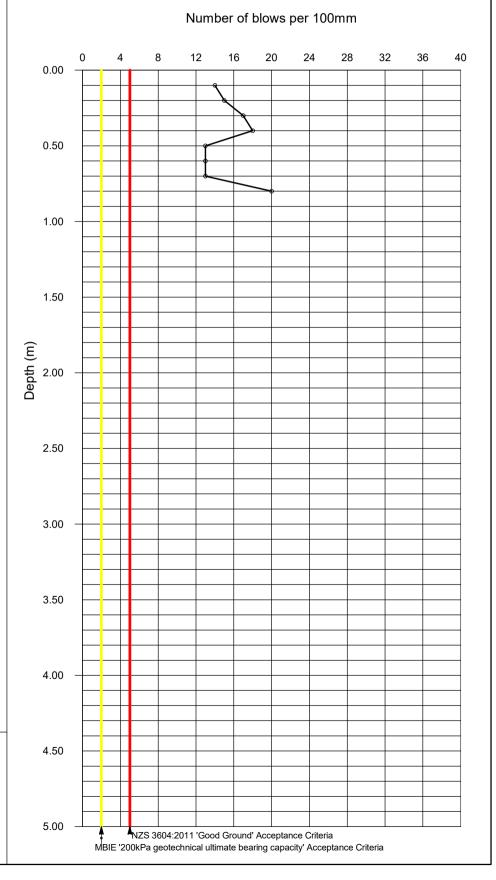
Lot 4017 - DCP1

DCP logs indicate 5 blows per 100mm penetration, which is equivalent to an ultimate bearing capacity of 300kPa, was consistently encountered from a shallow depth.

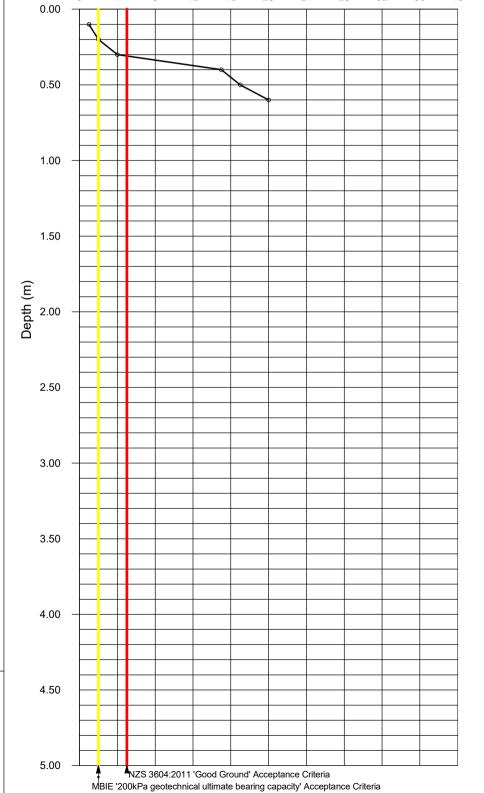
Lot 4017 - DCP3

20 blows for 100mm in the last increment. Co-ordinates and elevation data from site survey. Elevation based on Lyttelton Vertical Datum. Effective refusal, 20+ blows per 100mm of penetration.

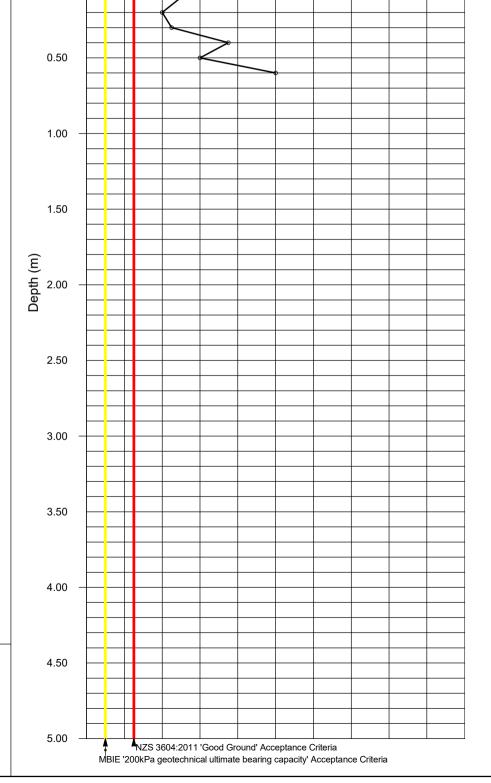
Lot 4017 - DCP4

20 blows for 100mm in the last increment.

Effective refusal, 20+ blows per 100mm of penetration.
