**Prestons Subdivision**  
**GEOTECHNICAL REPORT FOR LOT 1064**  
**CDL Land NZ Limited**

**13 September 2021**  
**Revision: 1**  
**Reference: 235361**

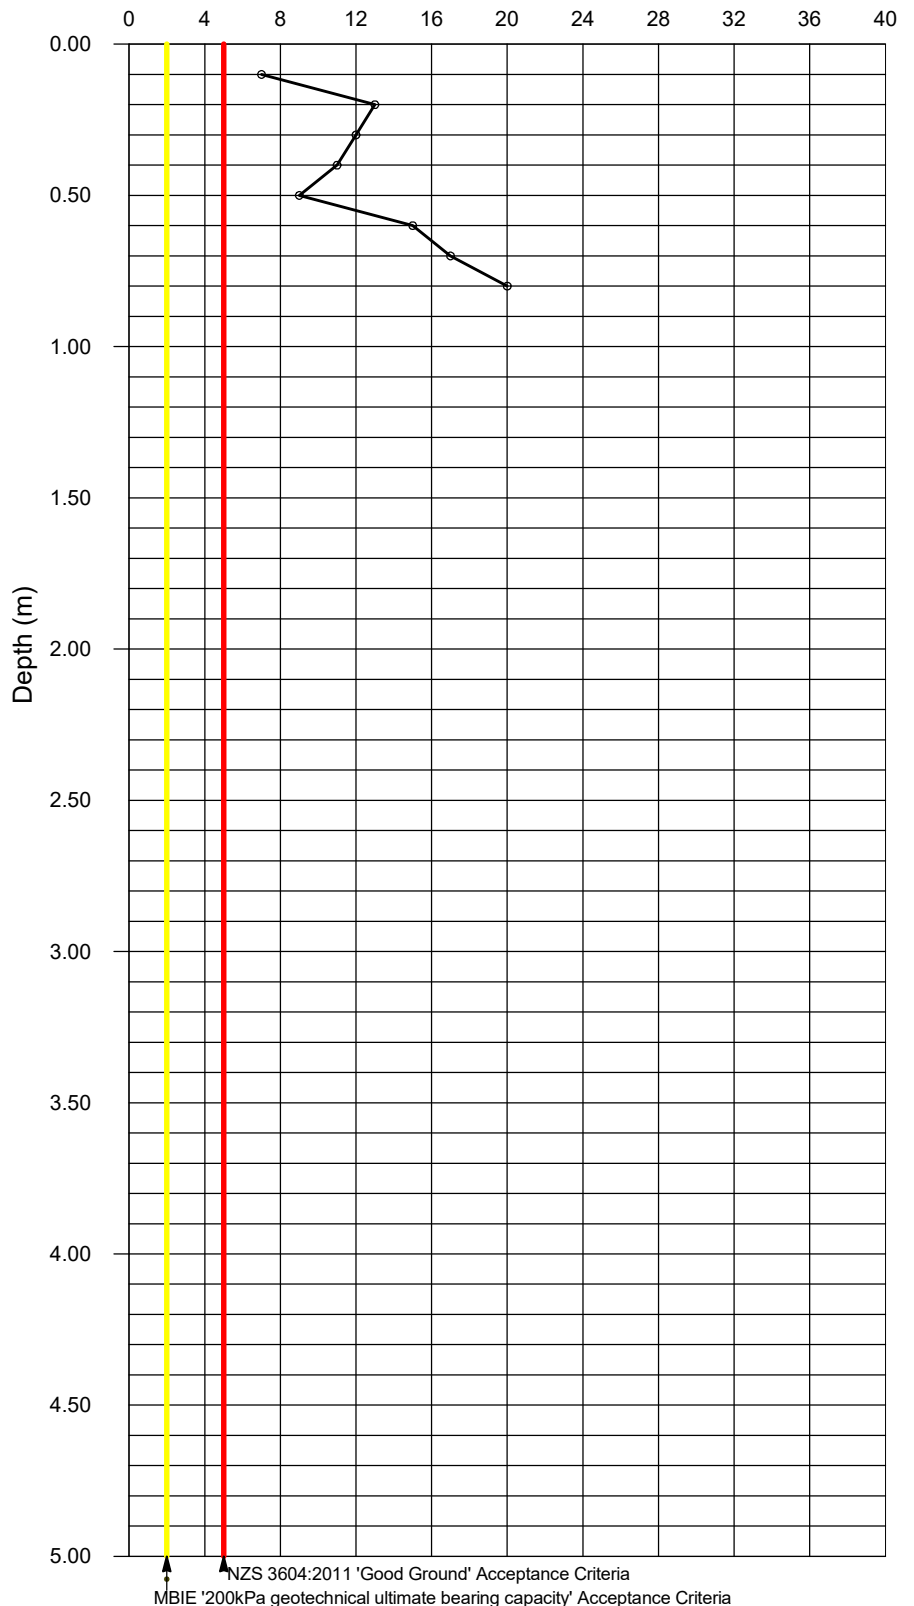
DCP logs indicate 5 blows per 100mm penetration, which is equivalent to an ultimate bearing capacity of 300kPa, was consistently encountered from a shallow depth.

20 blows for 100mm in the last increment.  
Co-ordinates and elevation data from site survey.  
Elevation based on Christchurch Drainage Datum.  
Effective refusal, 20+ blows per 100mm

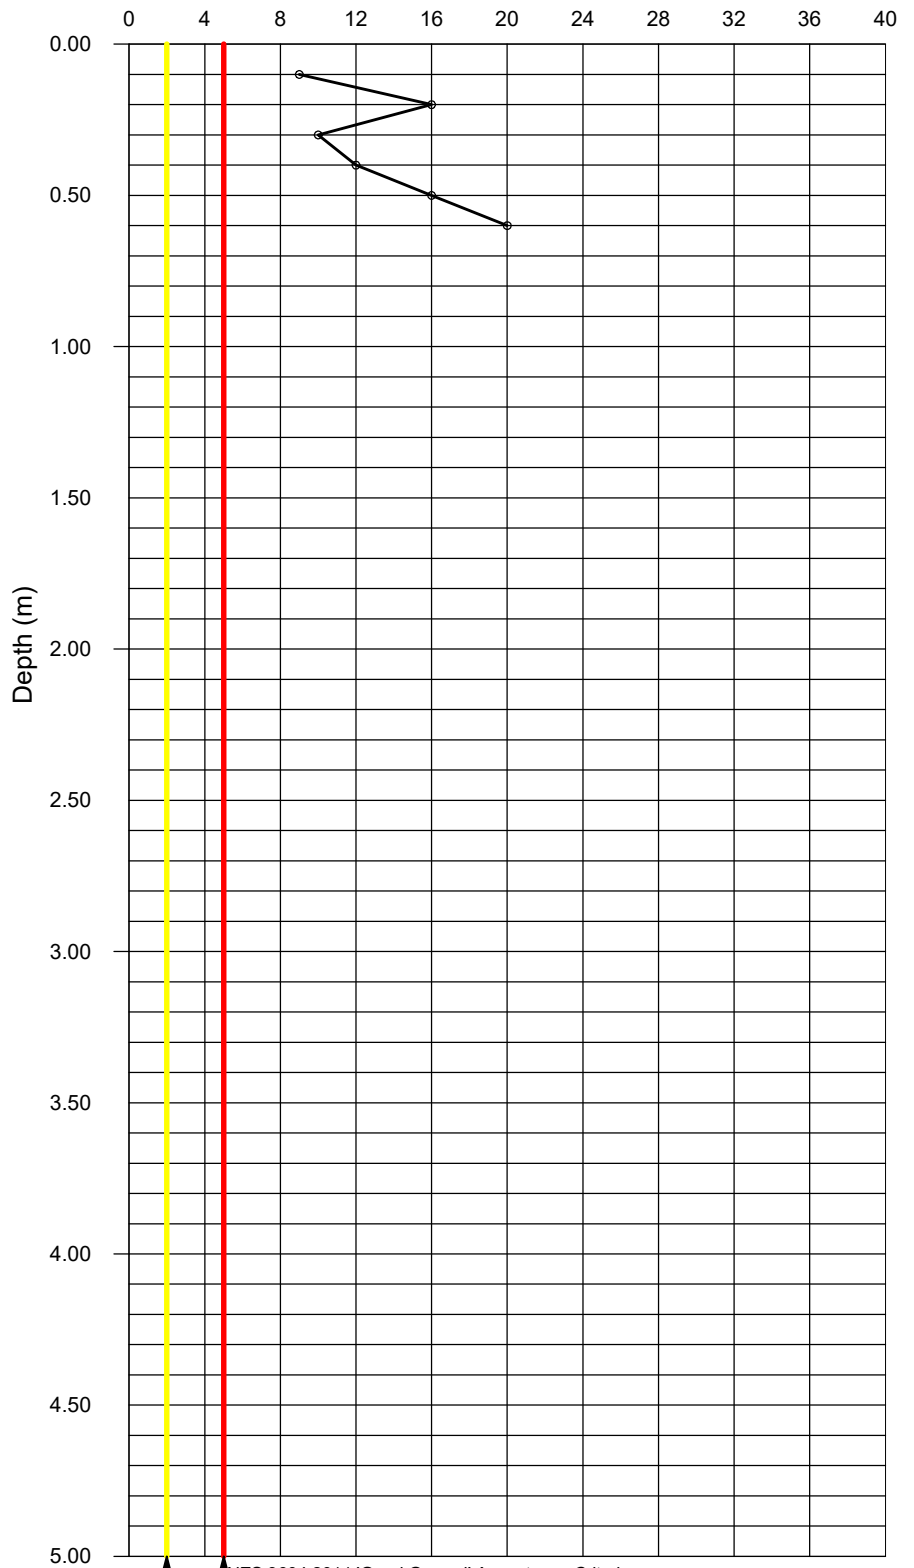
20 blows for 100mm in the last increment.  
Co-ordinates and elevation data from site survey.  
Elevation based on Christchurch Drainage Datum.  
Effective refusal, 20+ blows per 100mm
