Prestons Subdivision
GEOTECHNICAL REPORT FOR LOT 1065
CDL Land NZ Limited

13 September 2021 Revision: 1

Reference: 235361

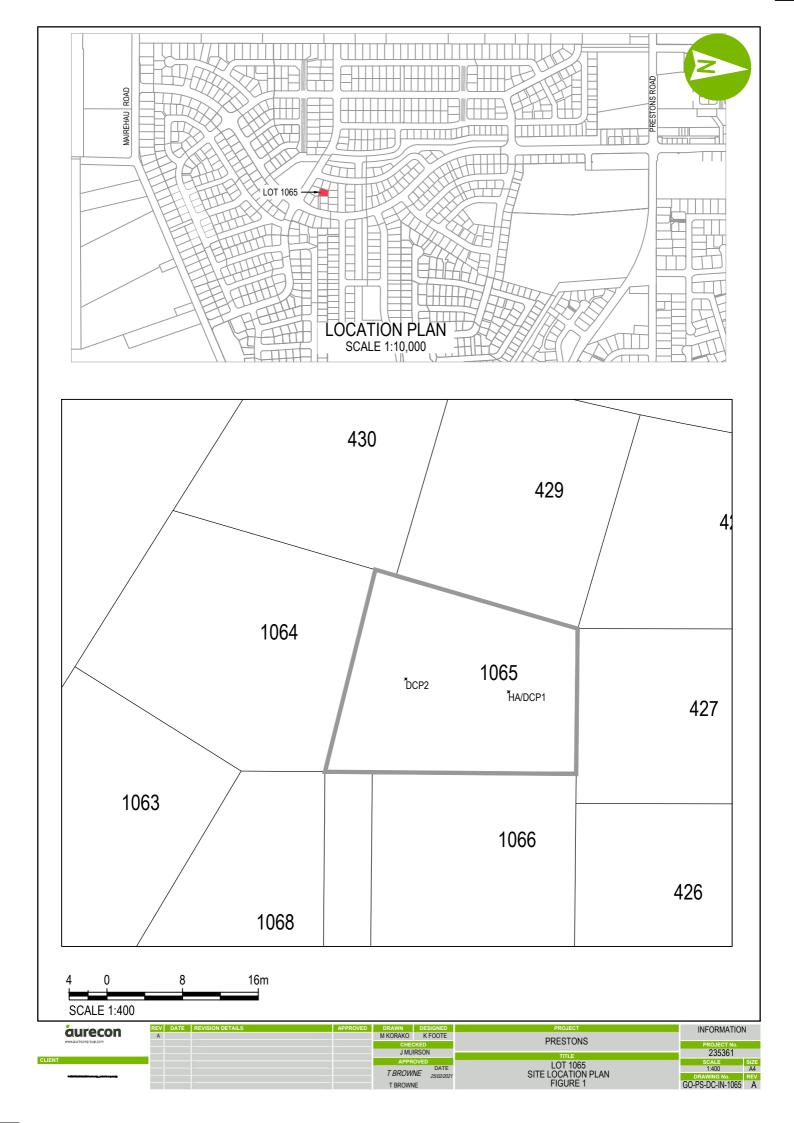
This building consent report is for Lot 1065 which is located in Stage 2 of the Prestons South Subdivision development (refer Figure 1 in Appendix A). The lot is bordered by residential lots to the north, east, south and west.

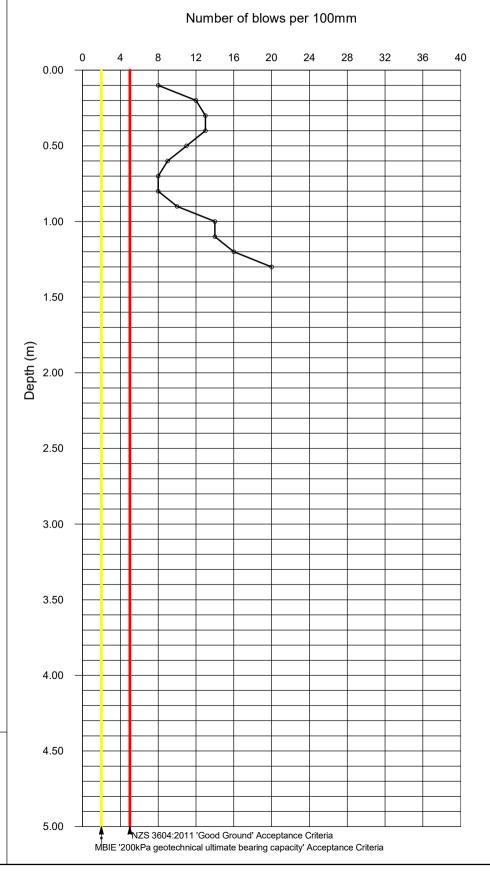
Lot 1065 - DCP1

DCP logs indicate 5 blows per 100mm penetration, which is equivalent to an ultimate bearing capacity of 300kPa, was consistently encountered from a shallow depth.

Effective refusal, 20+ blows per 100mm

Based on our understanding of the site works and the investigation results, we recommend that NZS3604:2011 compliant foundations are embedded a minimum depth of 0.35m below current ground level.

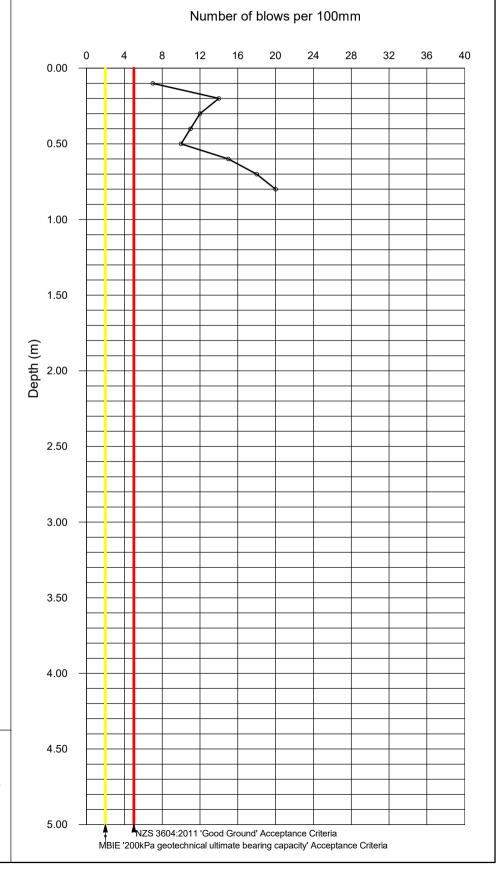
Lot 1065 - DCP2

Effective refusal, 20+ blows per 100mm
