Prestons Subdivision
GEOTECHNICAL REPORT FOR LOT 1068
CDL Land NZ Limited

13 September 2021
Revision: 1
Reference: 235361

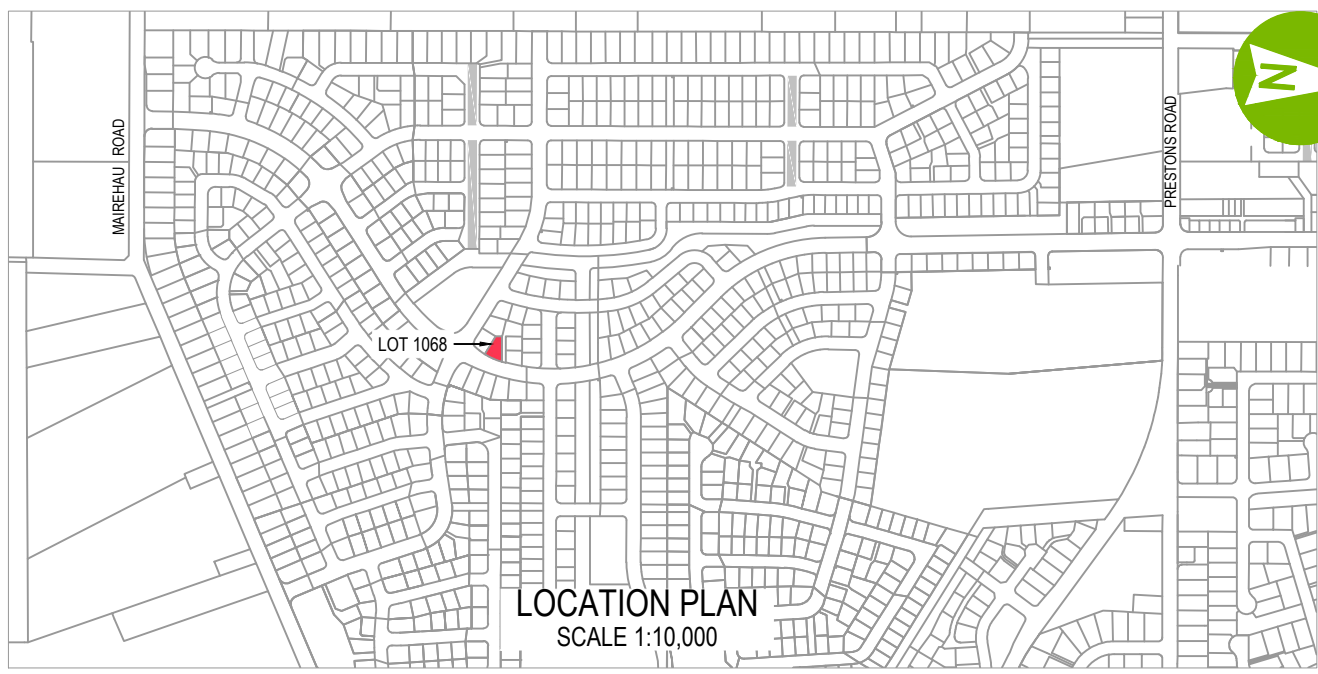
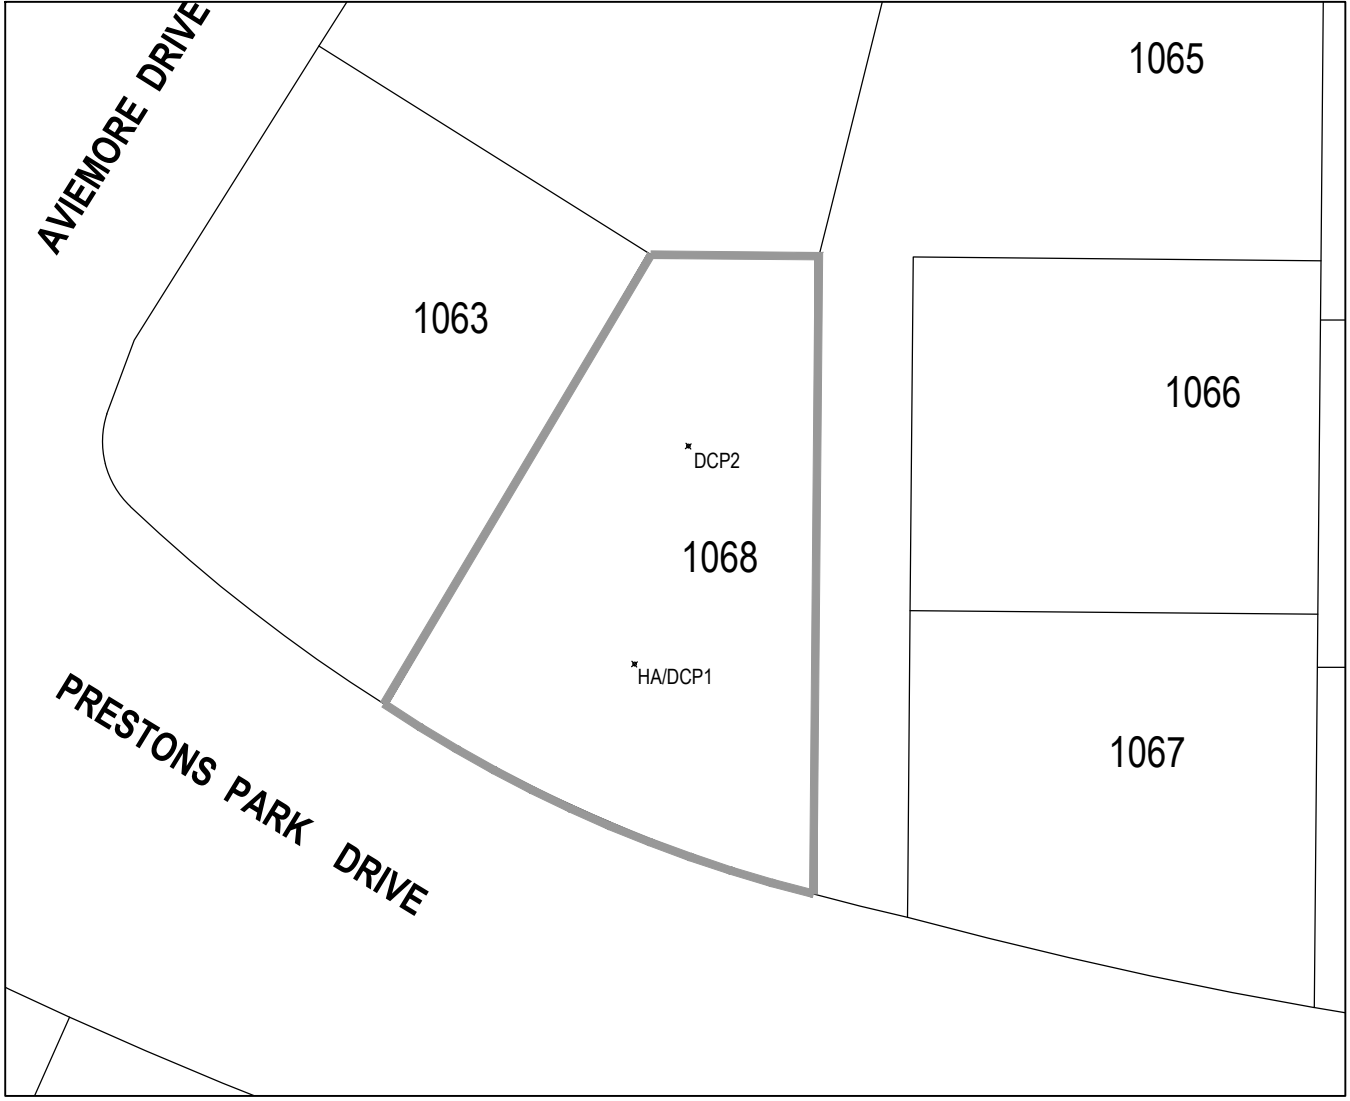
| | | | | | T BROWNE | DATE 25/02/2021 | LOT 1068 SITE LOCATION PLAN FIGURE 1 | 1:400 | A4 |

This building consent report is for Lot 1068 which is located in Stage 2 of the Prestons South Subdivision development (refer Figure 1 in Appendix A). The lot is bordered by residential lots to the north, south and west, with an access road to the east.

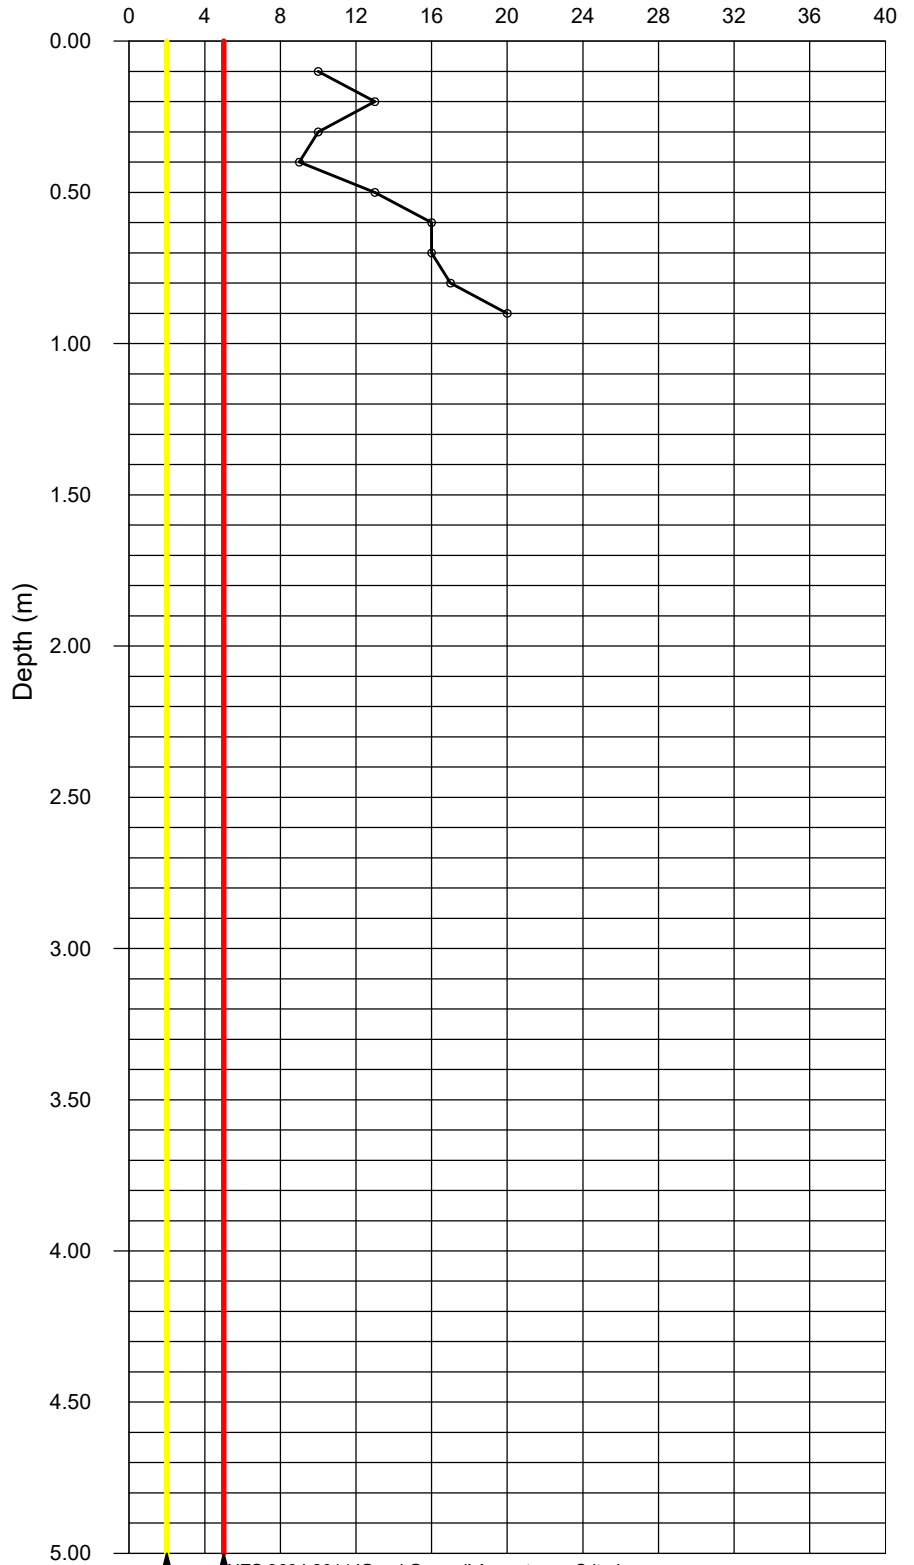
DCP logs indicate 5 blows per 100mm penetration, which is equivalent to an ultimate bearing capacity of 300kPa, was consistently encountered from a shallow depth.

20 blows for 100mm in the last increment.
Co-ordinates and elevation data from site survey.
Elevation based on Christchurch Drainage Datum.
Effective refusal, 20+ blows per 100mm

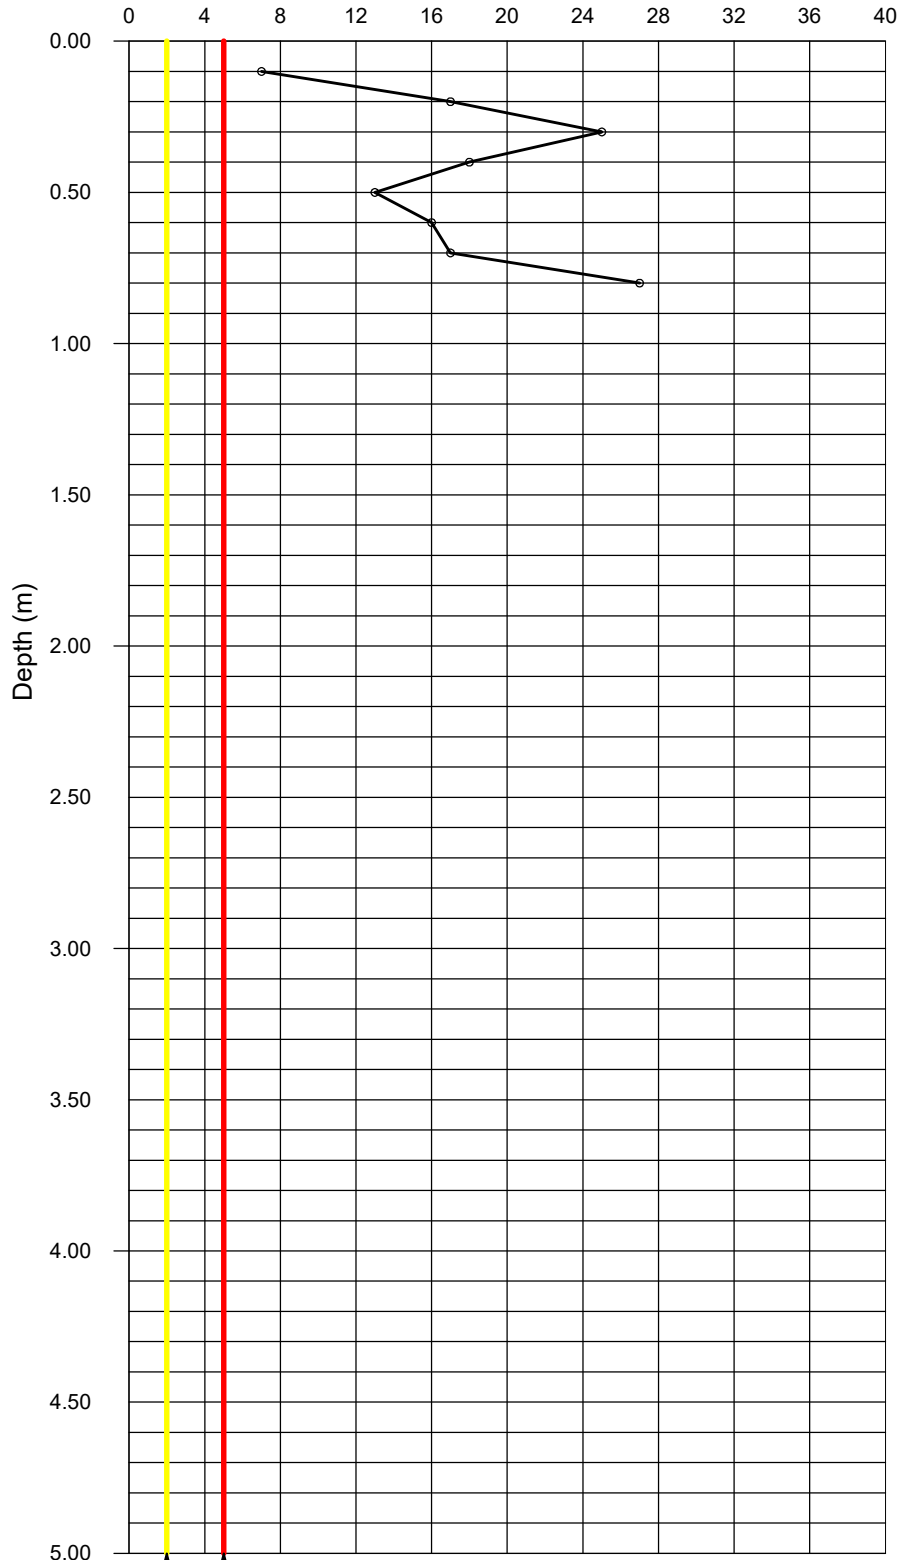
27 blows for 100mm in the last increment.
Co-ordinates and elevation data from site survey.
Elevation based on Christchurch Drainage Datum.
Effective refusal, 20+ blows per 100mm
