**Prestons Park Subdivision**  
**GEOTECHNICAL REPORT FOR LOT 978**  
**CDL Land NZ Limited**

**5 August 2022**  
**Revision: 1**  
**Reference: 235361**

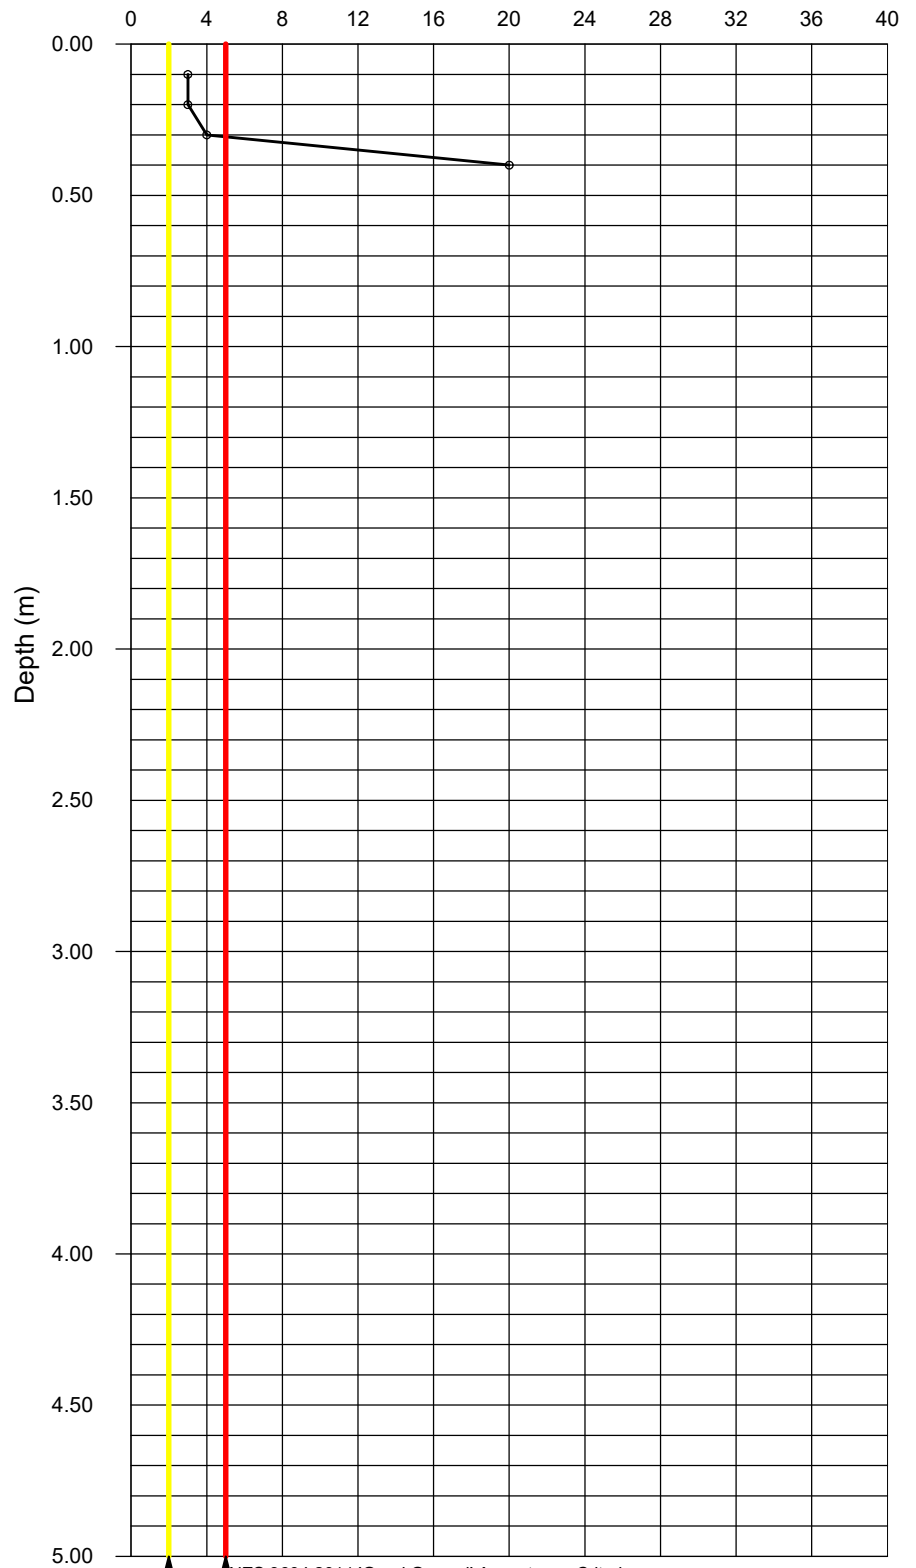
DCP logs indicate 5 blows per 100mm penetration, which is equivalent to an ultimate bearing capacity of 300kPa, was consistently encountered from a depth of 0.4m.

20 blows for 100mm in the last increment.  
Co-ordinates and elevation data from site survey.  
Elevation based on Christchurch Drainage Datum.  
Effective refusal, 20+ blows per 100mm

Based on our understanding of the site works and the investigation results, we recommend that NZS3604:2011 compliant foundations are embedded a minimum depth of 0.4m below current ground level.

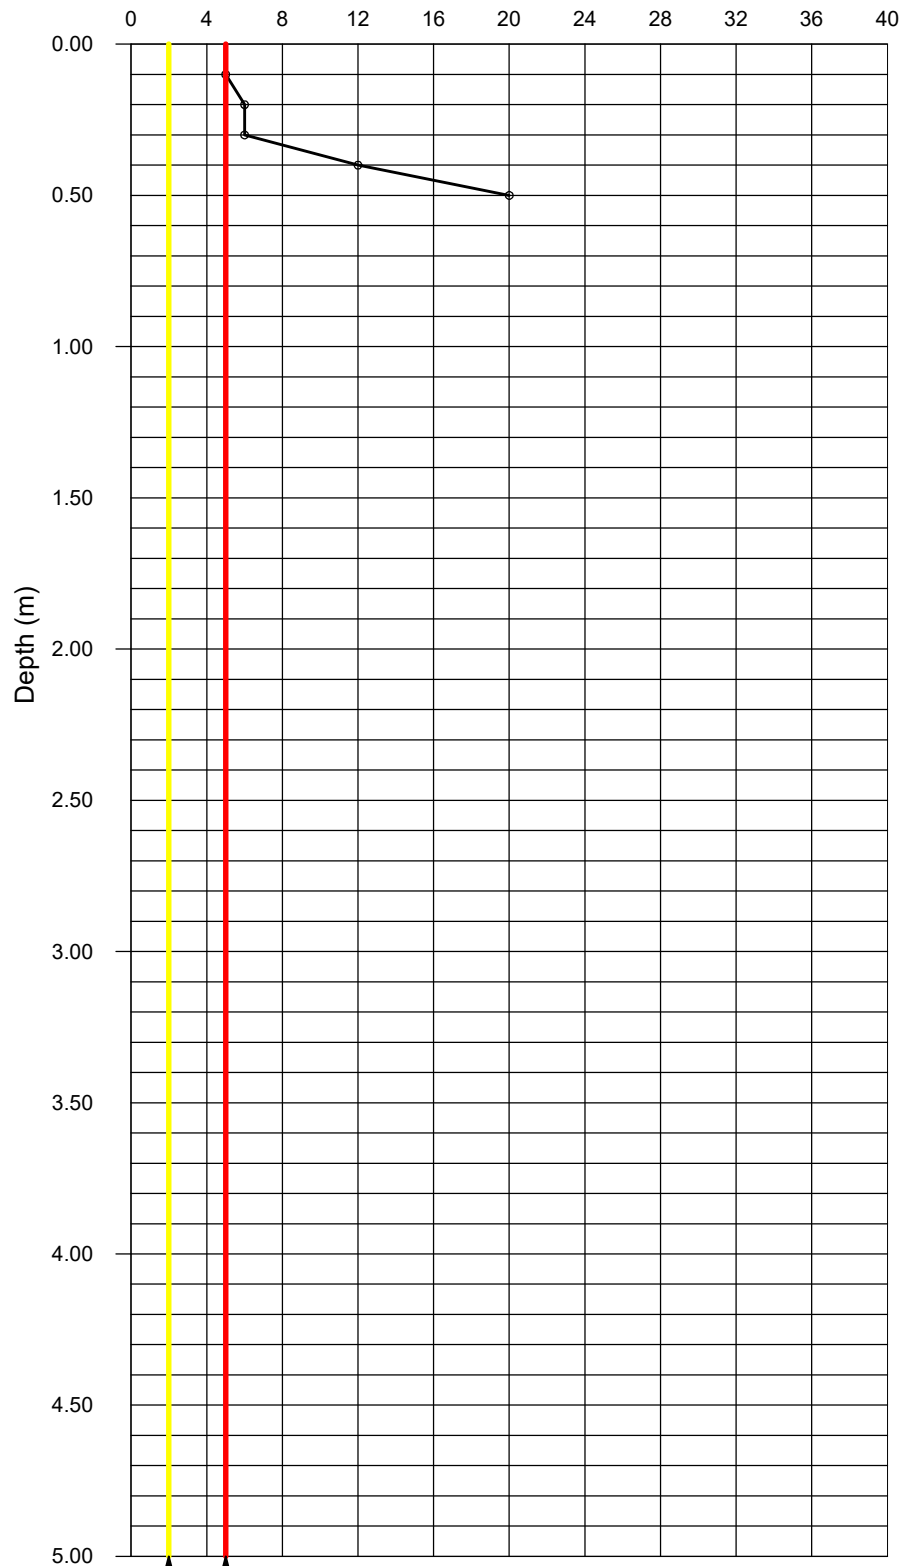
Depth (m)	Blows per 100 mm	Depth (m)	Blows per 100 mm
0.0	5	3.5	
0.1	6		
0.2	6		
0.3	12		
0.4	20		
0.5		4.0	
1.0		4.5	
1.5		5.0	
2.0			
2.5			
3.0			
3.5

20 blows for 100mm in the last increment.  
Co-ordinates and elevation data from site survey.  
Elevation based on Christchurch Drainage Datum.  
Effective refusal, 20+ blows per 100mm
