**Prestons Park Subdivision**  
**GEOTECHNICAL REPORT FOR LOT 1041**  
**CDL Land NZ Limited**

**5 August 2022**  
**Revision: 1**  
**Reference: 235361**

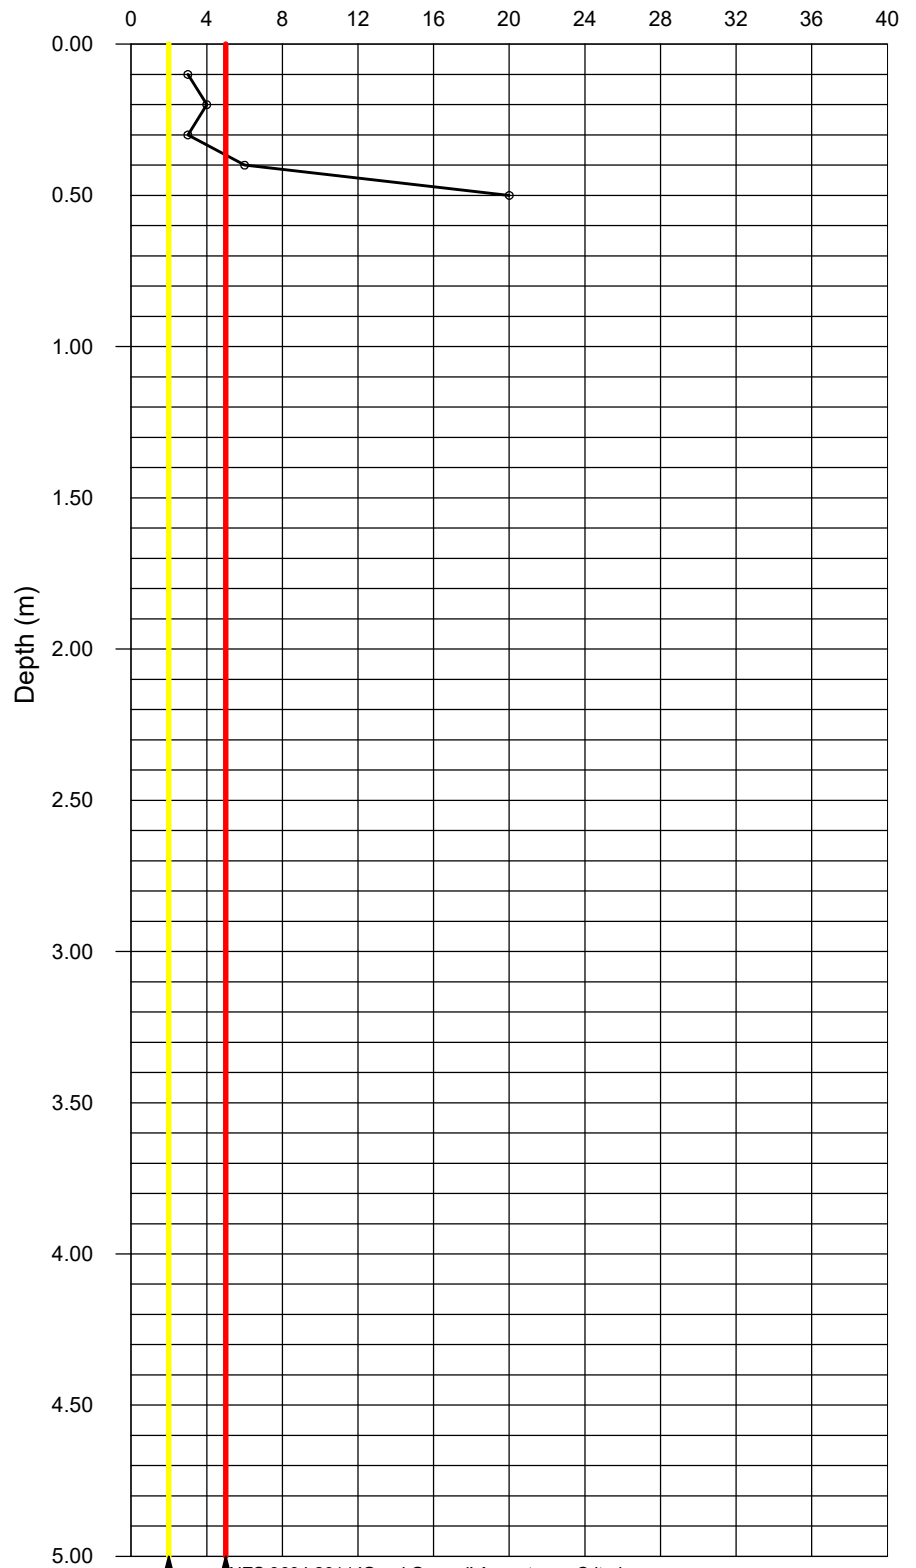
DCP logs indicate 5 blows per 100mm penetration, which is equivalent to an ultimate bearing capacity of 300kPa, was consistently encountered from a shallow depth.

20 blows for 100mm in the last increment.  
Co-ordinates and elevation data from site survey.  
Elevation based on Christchurch Drainage Datum.  
Effective refusal, 20+ blows per 100mm

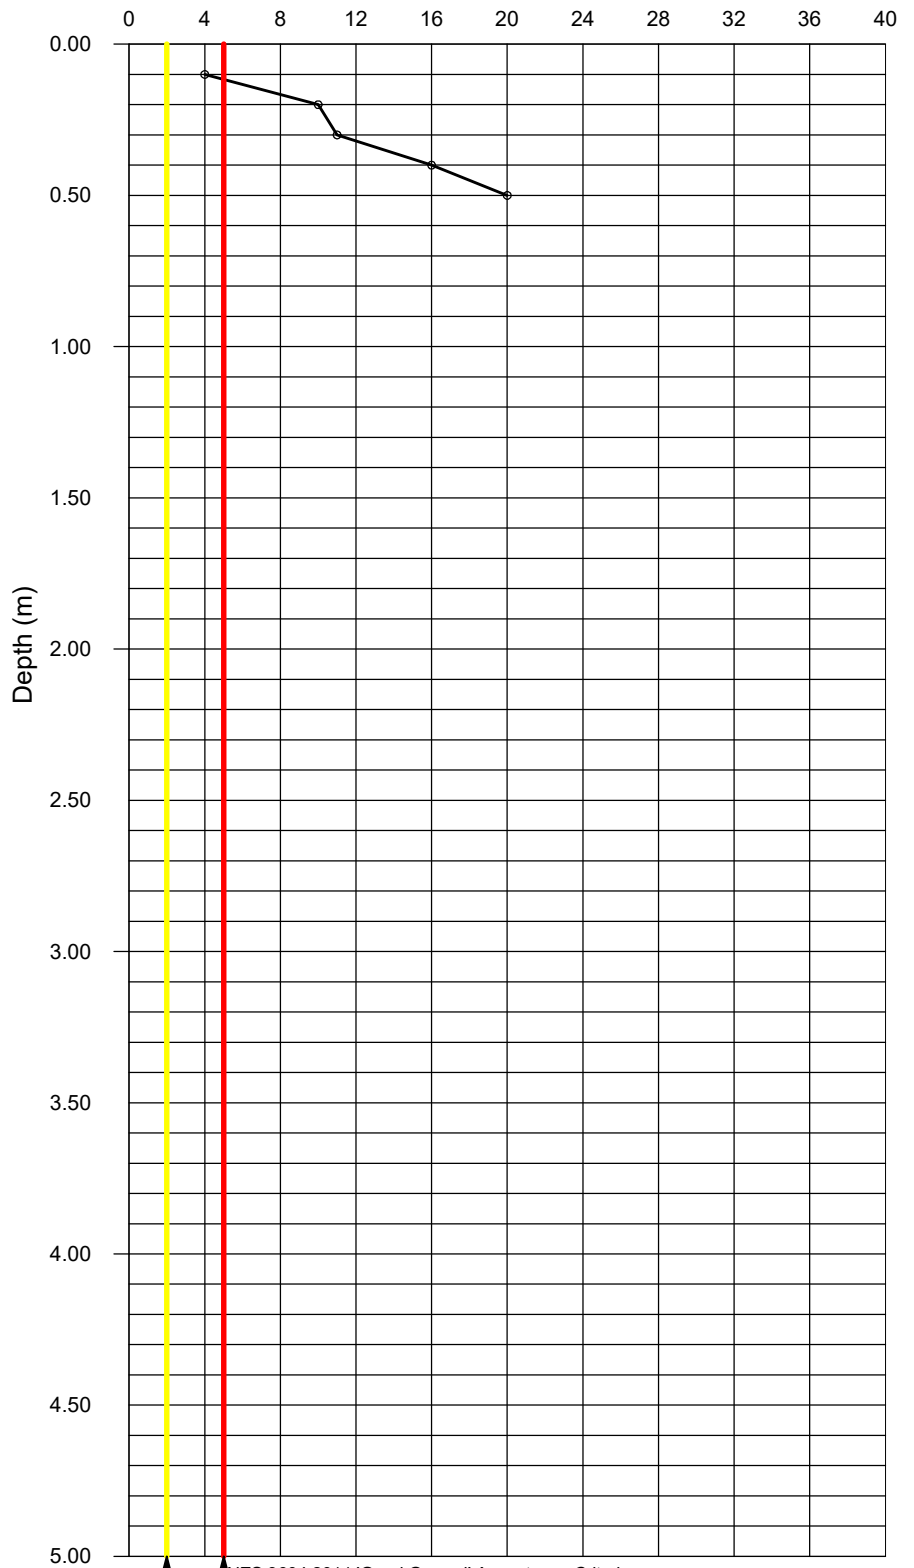
20 blows for 100mm in the last increment.  
Co-ordinates and elevation data from site survey.  
Elevation based on Christchurch Drainage Datum.  
Effective refusal, 20+ blows per 100mm
