Prestons Park Subdivision
GEOTECHNICAL REPORT FOR LOT 1043
CDL Land NZ Limited

5 August 2022
Revision: 1
Reference: 235361

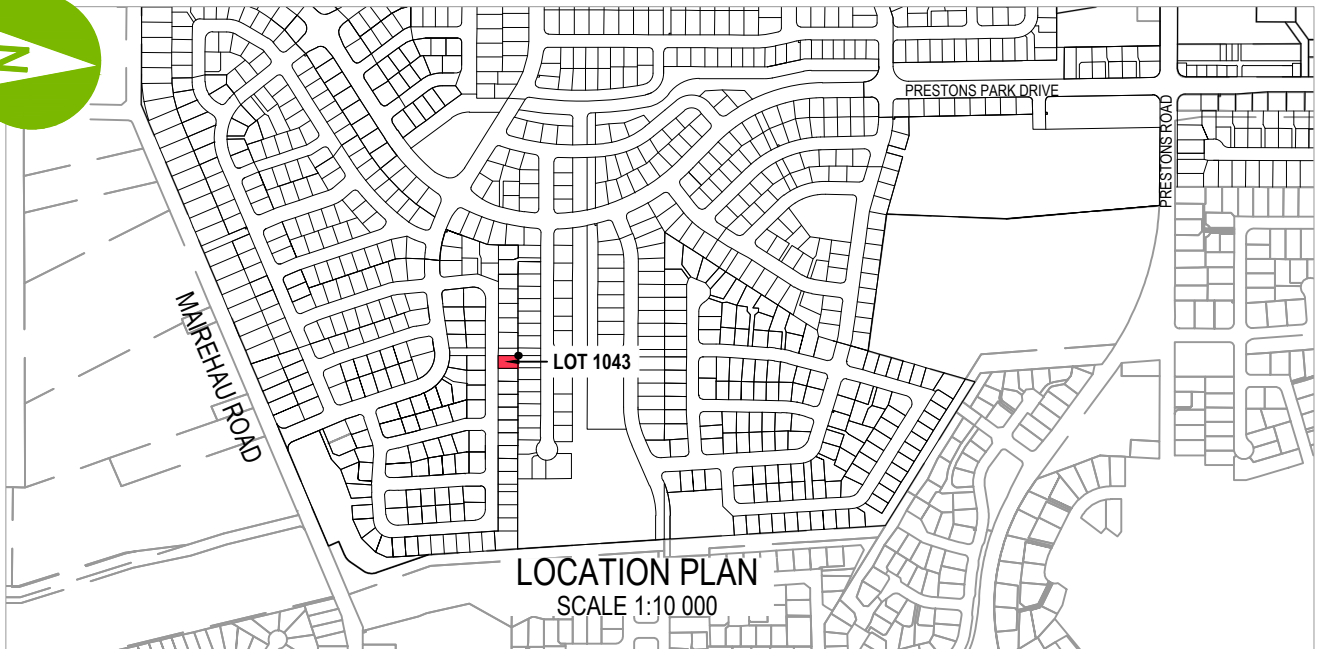
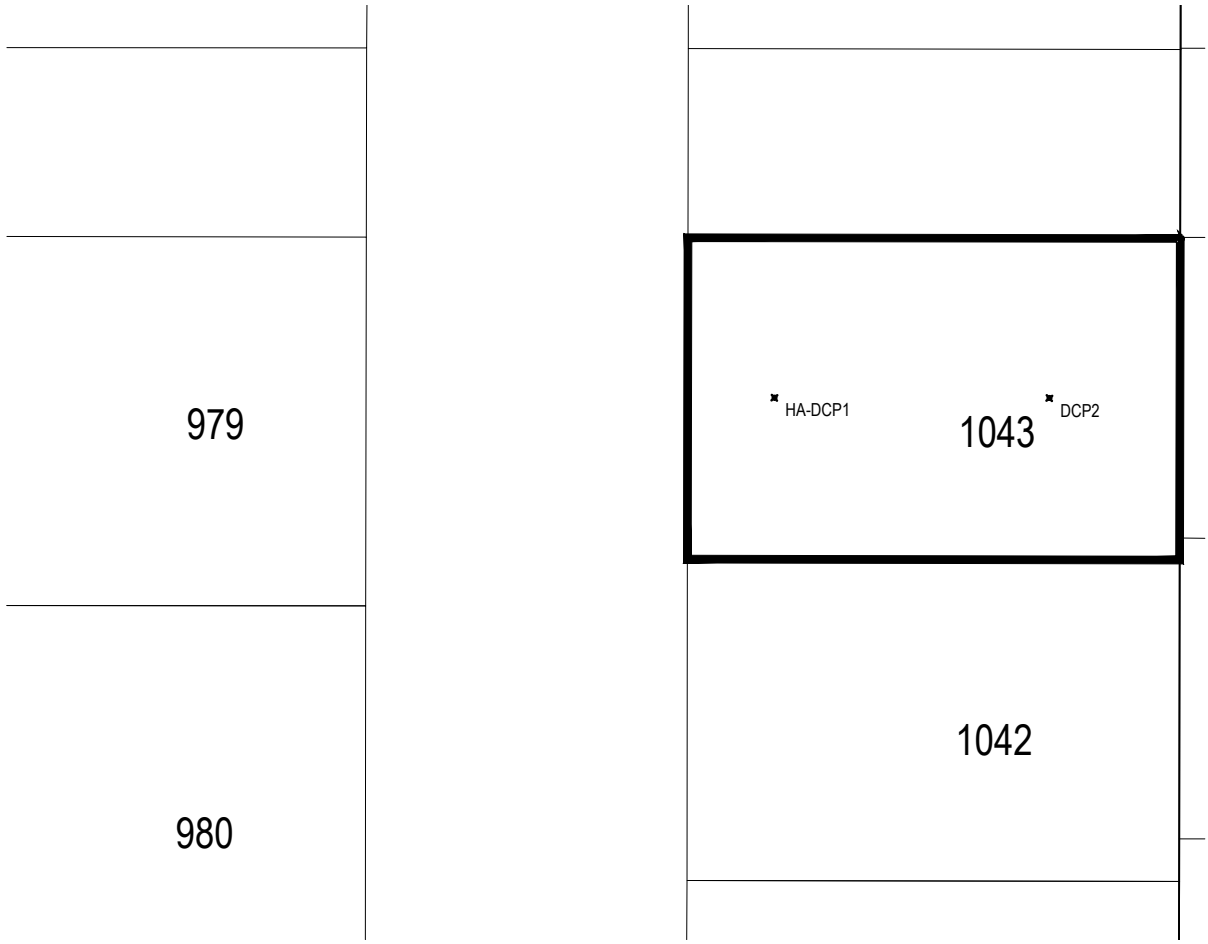
| | | | | | APPROVED | T BROWNE | DATE 03/05/22 | LOT 1043 SITE LOCATION PLAN FIGURE 1 | DRAWING No. |

This building consent report is for Lot 1043 which is located in Stage 5 of the Prestons Park Subdivision development (refer Figure 1 in Appendix A). The lot is bordered by residential lots to the north and east, an access road to the south and a reserve to the west.

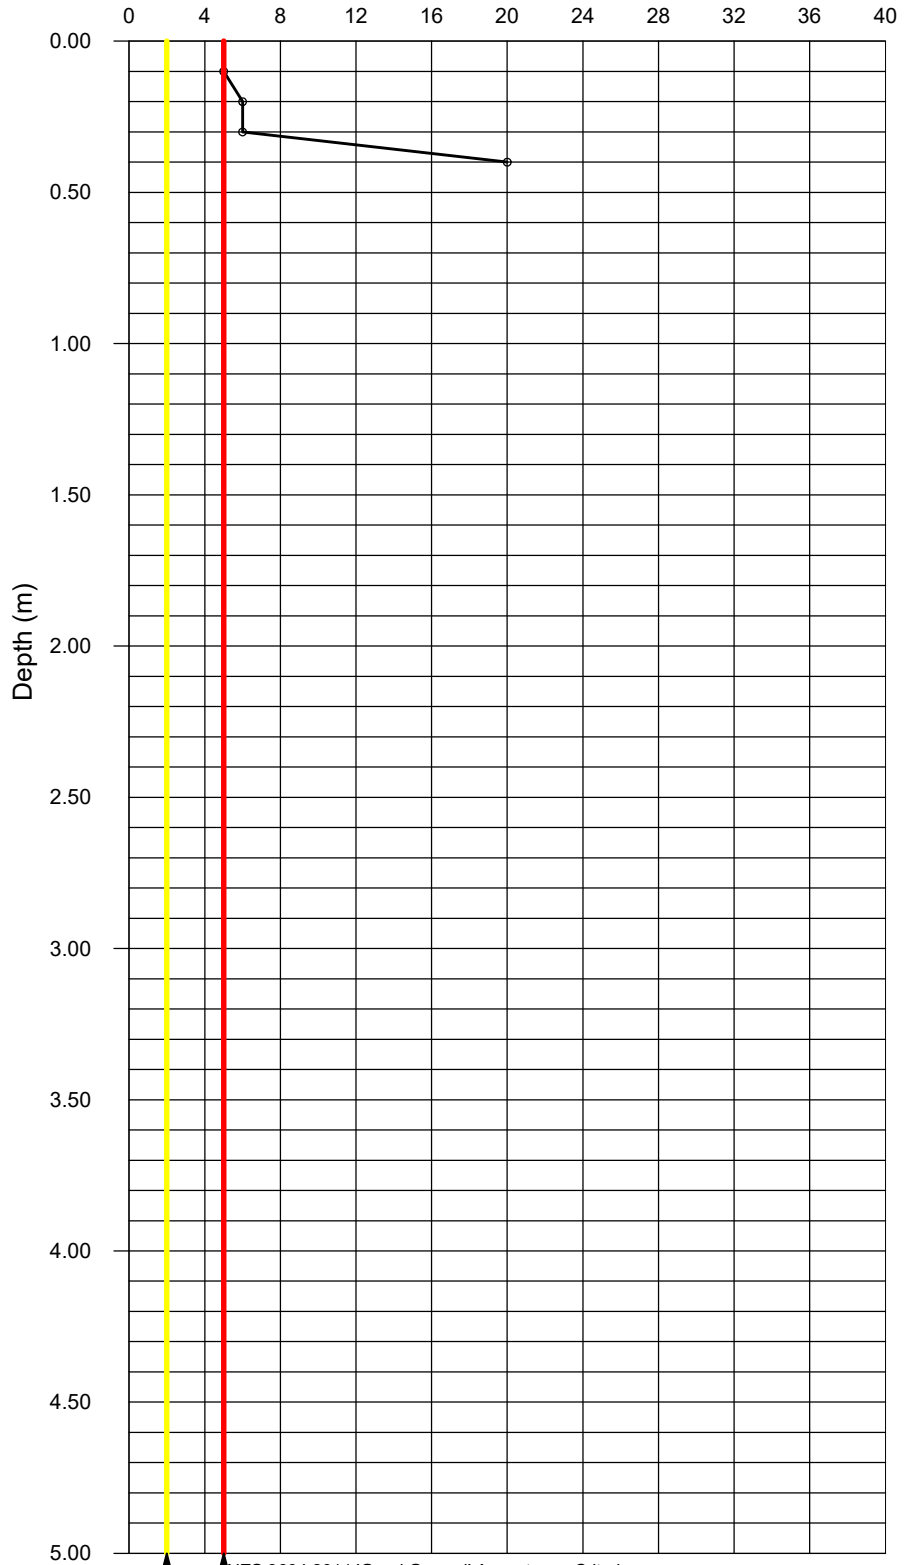
DCP logs indicate 5 blows per 100mm penetration, which is equivalent to an ultimate bearing capacity of 300kPa, was consistently encountered from a shallow depth.

20 blows for 100mm in the last increment.
Co-ordinates and elevation data from site survey.
Elevation based on Christchurch Drainage Datum.
Effective refusal, 20+ blows per 100mm

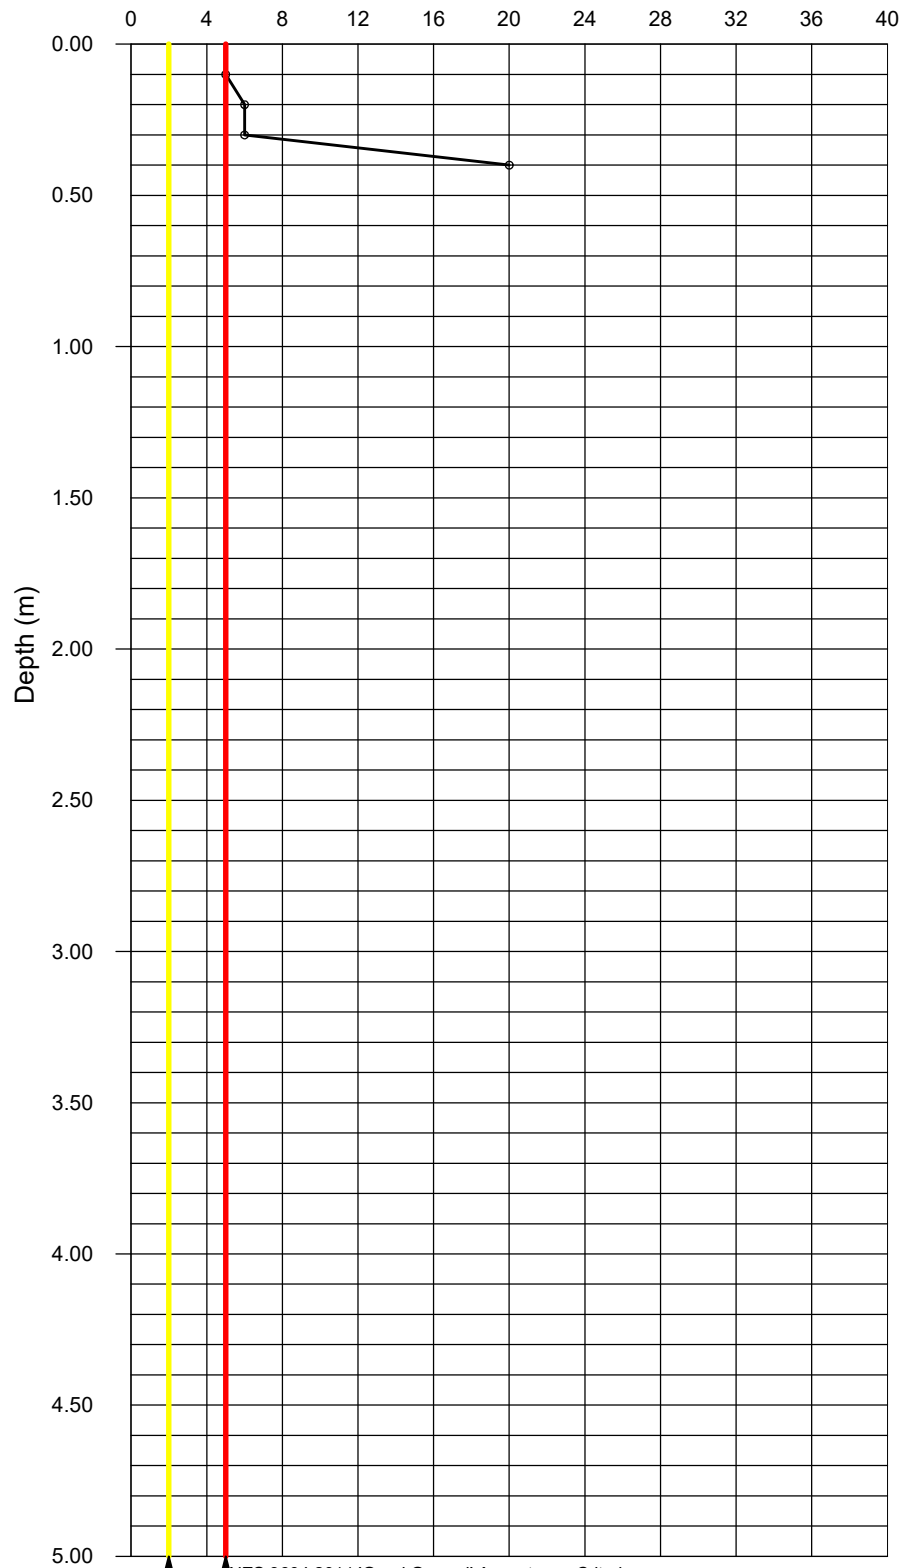
20 blows for 100mm in the last increment.
Co-ordinates and elevation data from site survey.
Elevation based on Christchurch Drainage Datum.
Effective refusal, 20+ blows per 100mm
