**Prestons Park Subdivision**  
**GEOTECHNICAL REPORT FOR LOT 1044**  
**CDL Land NZ Limited**

**5 August 2022**  
**Revision: 1**  
**Reference: 235361**

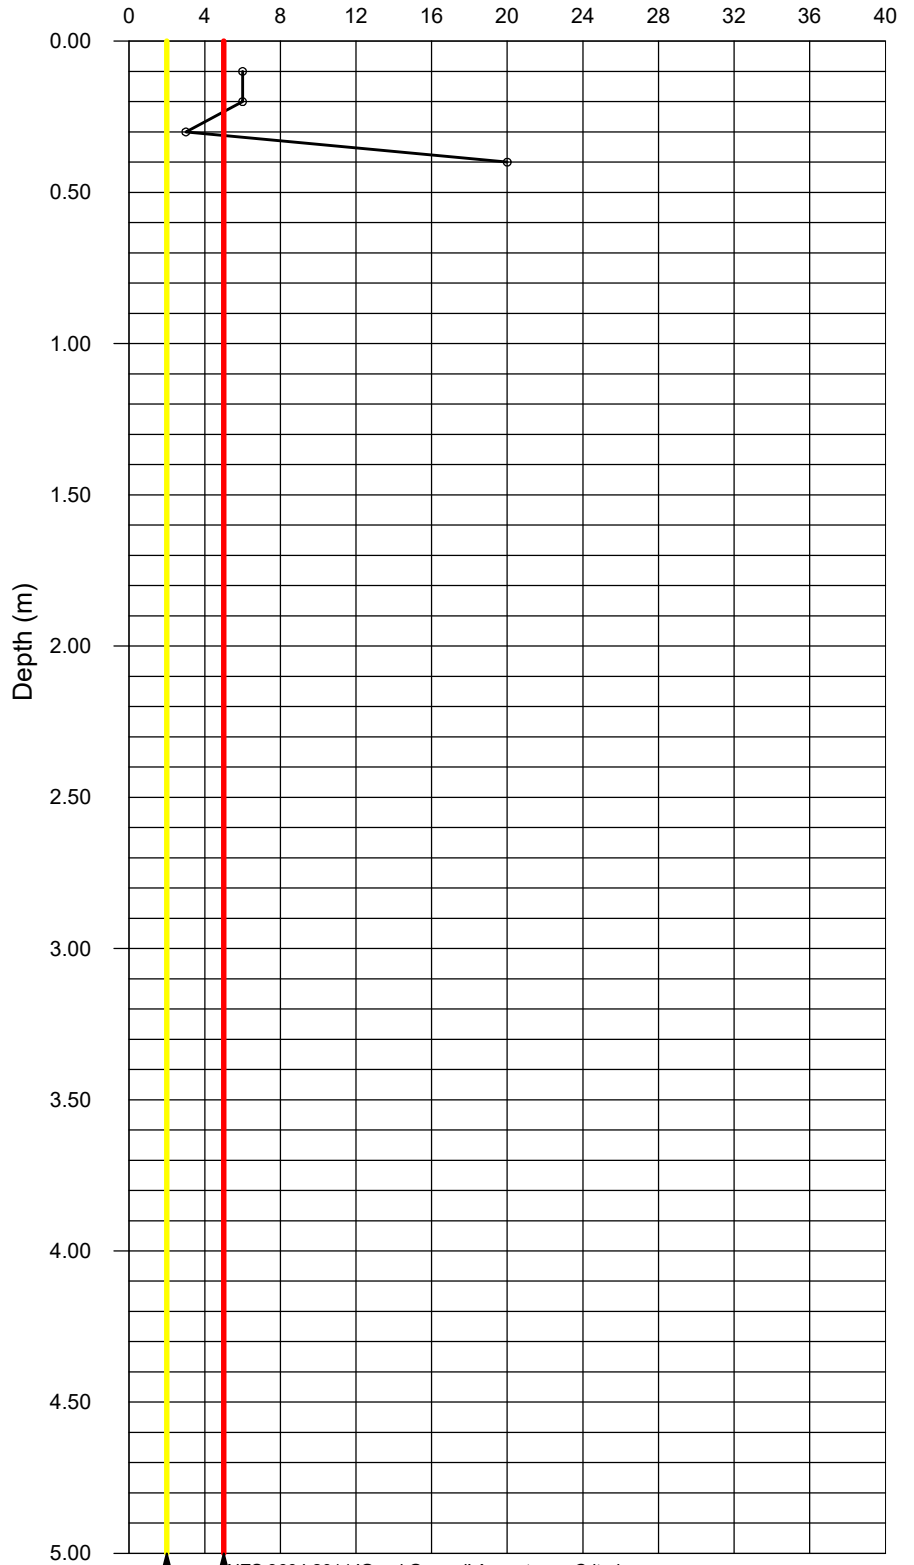
DCP logs indicate 5 blows per 100mm penetration, which is equivalent to an ultimate bearing capacity of 300kPa, was consistently encountered from a depth of 0.5m.

20 blows for 100mm in the last increment.  
Co-ordinates and elevation data from site survey.  
Elevation based on Christchurch Drainage Datum.  
Effective refusal, 20+ blows per 100mm

Based on our understanding of the site works and the investigation results, we recommend that NZS3604:2011 compliant foundations are embedded a minimum depth of 0.5m below current ground level.

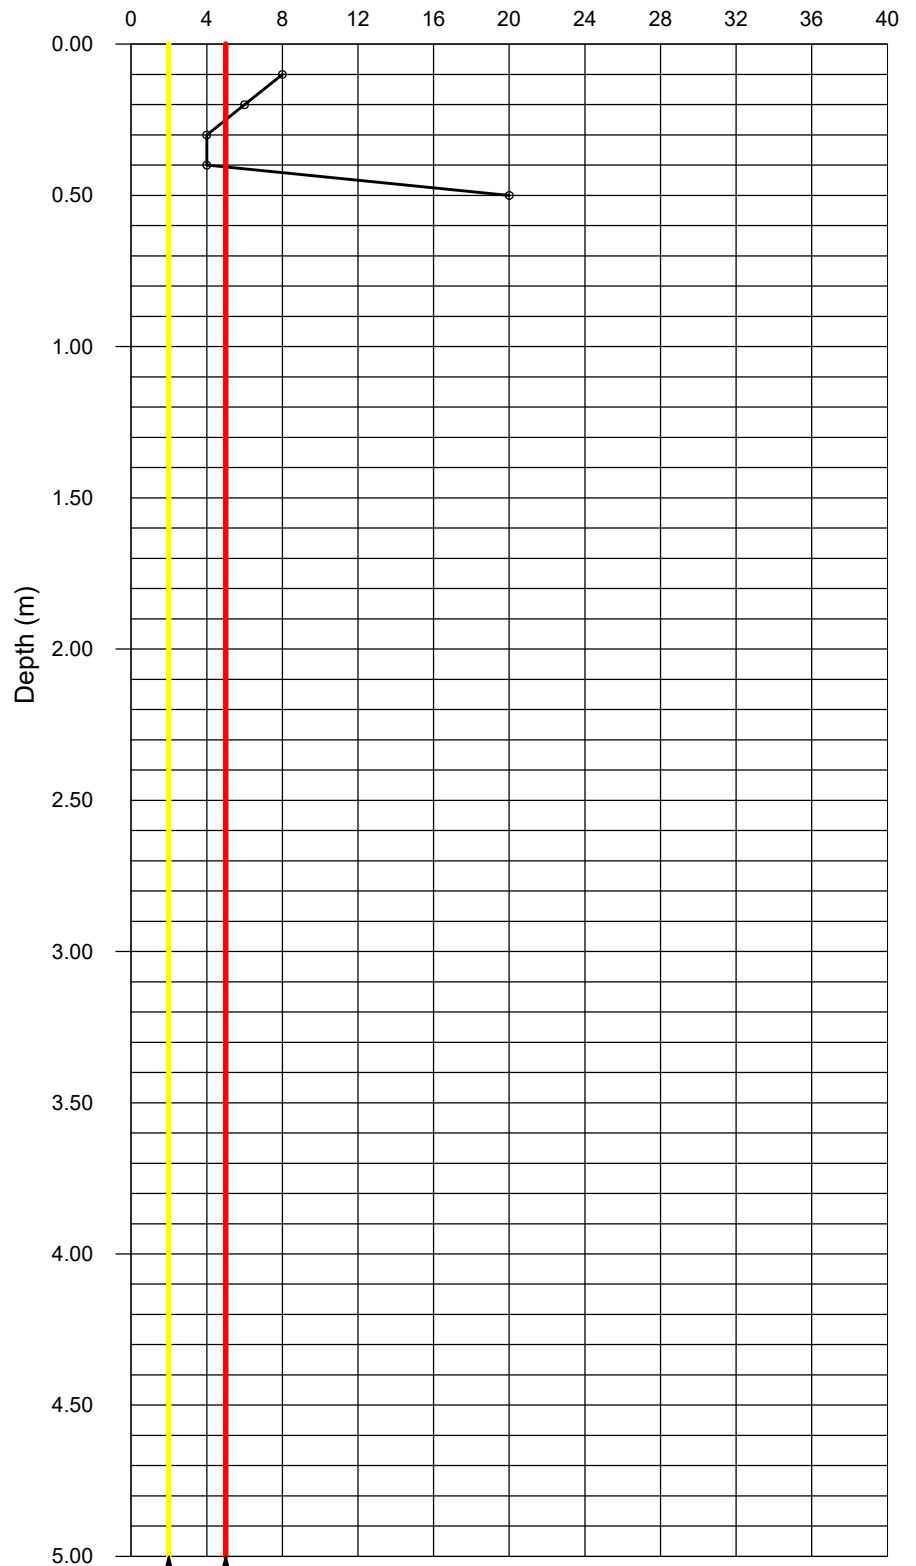
20 blows for 100mm in the last increment.  
Co-ordinates and elevation data from site survey.  
Elevation based on Christchurch Drainage Datum.  
Effective refusal, 20+ blows per 100mm
