**Prestons Park Subdivision**  
**GEOTECHNICAL REPORT FOR LOT 1045**  
**CDL Land NZ Limited**

**3 August 2022**  
**Revision: 1**  
**Reference: 235361**

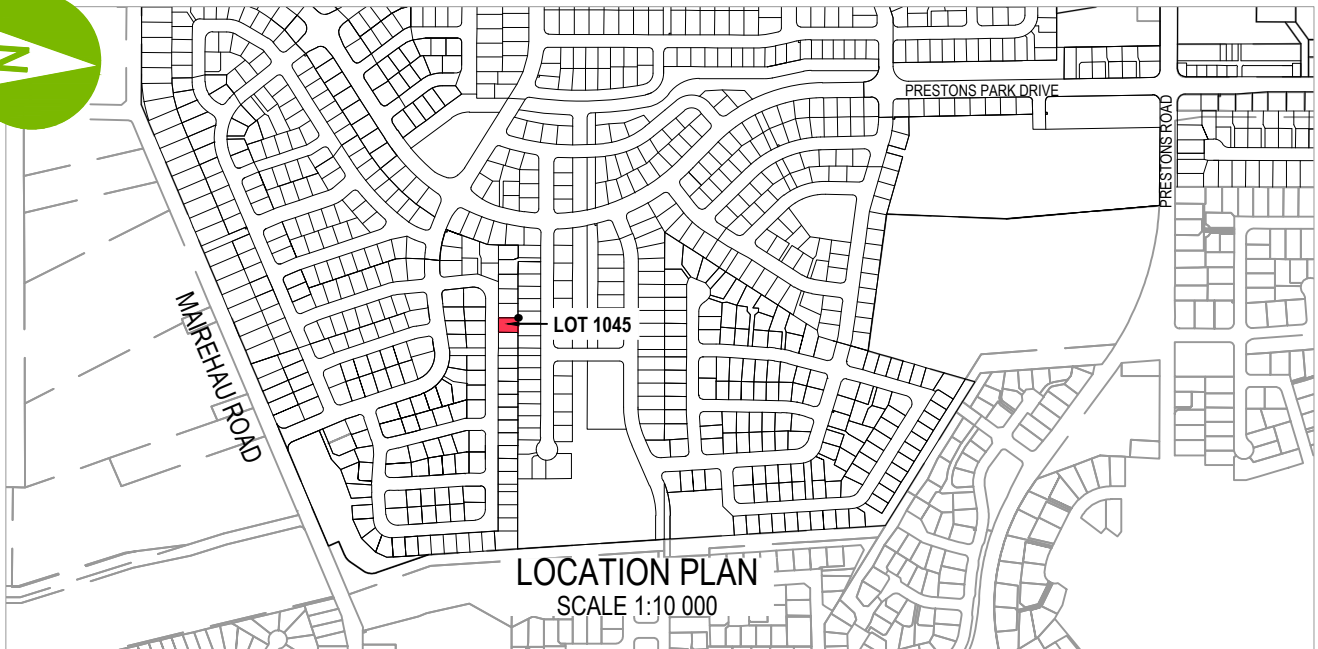
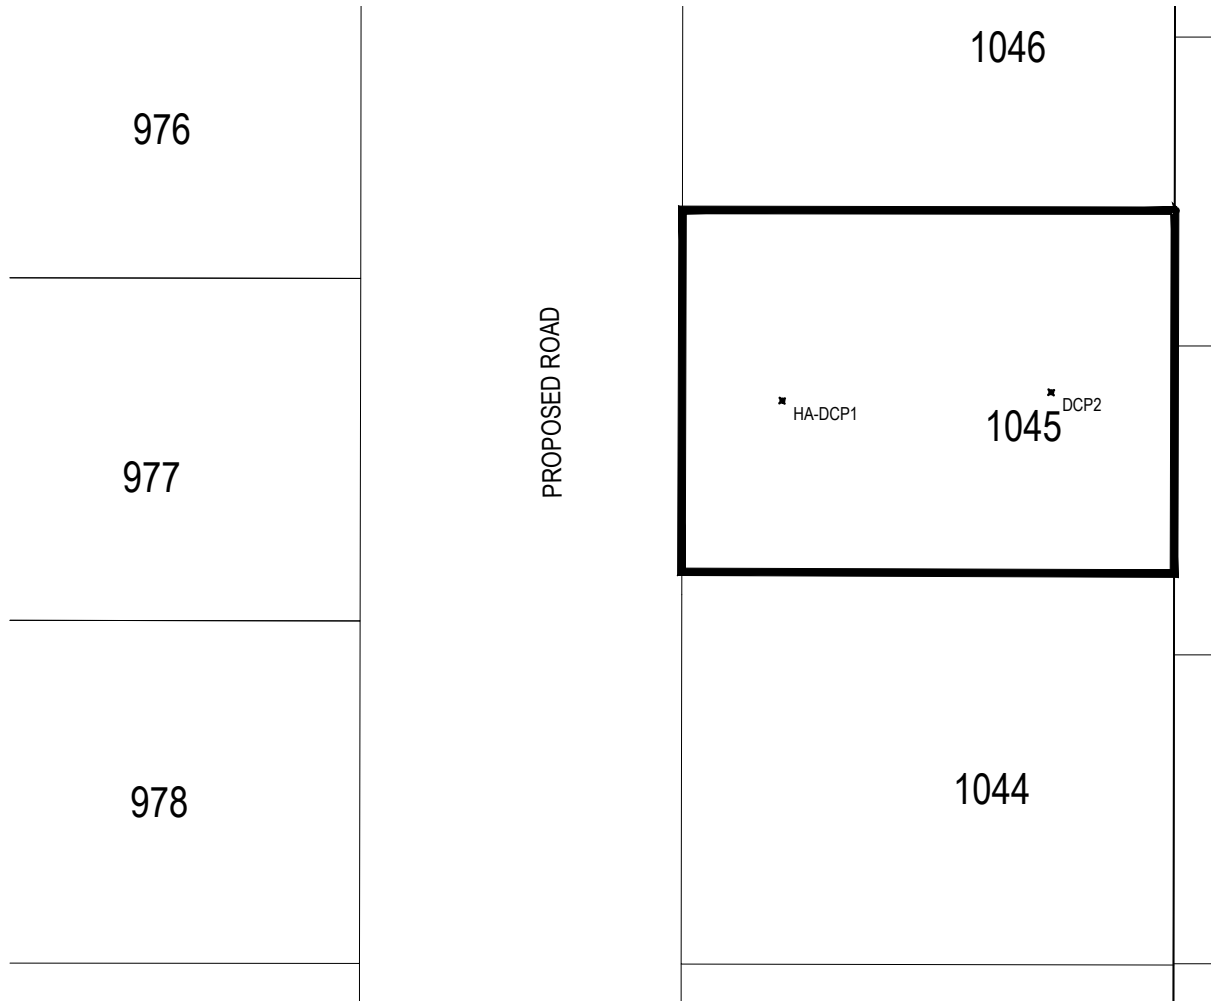
PROJECT
PRESTONS PARK
TITLE
LOT 1045 SITE LOCATION PLAN FIGURE 1

This building consent report is for Lot 1045 which is located in Stage 5 of the Prestons Park Subdivision development (refer Figure 1 in Appendix A). The lot is bordered by residential lots to the north, east and west, with an access road to the south.

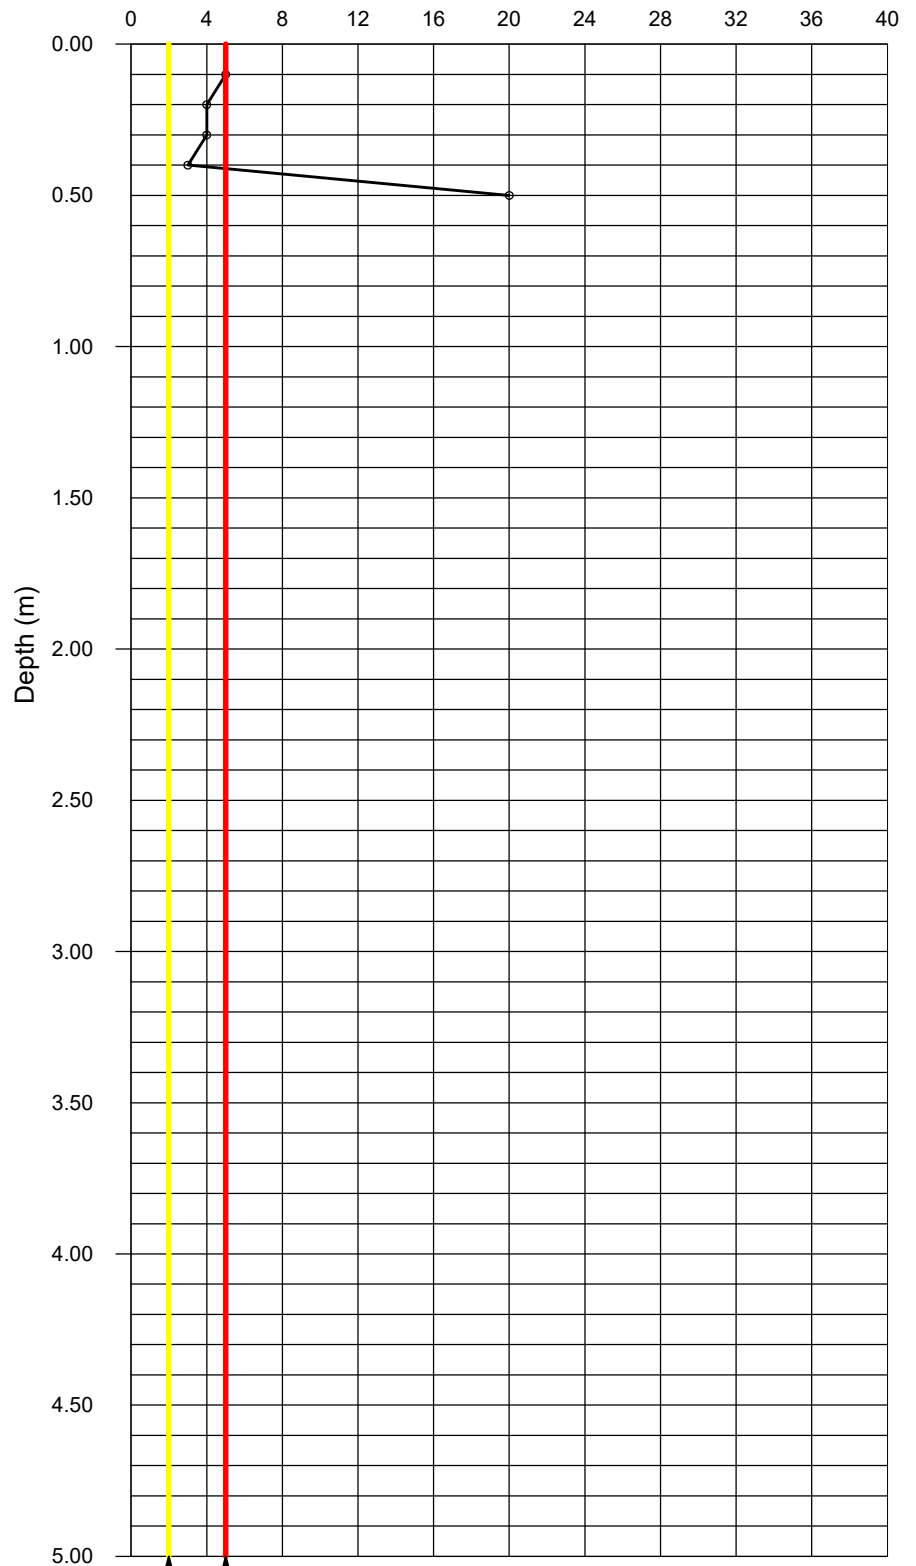
DCP logs indicate 5 blows per 100mm penetration, which is equivalent to an ultimate bearing capacity of 300kPa, was consistently encountered from a depth of 0.5m.

Depth (m)	Blows per 100 mm	Depth (m)	Blows per 100 mm
0.0	5	3.5	
	4		
	4		
	3		
0.5	20	4.0	
1.0		4.5	
1.5		5.0	
2.0			
2.5			
3.0			
3.5

20 blows for 100mm in the last increment.  
Co-ordinates and elevation data from site survey.  
Elevation based on Christchurch Drainage Datum.  
Effective refusal, 20+ blows per 100mm

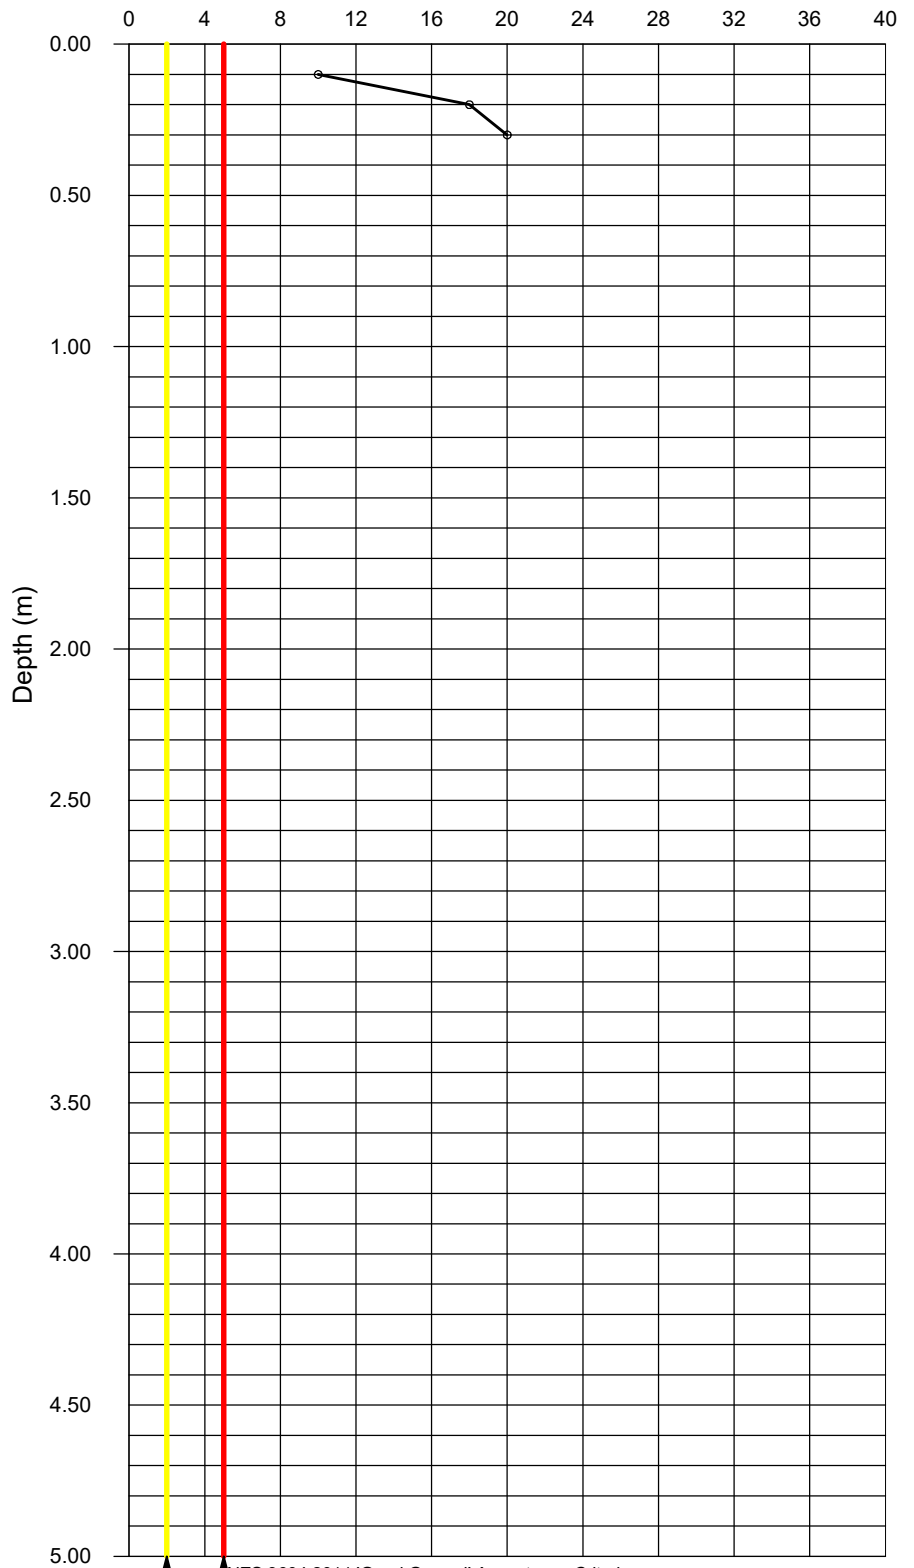
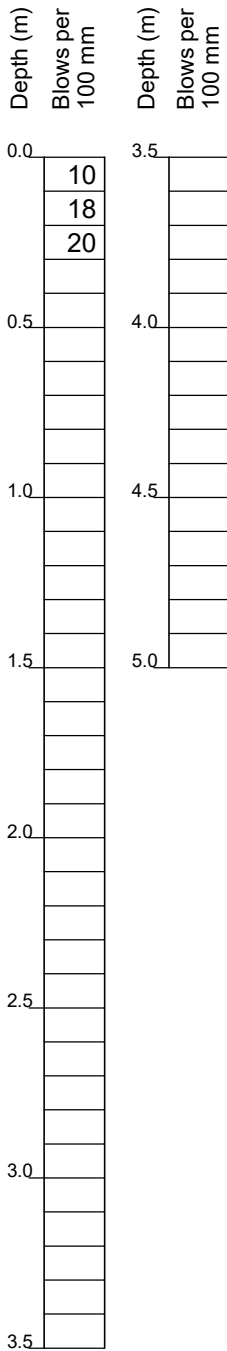
20 blows for 100mm in the last increment.  
Co-ordinates and elevation data from site survey.  
Elevation based on Christchurch Drainage Datum.  
Effective refusal, 20+ blows per 100mm
