Prestons Park Subdivision
GEOTECHNICAL REPORT FOR LOT 1046
CDL Land NZ Limited

3 August 2022
Revision: 1
Reference: 235361

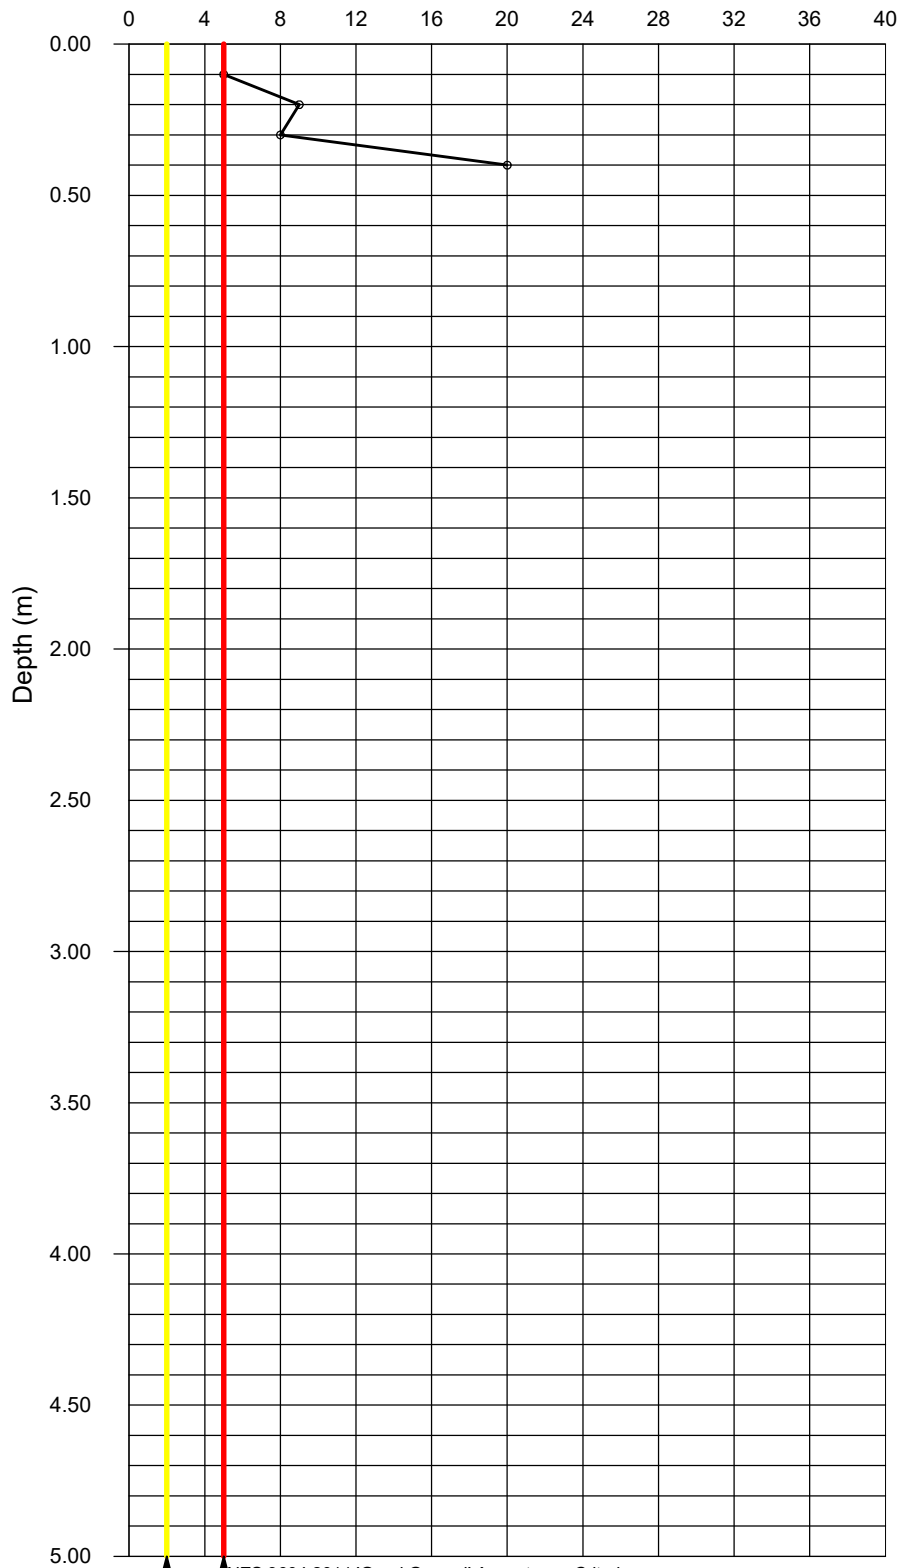
Remarks:

20 blows for 100mm in the last increment.
Co-ordinates and elevation data from site survey.
Elevation based on Christchurch Drainage Datum.
Effective refusal, 20+ blows per 100mm

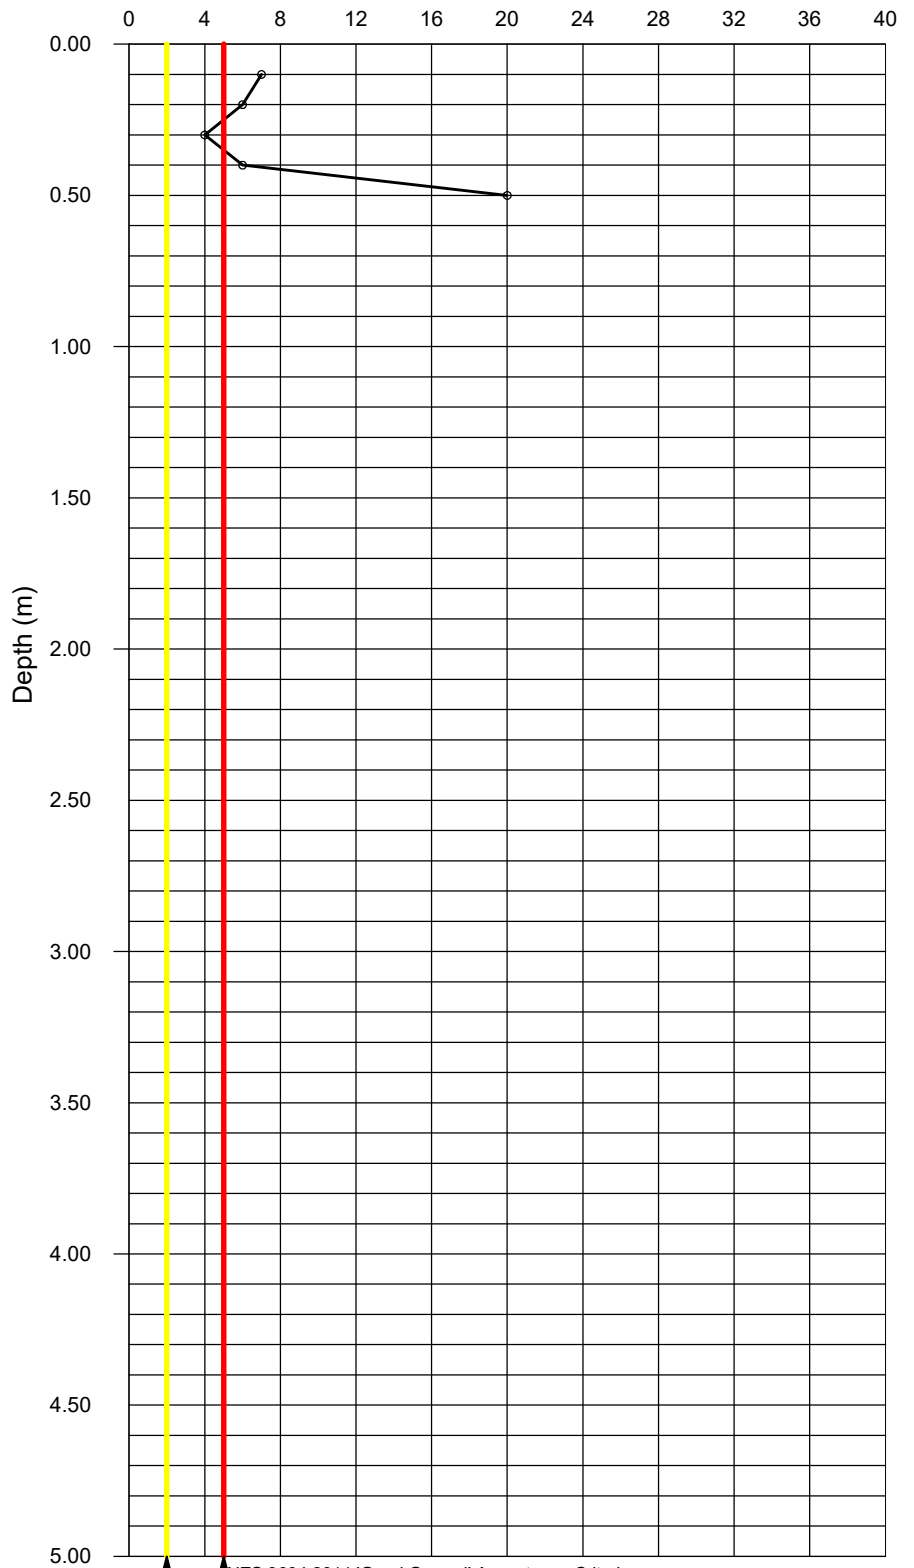
Depth (m)	Blows per 100 mm	Depth (m)	Blows per 100 mm
0.0	7	3.5	
	6		
	4		
	6		
0.5	20	4.0	
1.0		4.5	
1.5		5.0	
2.0			
2.5			
3.0			
3.5

Remarks:

20 blows for 100mm in the last increment.
Co-ordinates and elevation data from site survey.
Elevation based on Christchurch Drainage Datum.
Effective refusal, 20+ blows per 100mm
