Prestons Park Subdivision
GEOTECHNICAL REPORT FOR LOT 992
CDL Land NZ Limited

9 November 2022
Revision: 1
Reference: 235361

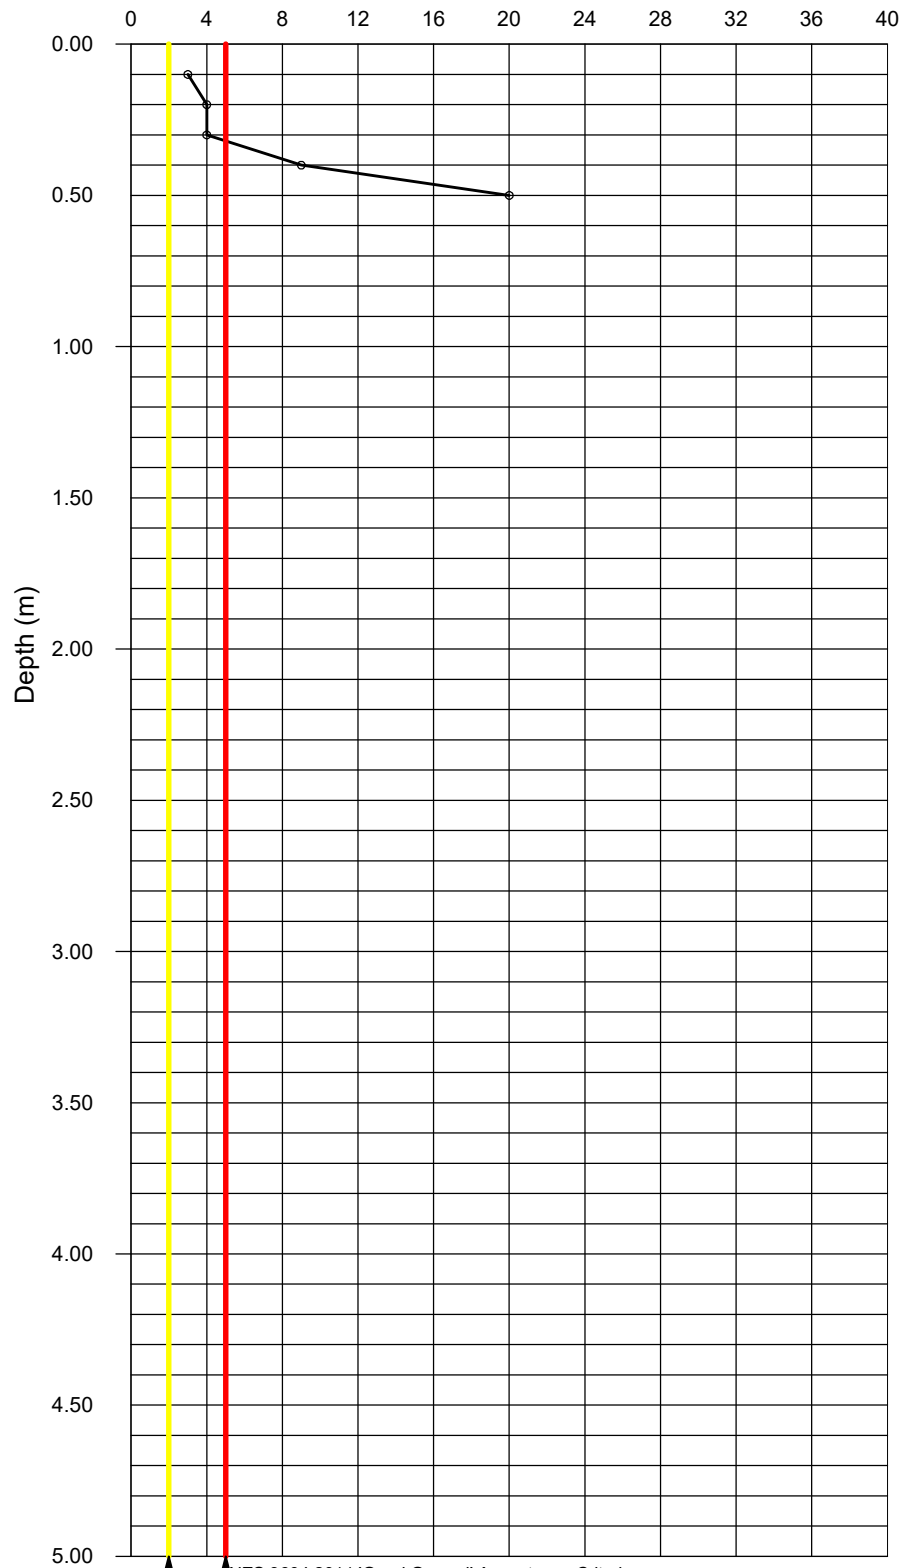
Depth (m)	Blows per 100 mm	Depth (m)	Blows per 100 mm
0.0	3	3.5	
0.1	4	4.0	
0.2	4	4.5	
0.3	9	5.0	
0.4	20		
0.5			
1.0			
1.5			
2.0			
2.5			
3.0			
3.5

20 blows for 100mm in the last increment.
Co-ordinates and elevation data from site survey.
Elevation based on Christchurch Drainage Datum.
Effective refusal, 20+ blows per 100mm

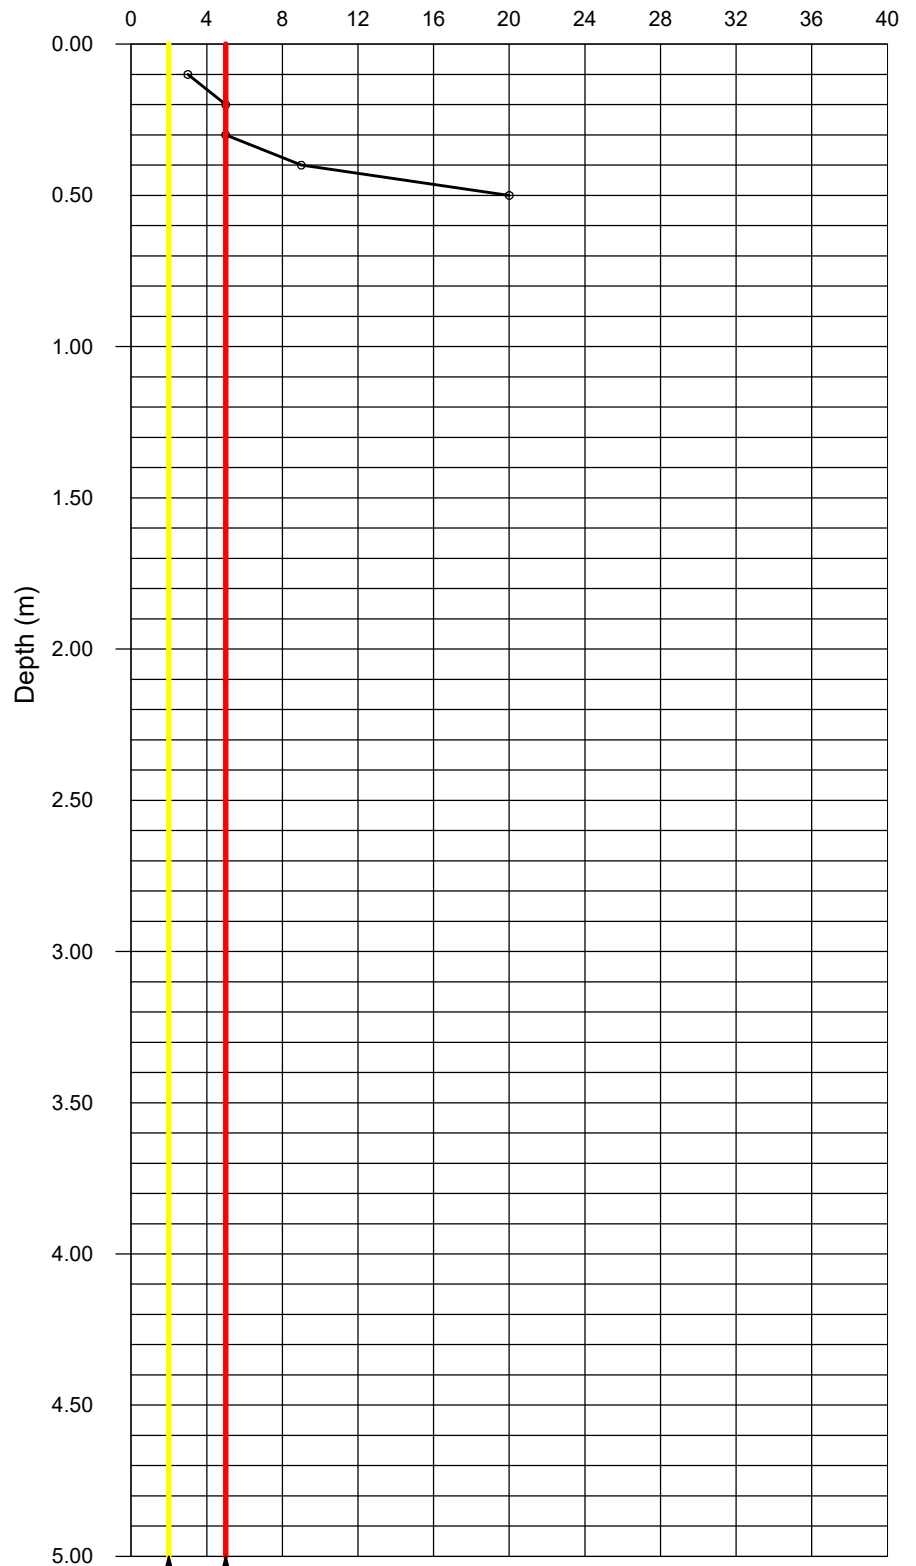
Depth (m)	Blows per 100 mm	Depth (m)	Blows per 100 mm
0.0	3	3.5	
0.1	5		
0.2	5		
0.3	9		
0.4	20	4.0	
0.5			
1.0		4.5	
1.5		5.0	
2.0			
2.5			
3.0			
3.5

20 blows for 100mm in the last increment.
Co-ordinates and elevation data from site survey.
Elevation based on Christchurch Drainage Datum.
Effective refusal, 20+ blows per 100mm
