Prestons Park Subdivision  
GEOTECHNICAL REPORT FOR LOT 1005  
CDL Land NZ Limited

9 November 2022  
Revision: 1  
Reference: 235361

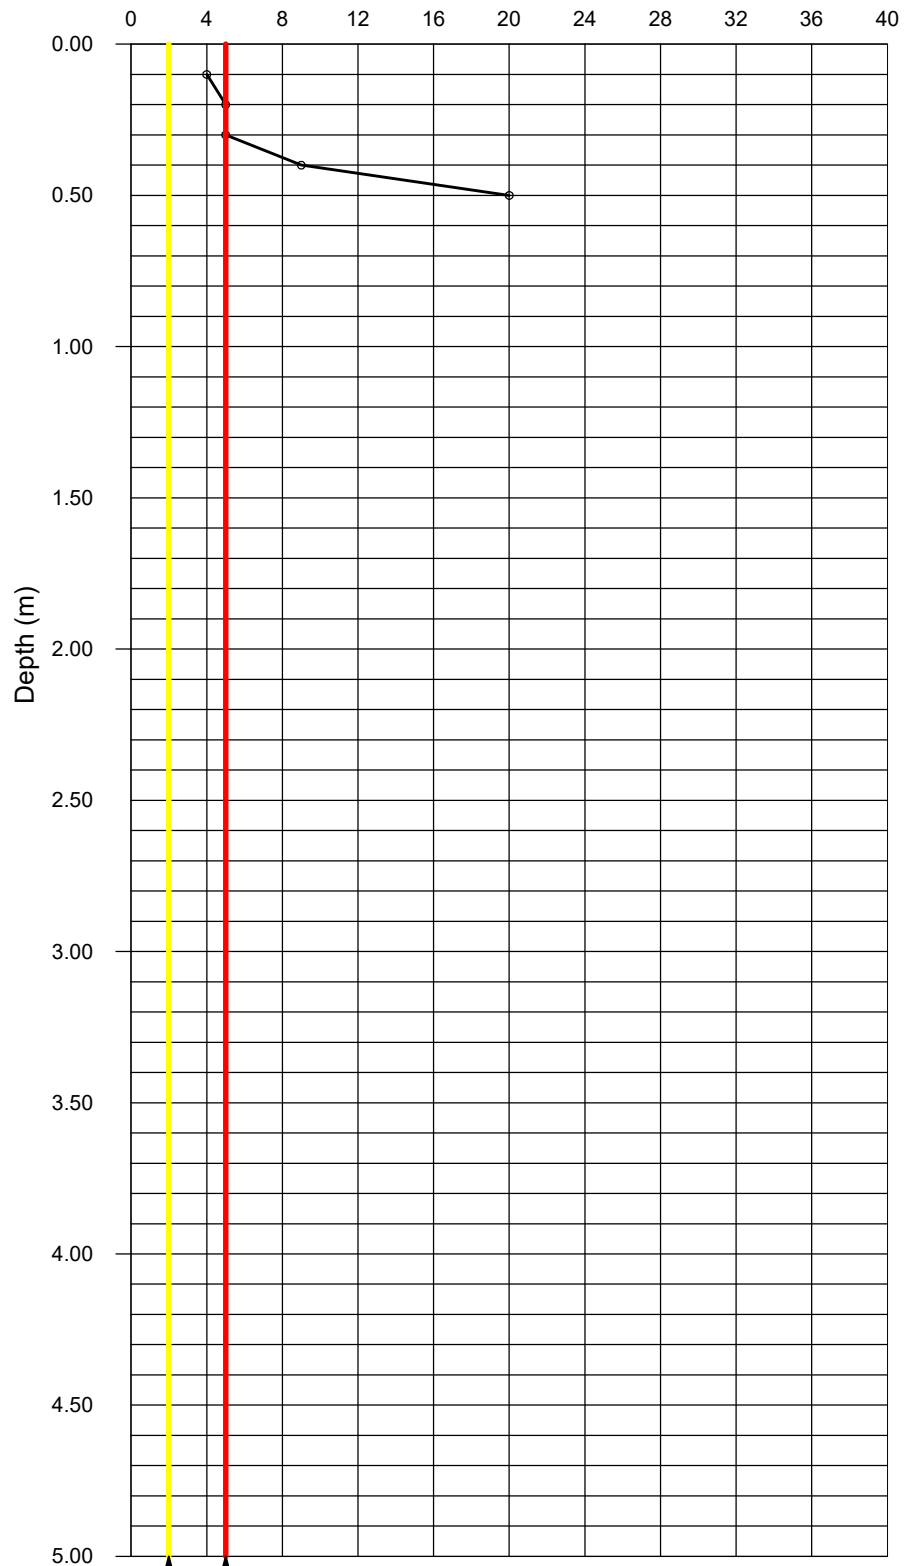
DCP logs indicate 5 blows per 100mm penetration, which is equivalent to an ultimate bearing capacity of 300kPa, was consistently encountered from a depth of 0.4m.

20 blows for 100mm in the last increment.  
Co-ordinates and elevation data from site survey.  
Elevation based on Christchurch Drainage Datum.  
Effective refusal, 20+ blows per 100mm
