Prestons Park Subdivision
GEOTECHNICAL REPORT FOR LOT 1030
CDL Land NZ Limited

9 November 2022
Revision: 1
Reference: 235361

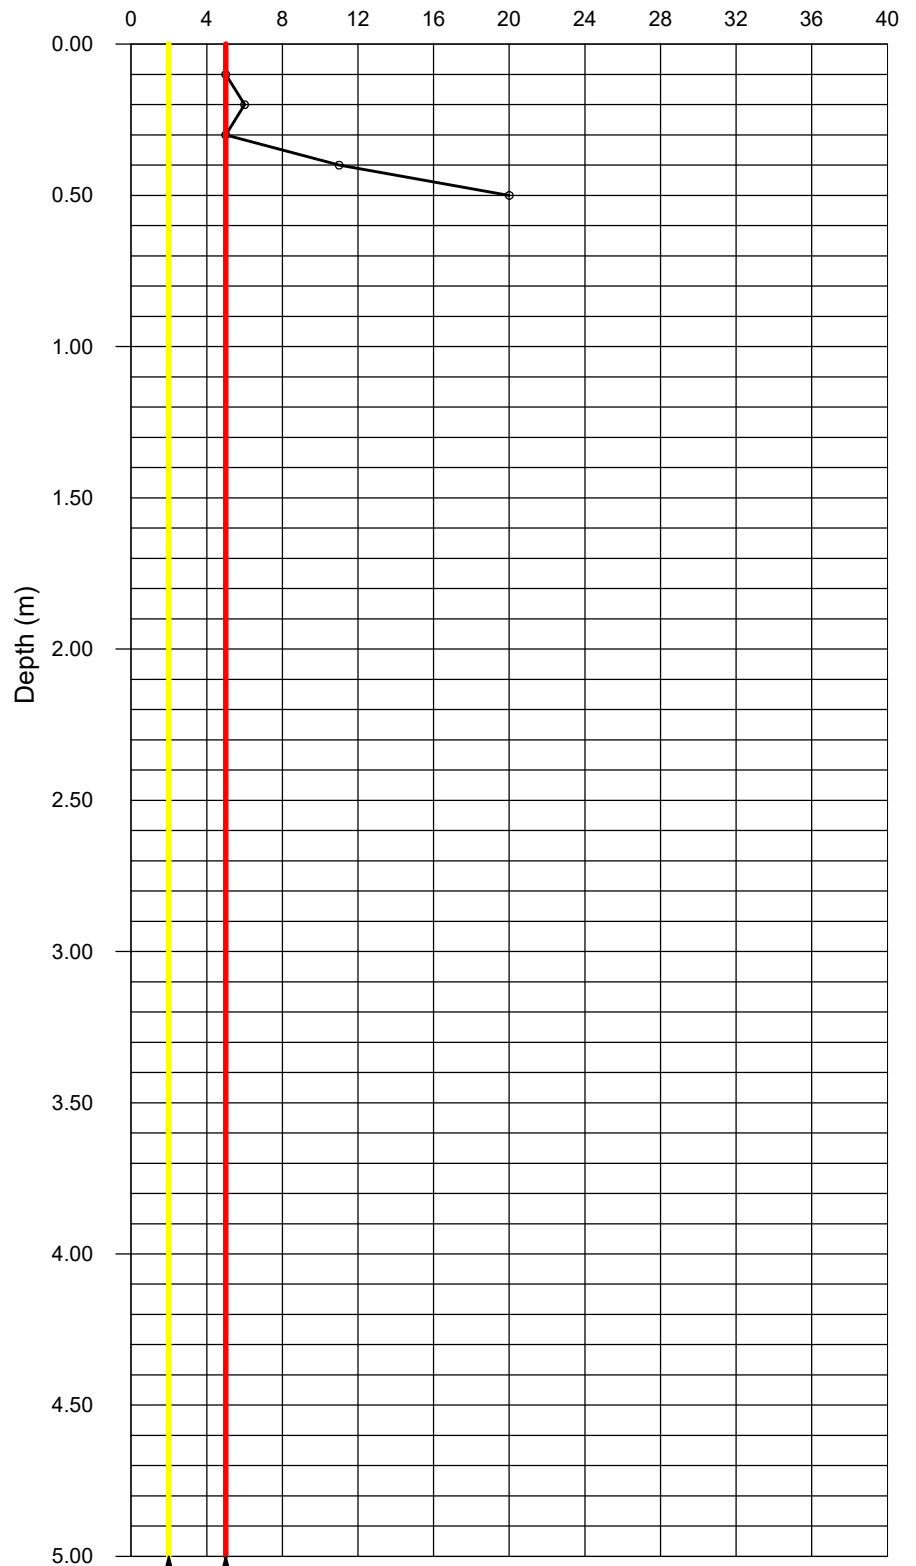
DCP logs indicate two blows per 100mm penetration, which is equivalent to an ultimate bearing capacity of 200kPa, was consistently encountered from a shallow depth.

20 blows for 100mm in the last increment.
Co-ordinates and elevation data from site survey.
Elevation based on Christchurch Drainage Datum.
Effective refusal, 20+ blows per 100mm

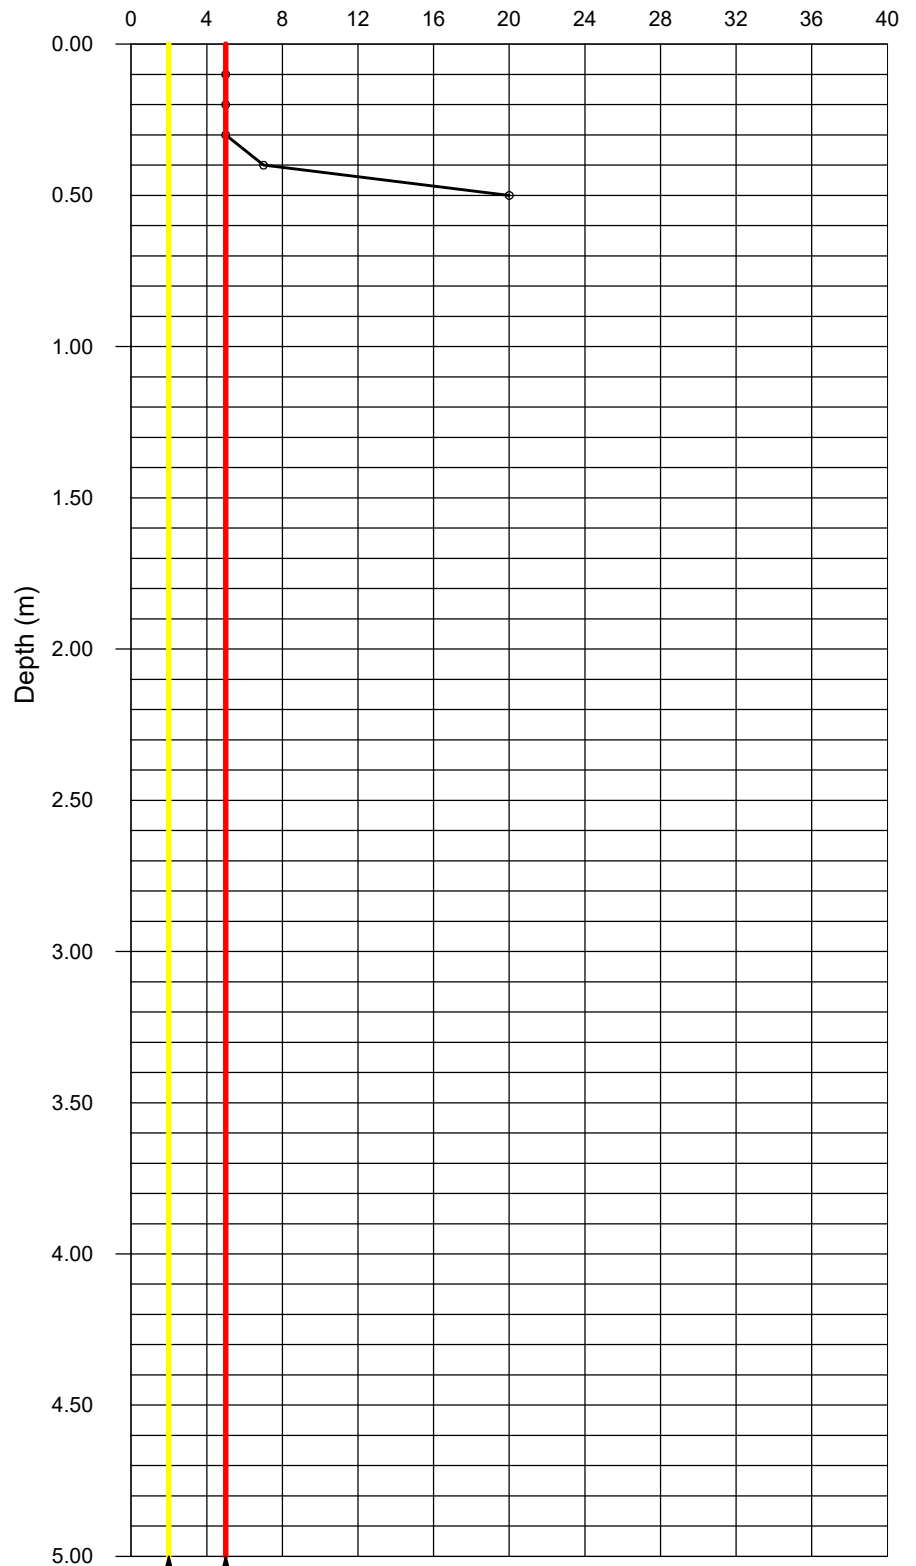
20 blows for 100mm in the last increment.
Co-ordinates and elevation data from site survey.
Elevation based on Christchurch Drainage Datum.
Effective refusal, 20+ blows per 100mm
