Prestons Park Subdivision  
GEOTECHNICAL REPORT FOR LOT 1031  
CDL Land NZ Limited

9 November 2022  
Revision: 1  
Reference: 235361

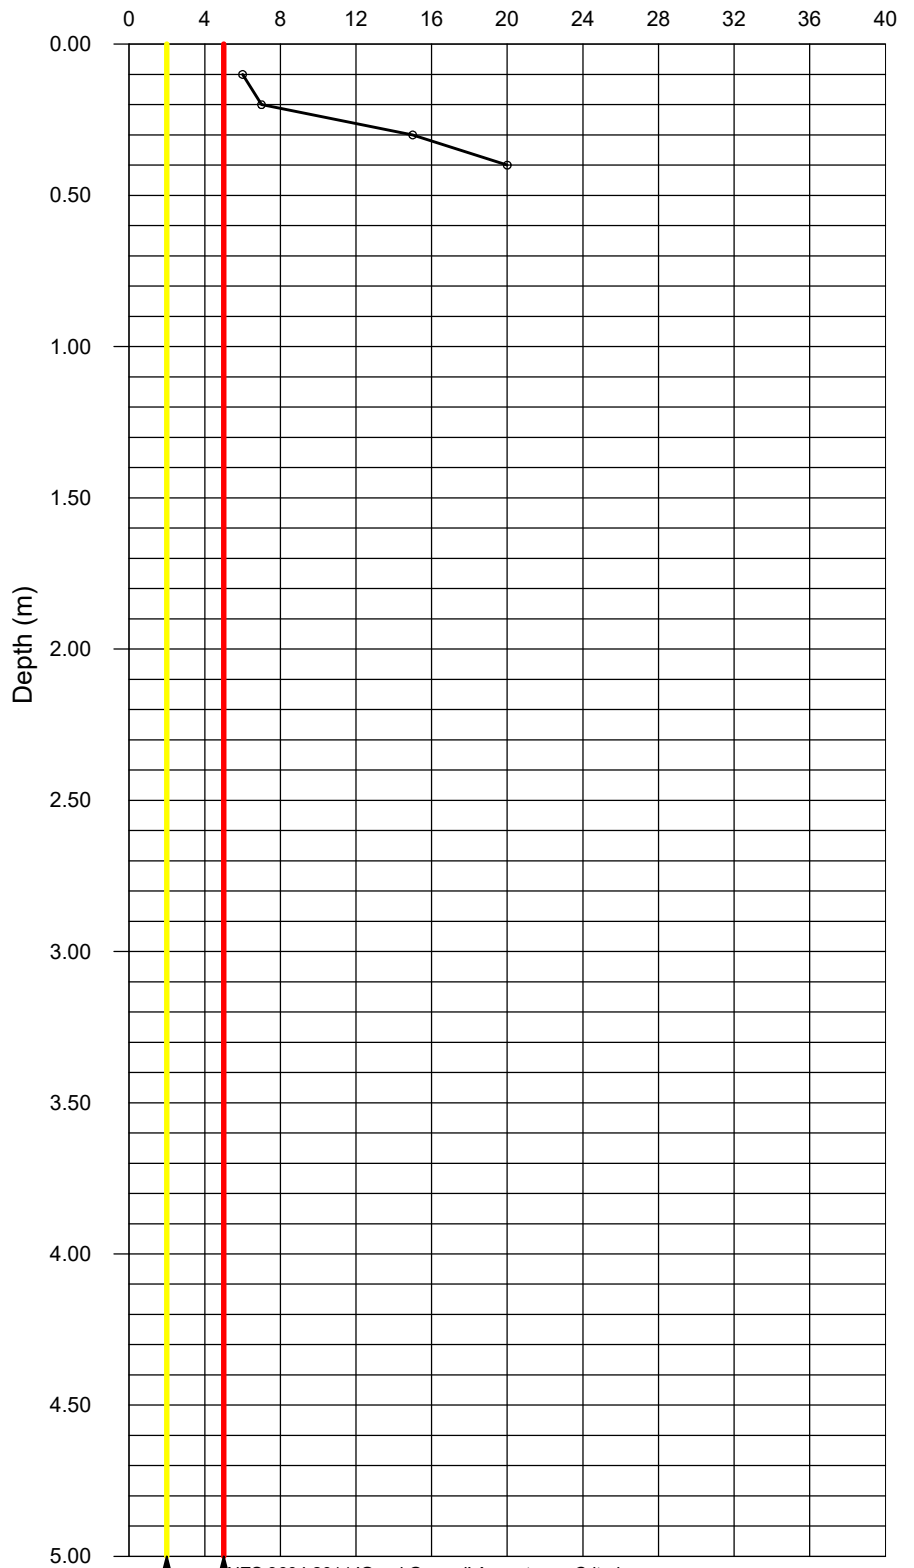
DCP logs indicate 5 blows per 100mm penetration, which is equivalent to an ultimate bearing capacity of 300kPa, was consistently encountered from a shallow depth.

20 blows for 100mm in the last increment.  
Co-ordinates and elevation data from site survey.  
Elevation based on Christchurch Drainage Datum.  
Effective refusal, 20+ blows per 100mm

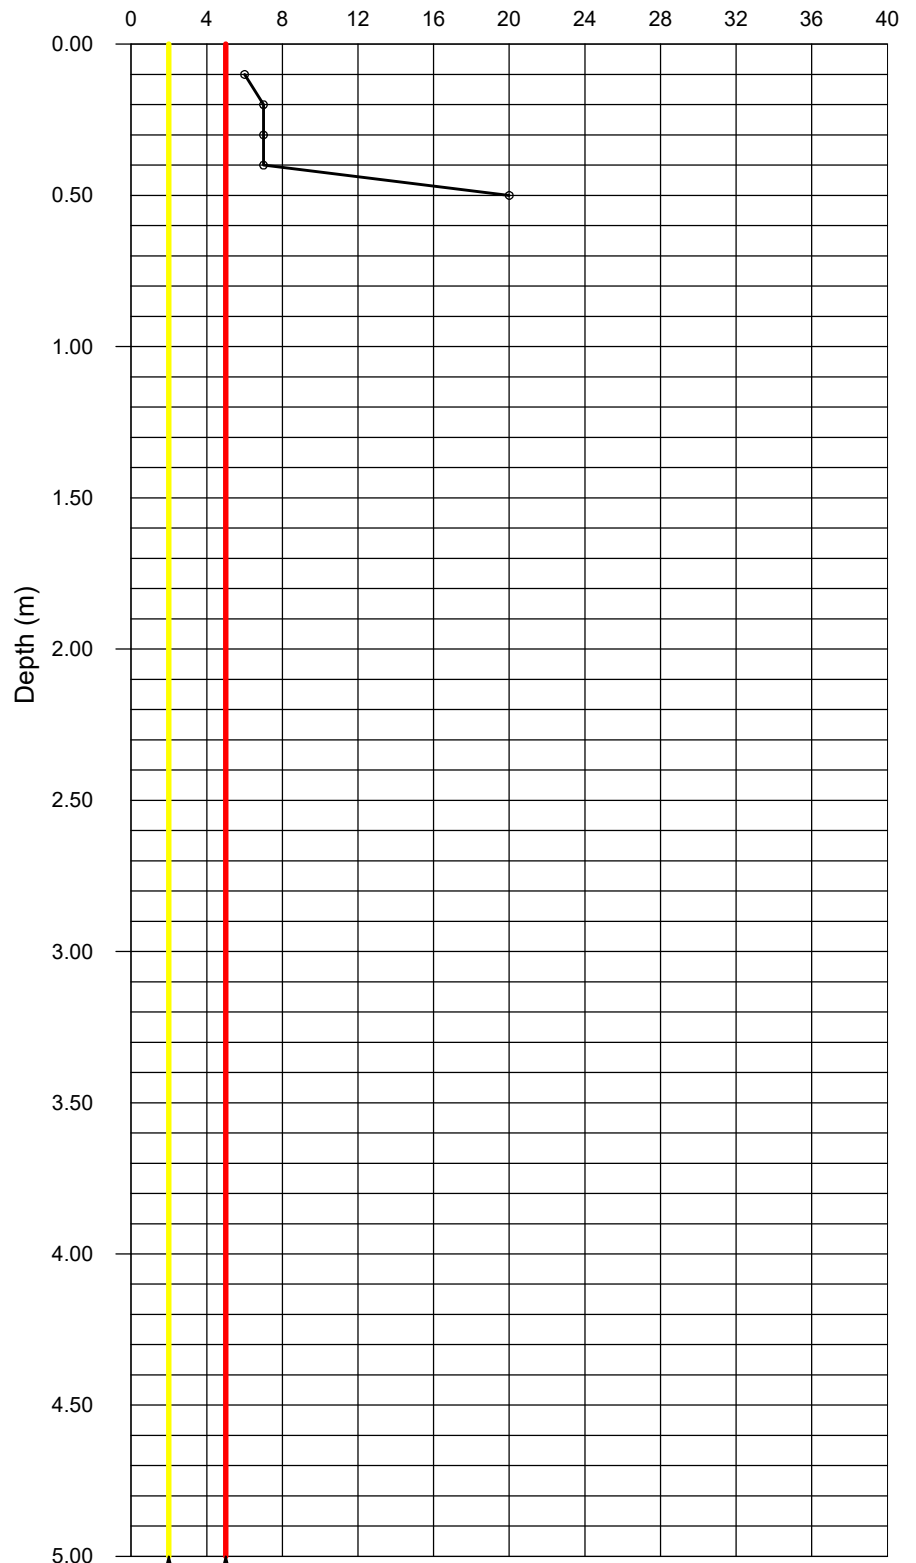
Depth (m)	Blows per 100 mm	Depth (m)	Blows per 100 mm
0.0	6	3.5	
0.1	7		
0.2	7		
0.3	7		
0.4	20		
0.5		4.0	
1.0		4.5	
1.5		5.0	
2.0			
2.5			
3.0			
3.5

20 blows for 100mm in the last increment.  
Co-ordinates and elevation data from site survey.  
Elevation based on Christchurch Drainage Datum.  
Effective refusal, 20+ blows per 100mm
