Prestons Park Subdivision
GEOTECHNICAL REPORT FOR LOT 1032
CDL Land NZ Limited

9 November 2022
Revision: 1
Reference: 235361

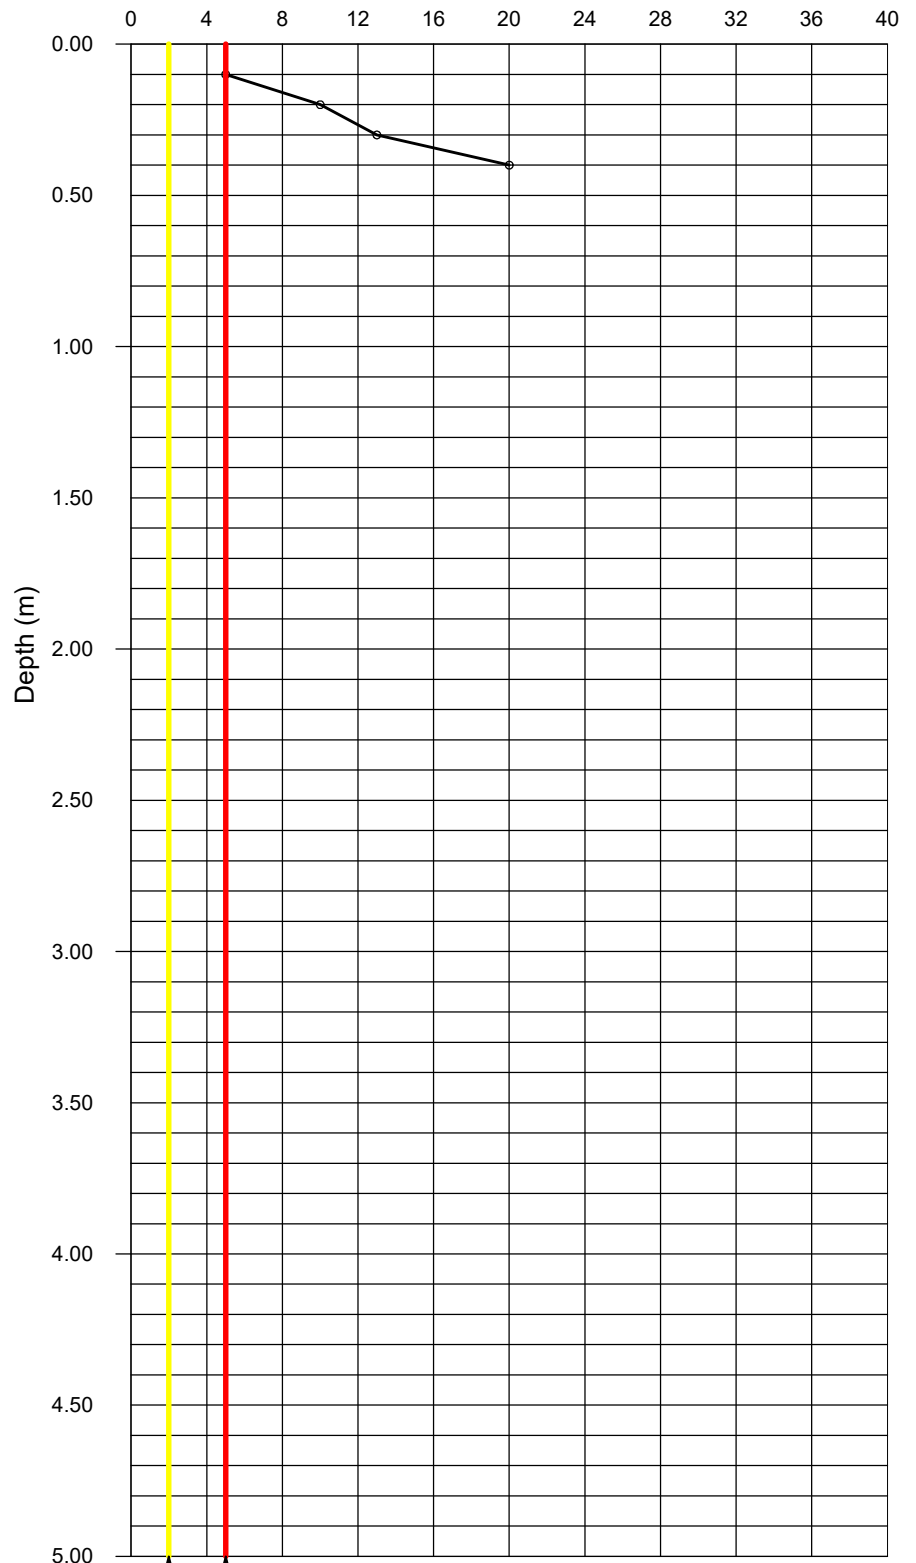
DCP logs indicate 5 blows per 100mm penetration, which is equivalent to an ultimate bearing capacity of 300kPa, was consistently encountered from a shallow depth.

20 blows for 100mm in the last increment.
Co-ordinates and elevation data from site survey.
Elevation based on Christchurch Drainage Datum.
Effective refusal, 20+ blows per 100mm

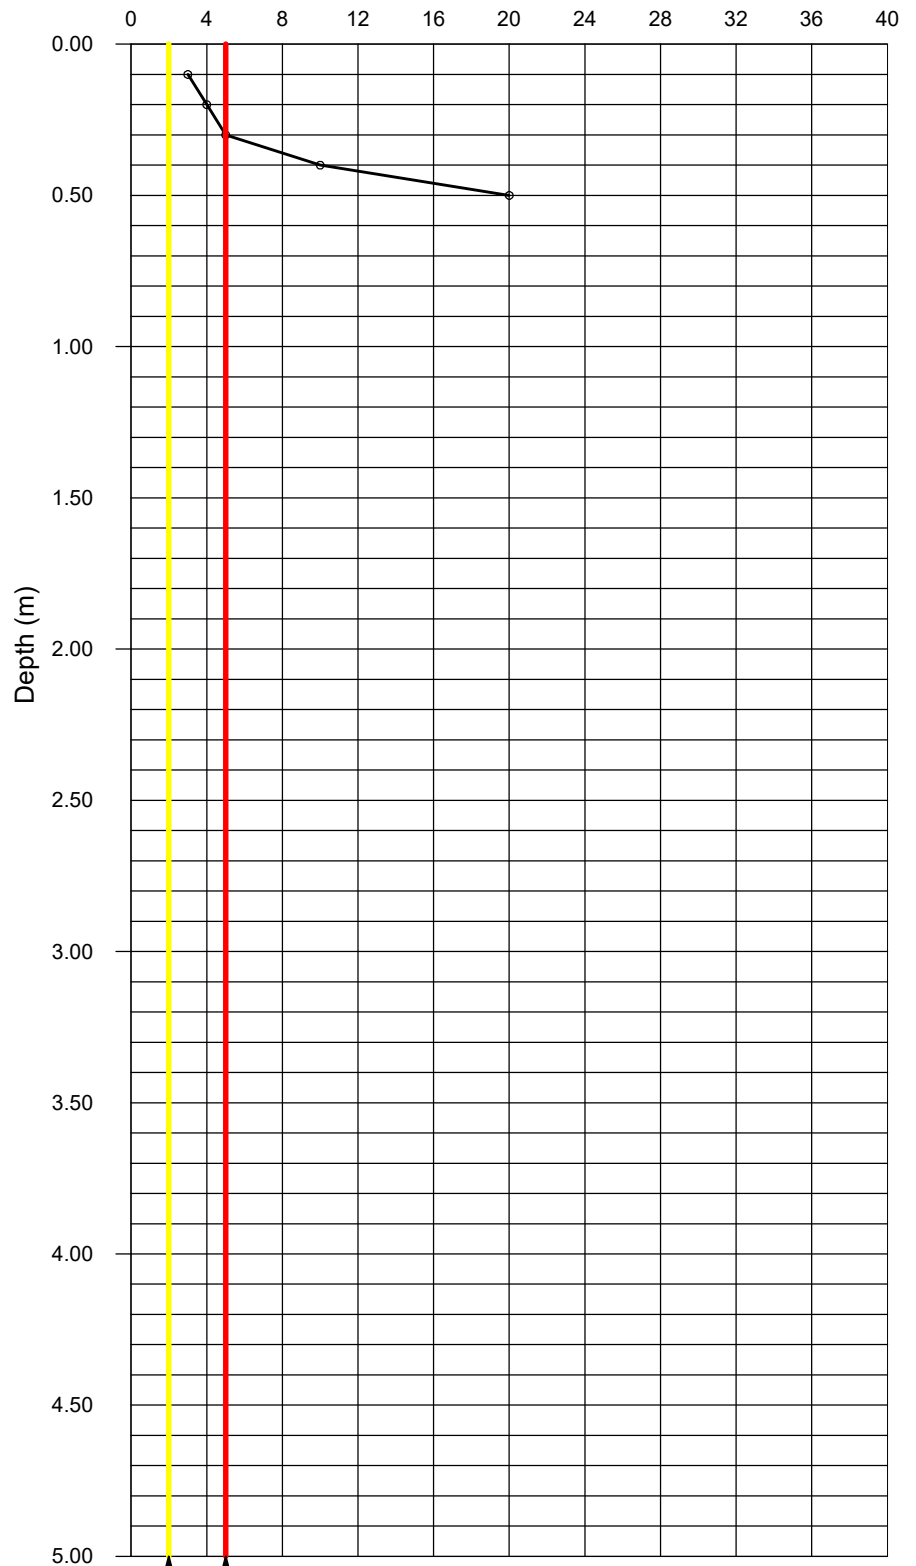
Depth (m)	Blows per 100 mm	Depth (m)	Blows per 100 mm
0.0	3	3.5	
0.1	4		
0.2	5		
0.3	10		
0.4	20		
0.5		4.0	
1.0		4.5	
1.5		5.0	
2.0			
2.5			
3.0			
3.5

20 blows for 100mm in the last increment.
Co-ordinates and elevation data from site survey.
Elevation based on Christchurch Drainage Datum.
Effective refusal, 20+ blows per 100mm
