Prestons Park Subdivision GEOTECHNICAL REPORT FOR LOT 1033 CDL Land NZ Limited

9 November 2022 Revision: 1 Reference: 235361

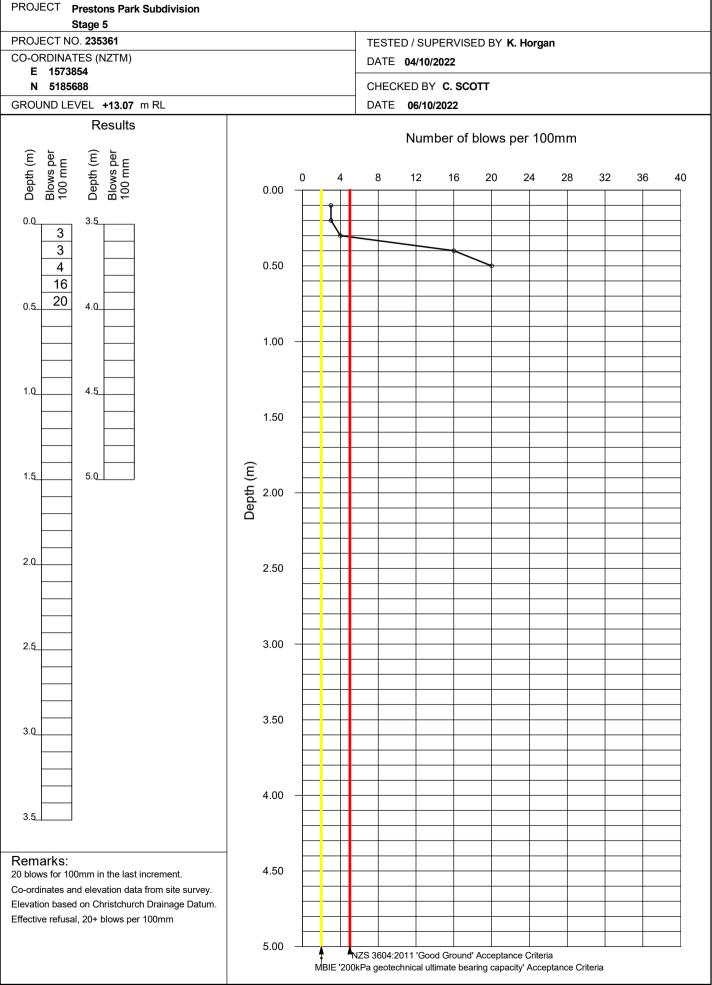
Lot 1033 - DCP1

DCP logs indicate 5 blows per 100mm penetration, which is equivalent to an ultimate bearing capacity of 300kPa, was consistently encountered from a shallow depth.
