Prestons Park Subdivision
GEOTECHNICAL REPORT FOR LOT 1036
CDL Land NZ Limited

21 November 2022
Revision: 1
Reference: 235361

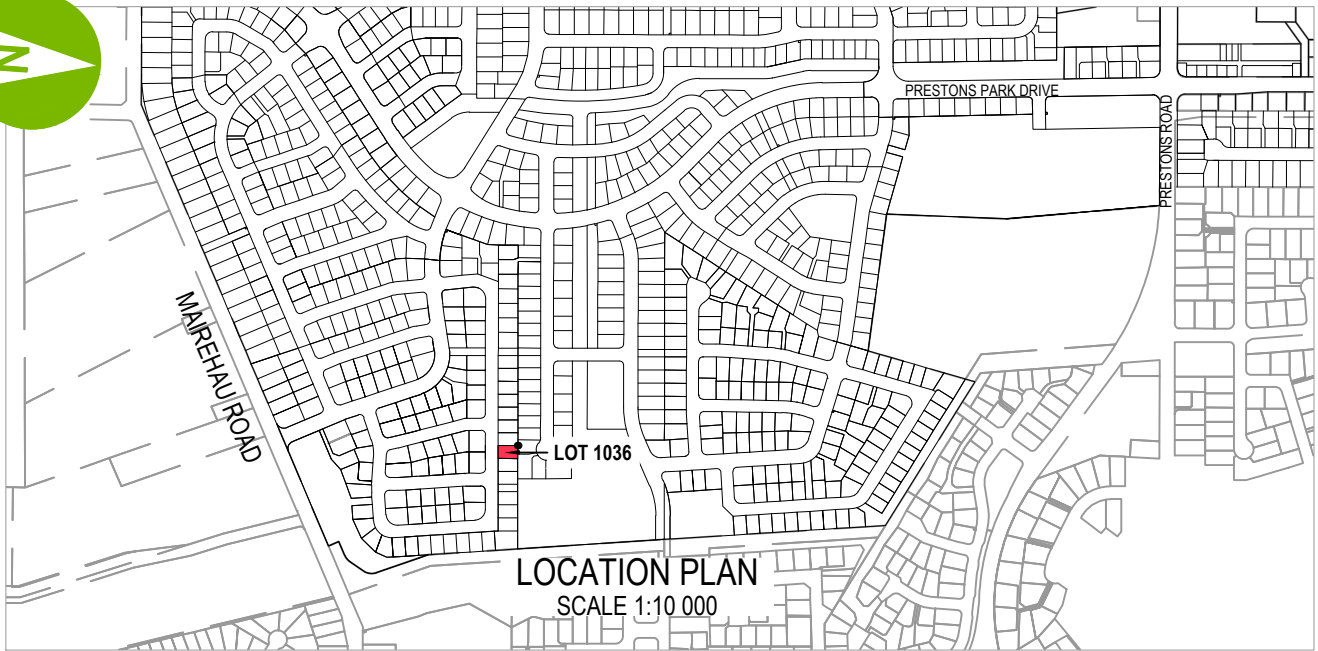
TITLE
LOT 1036
SITE LOCATION PLAN
FIGURE 1

This building consent report is for Lot 1036 which is located in Stage 5 of the Prestons Park Subdivision development (refer Figure 1 in Appendix A). The lot is bordered by residential lots to the north, east and west, with an access road to the south.

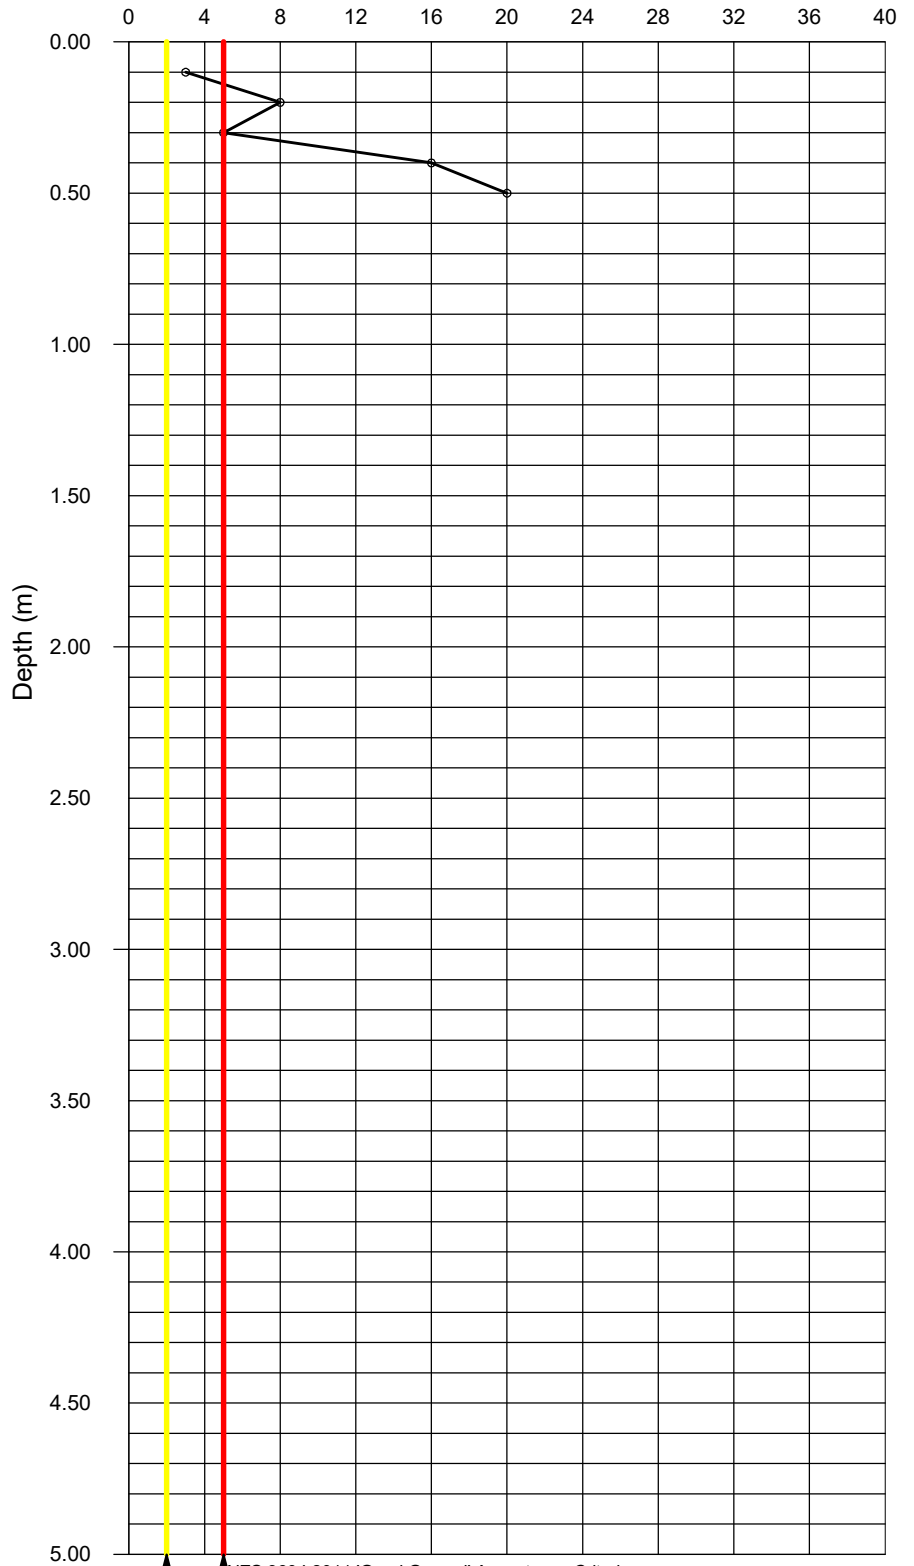
DCP logs indicate two blows per 100mm penetration, which is equivalent to an ultimate bearing capacity of 200kPa, was consistently encountered from a shallow depth.

20 blows for 100mm in the last increment.
Co-ordinates and elevation data from site survey.
Elevation based on Christchurch Drainage Datum.
Effective refusal, 20+ blows per 100mm

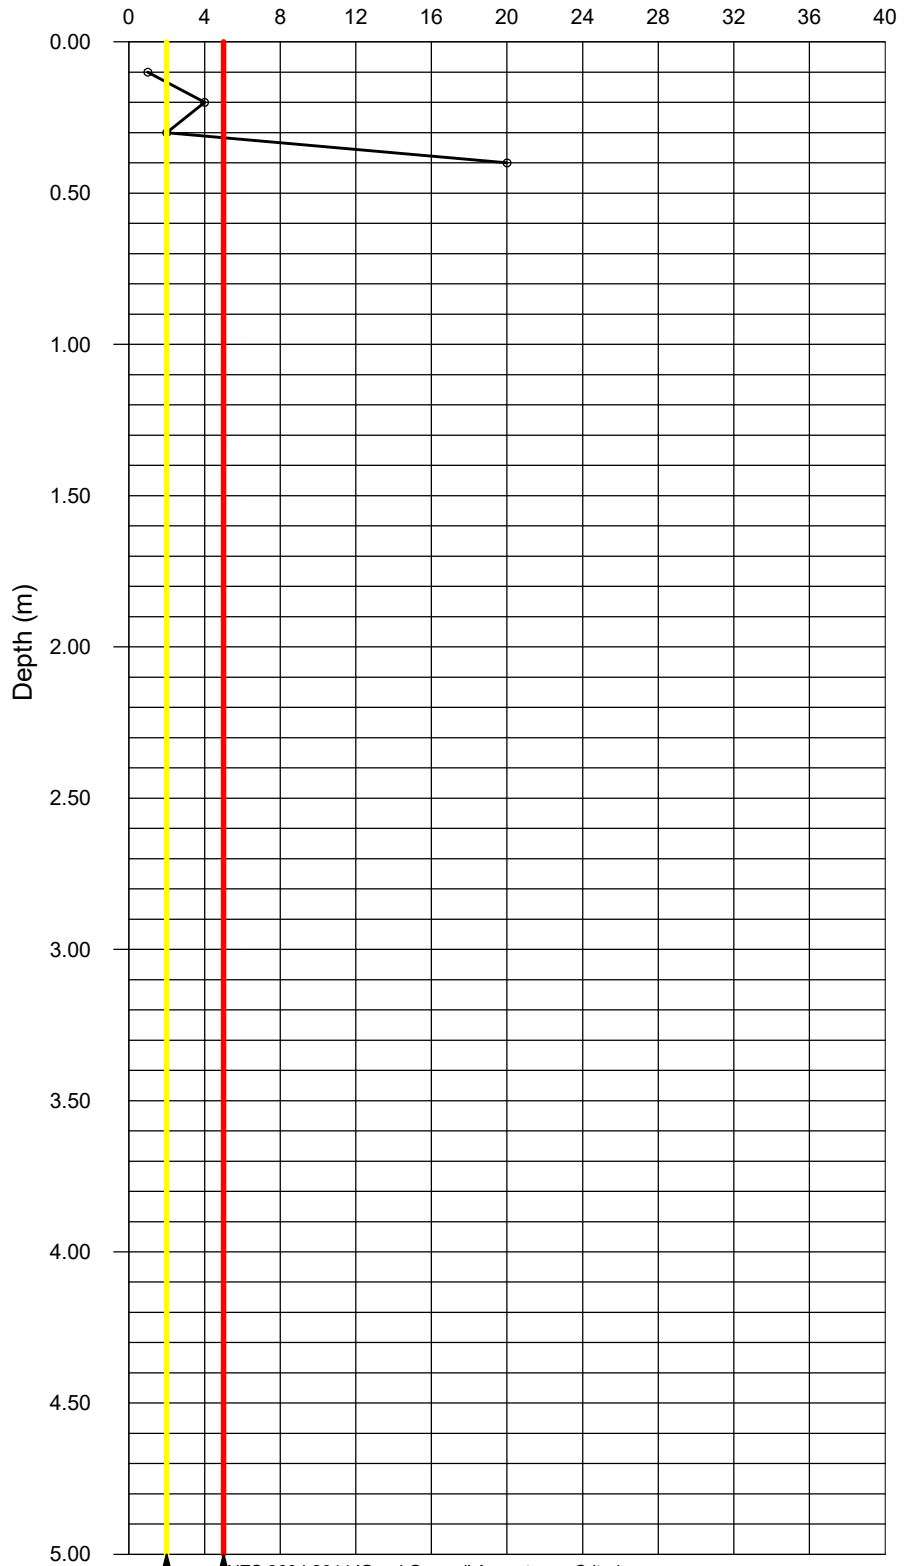
20 blows for 100mm in the last increment.
Co-ordinates and elevation data from site survey.
Elevation based on Christchurch Drainage Datum.
Effective refusal, 20+ blows per 100mm
