**Prestons Park Subdivision**  
**GEOTECHNICAL REPORT FOR LOT 1040**  
**CDL Land NZ Limited**

**21 November 2022**  
**Revision: 1**  
**Reference: 235361**

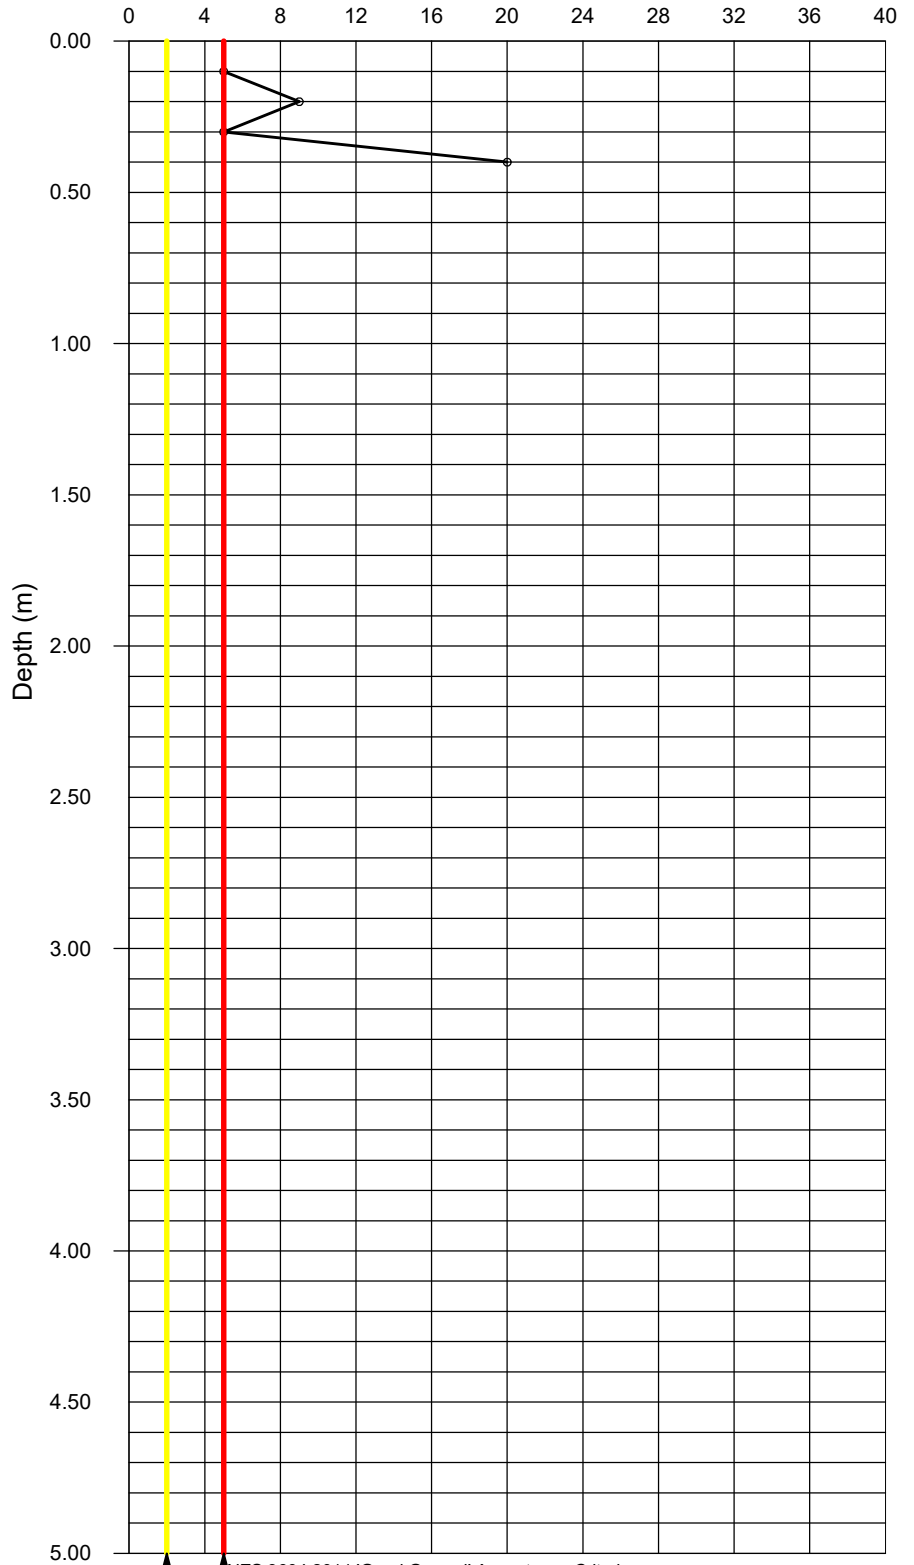
DCP logs indicate 5 blows per 100mm penetration, which is equivalent to an ultimate bearing capacity of 300kPa, was consistently encountered from a depth of 0.4m.

20 blows for 100mm in the last increment.  
Co-ordinates and elevation data from site survey.  
Elevation based on Christchurch Drainage Datum.  
Effective refusal, 20+ blows per 100mm

Based on our understanding of the site works and the investigation results, we recommend that NZS3604:2011 compliant foundations are embedded a minimum depth of 0.4m below current ground level.

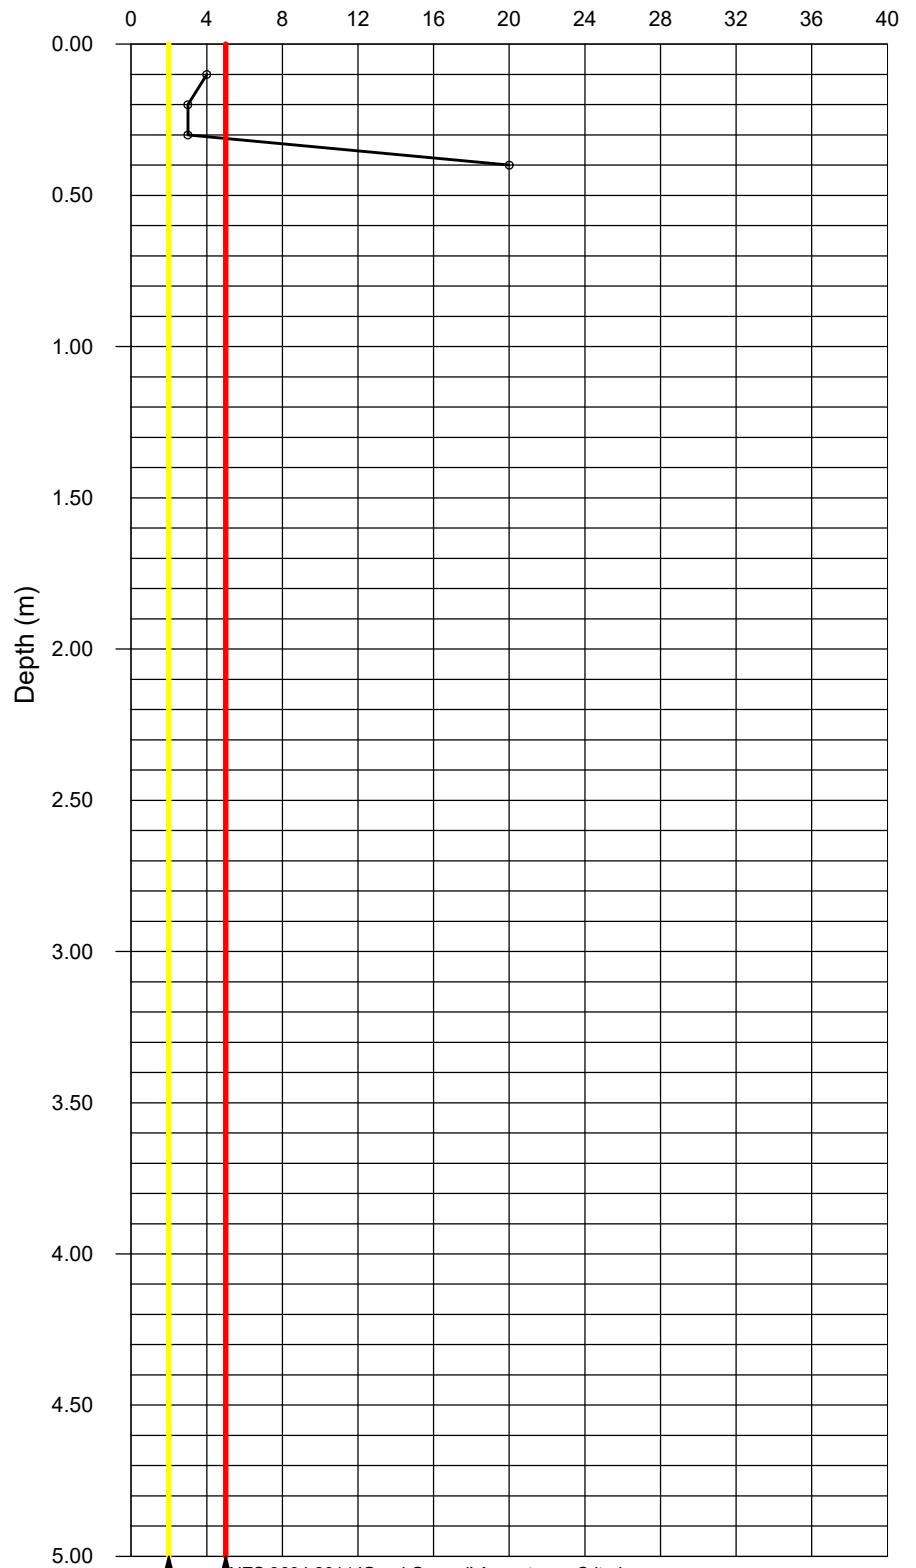
20 blows for 100mm in the last increment.  
Co-ordinates and elevation data from site survey.  
Elevation based on Christchurch Drainage Datum.  
Effective refusal, 20+ blows per 100mm
