Prestons Park Subdivision
GEOTECHNICAL REPORT FOR LOT 947
CDL Land NZ Limited

28 June 2023
Revision: 1
Reference: 235361

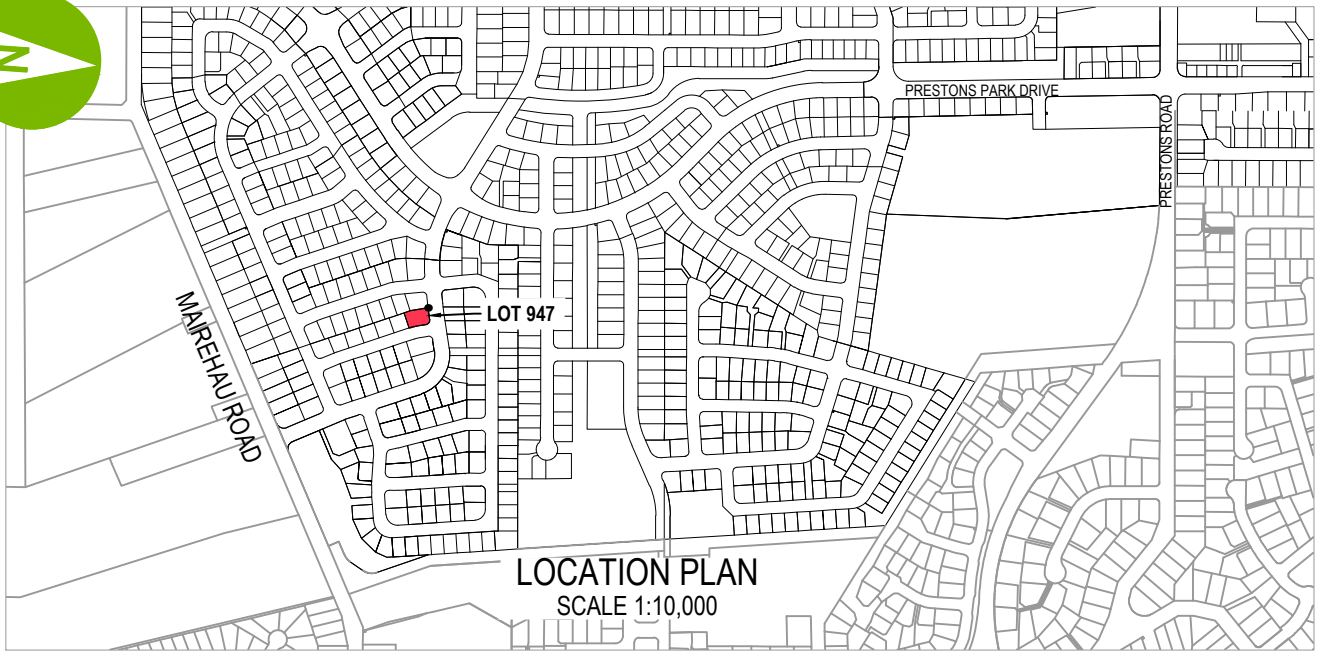
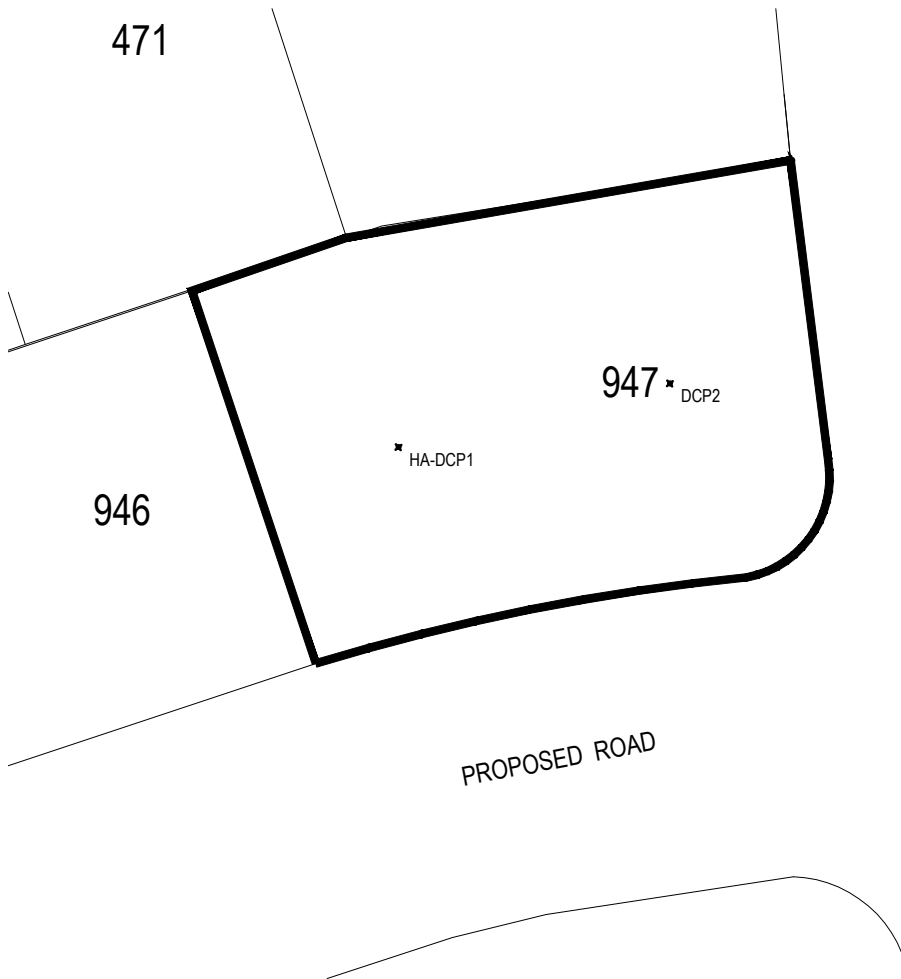
This building consent report is for Lot 947 which is located in Stage 5 of the Prestons Park Subdivision development (refer Figure 1 in Appendix A). The lot is bordered by residential lots to the west and south, with road access to the north and east.

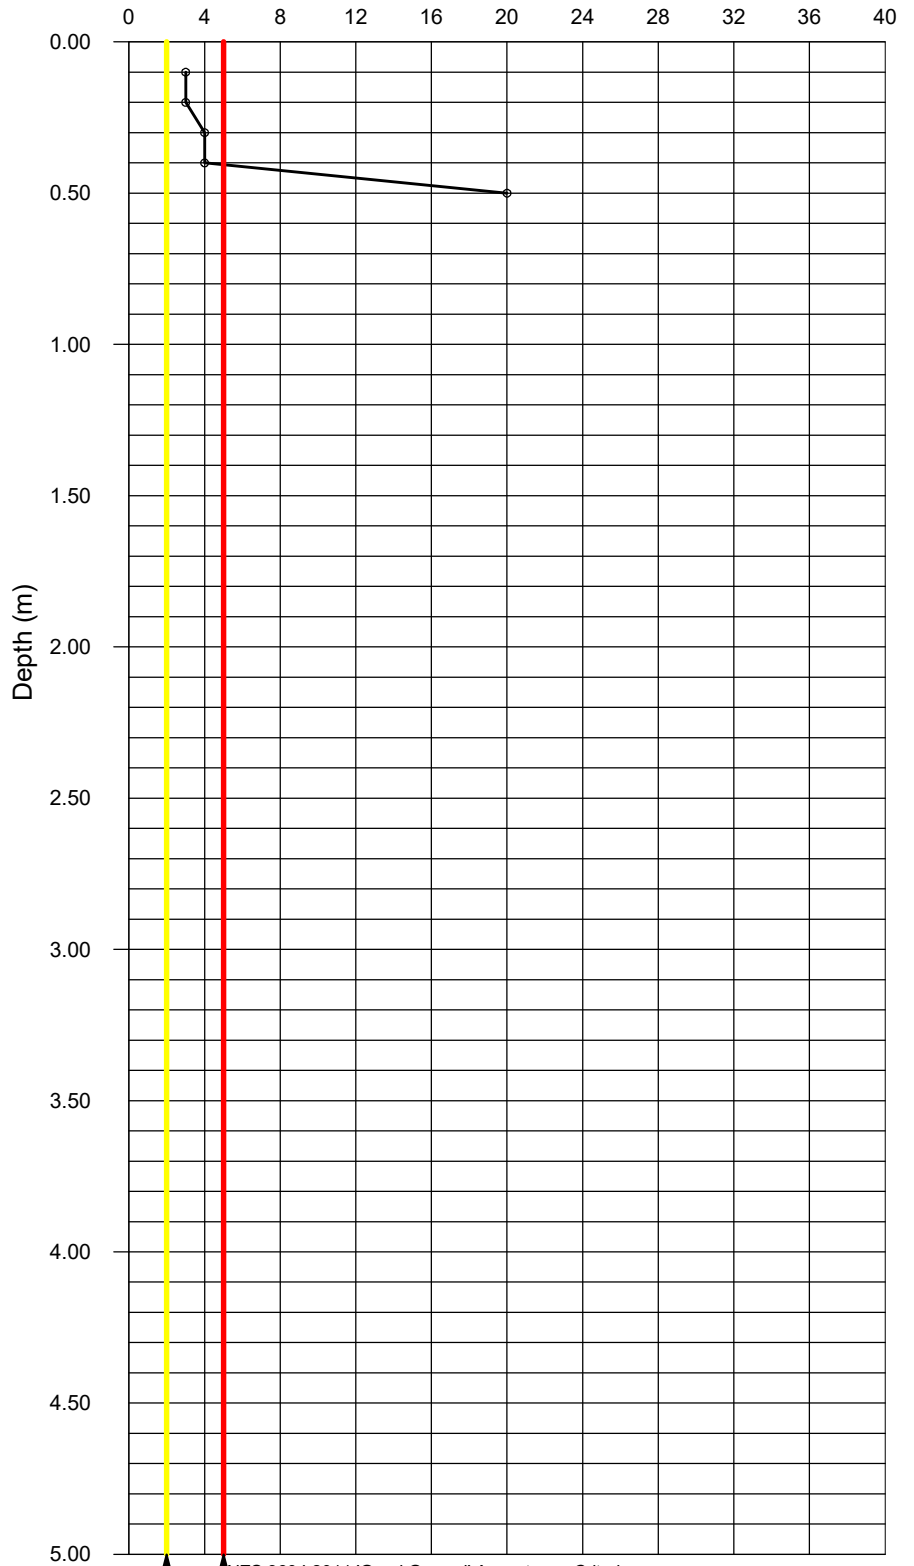
DCP logs indicate 5 blows per 100mm penetration, which is equivalent to an ultimate bearing capacity of 300kPa, was consistently encountered from a depth of 0.4m.

20 blows for 100mm in the last increment.
Co-ordinates and elevation data from site survey.
Elevation based on Christchurch Drainage Datum.
Effective refusal, 20+ blows per 100mm

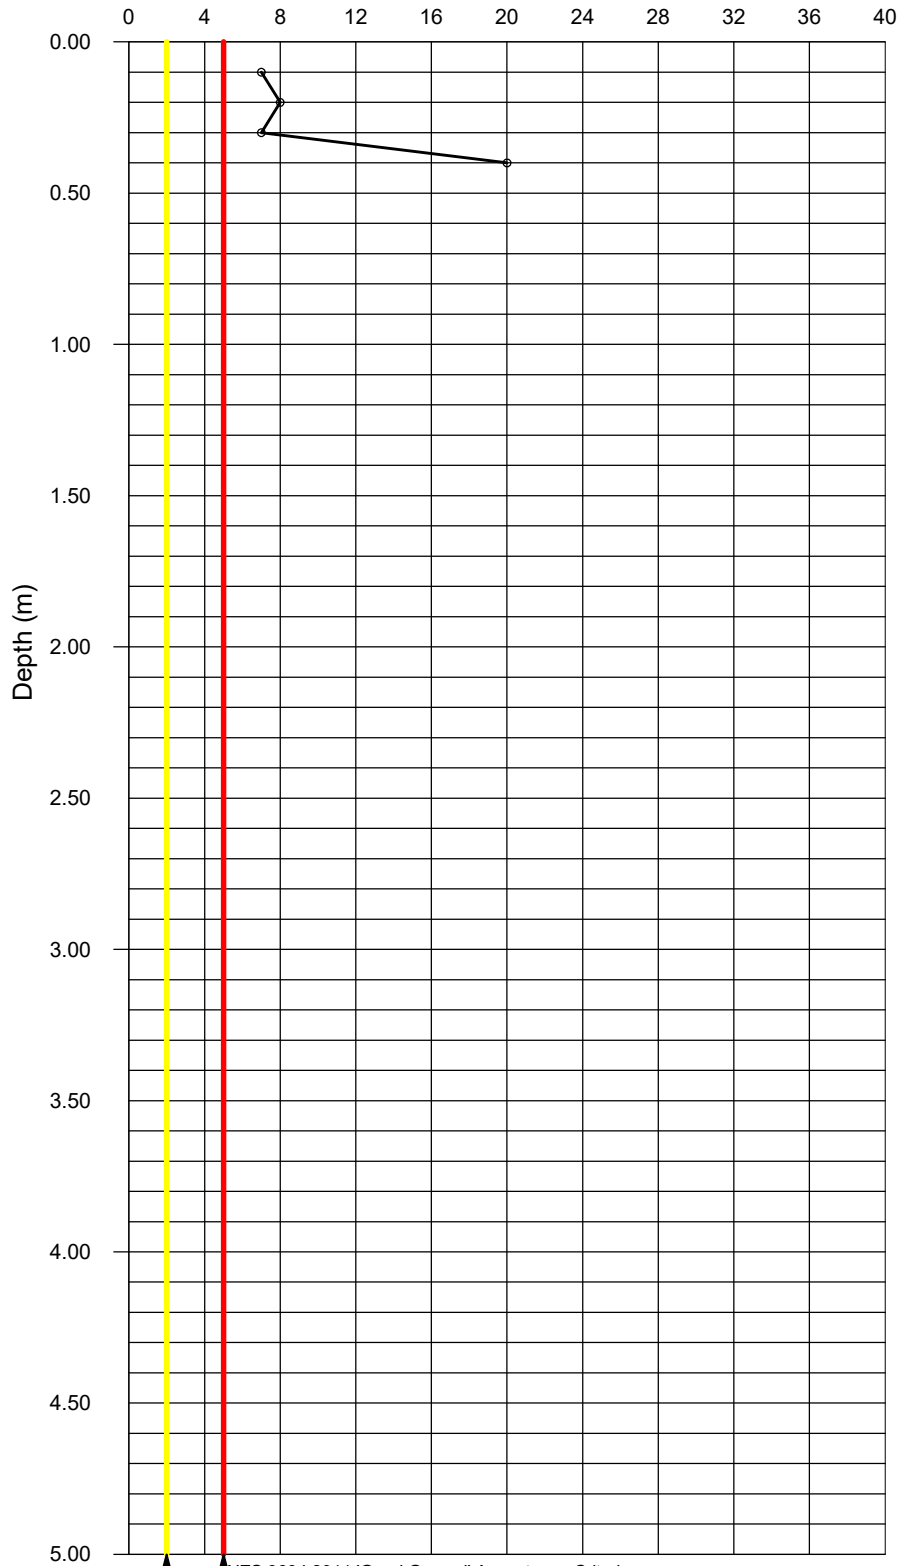
20 blows for 100mm in the last increment.
Co-ordinates and elevation data from site survey.
Elevation based on Christchurch Drainage Datum.
Effective refusal, 20+ blows per 100mm
