**Prestons Park Subdivision**  
**GEOTECHNICAL REPORT FOR LOT 971**  
**CDL Land NZ Limited**

**28 June 2023**  
**Revision: 1**  
**Reference: 235361**

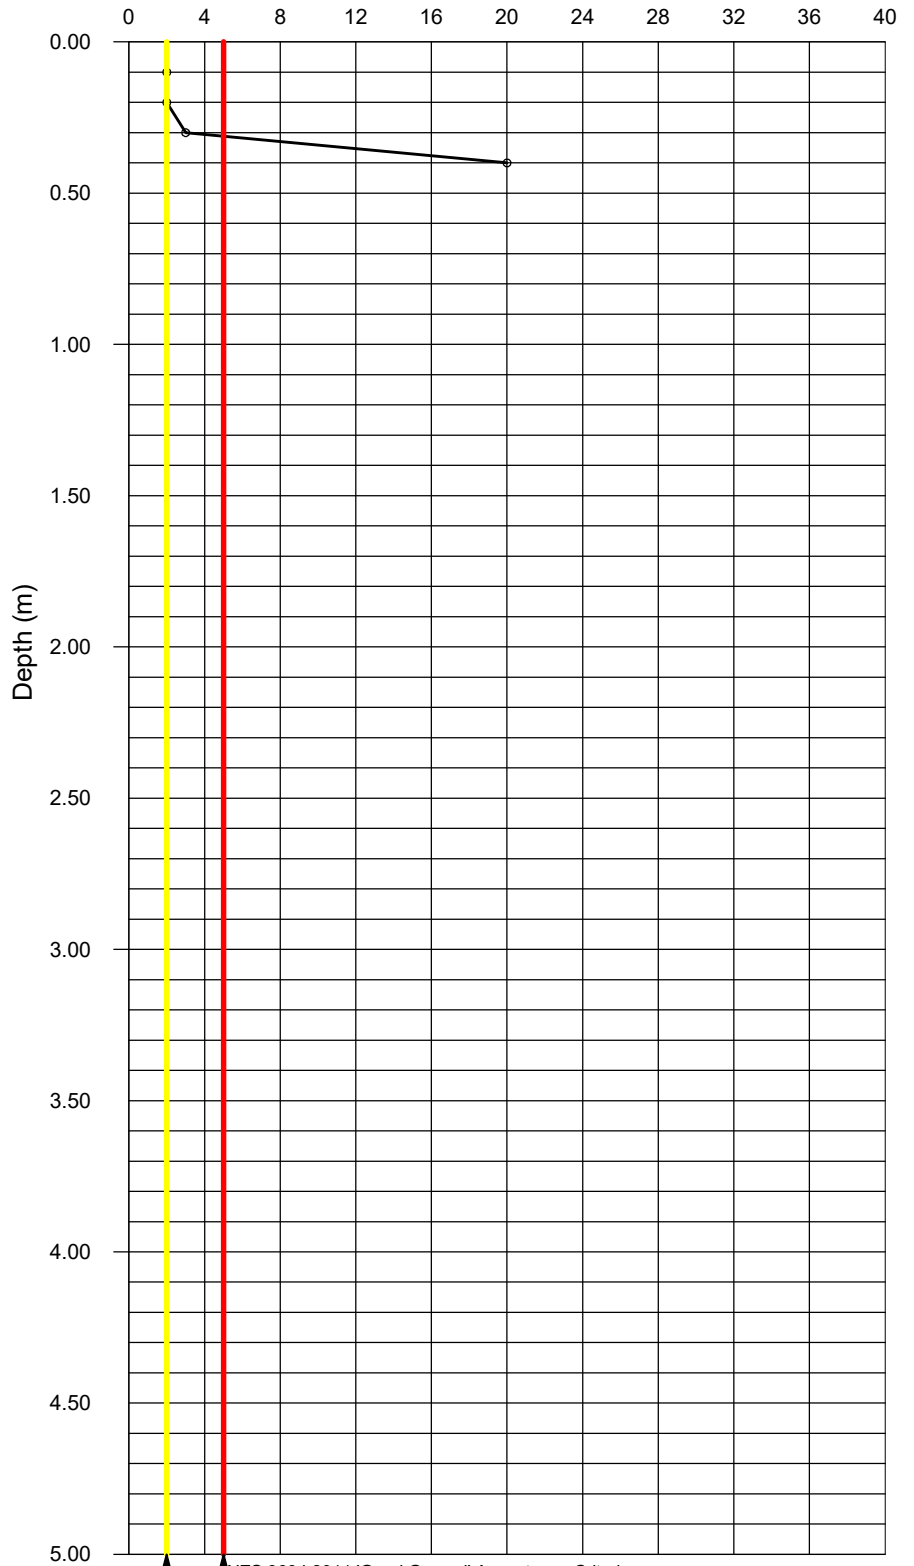
DCP logs indicate 5 blows per 100mm penetration, which is equivalent to an ultimate bearing capacity of 300kPa, was consistently encountered from a shallow depth.

20 blows for 100mm in the last increment.  
Co-ordinates and elevation data from site survey.  
Elevation based on Christchurch Drainage Datum.  
Effective refusal, 20+ blows per 100mm

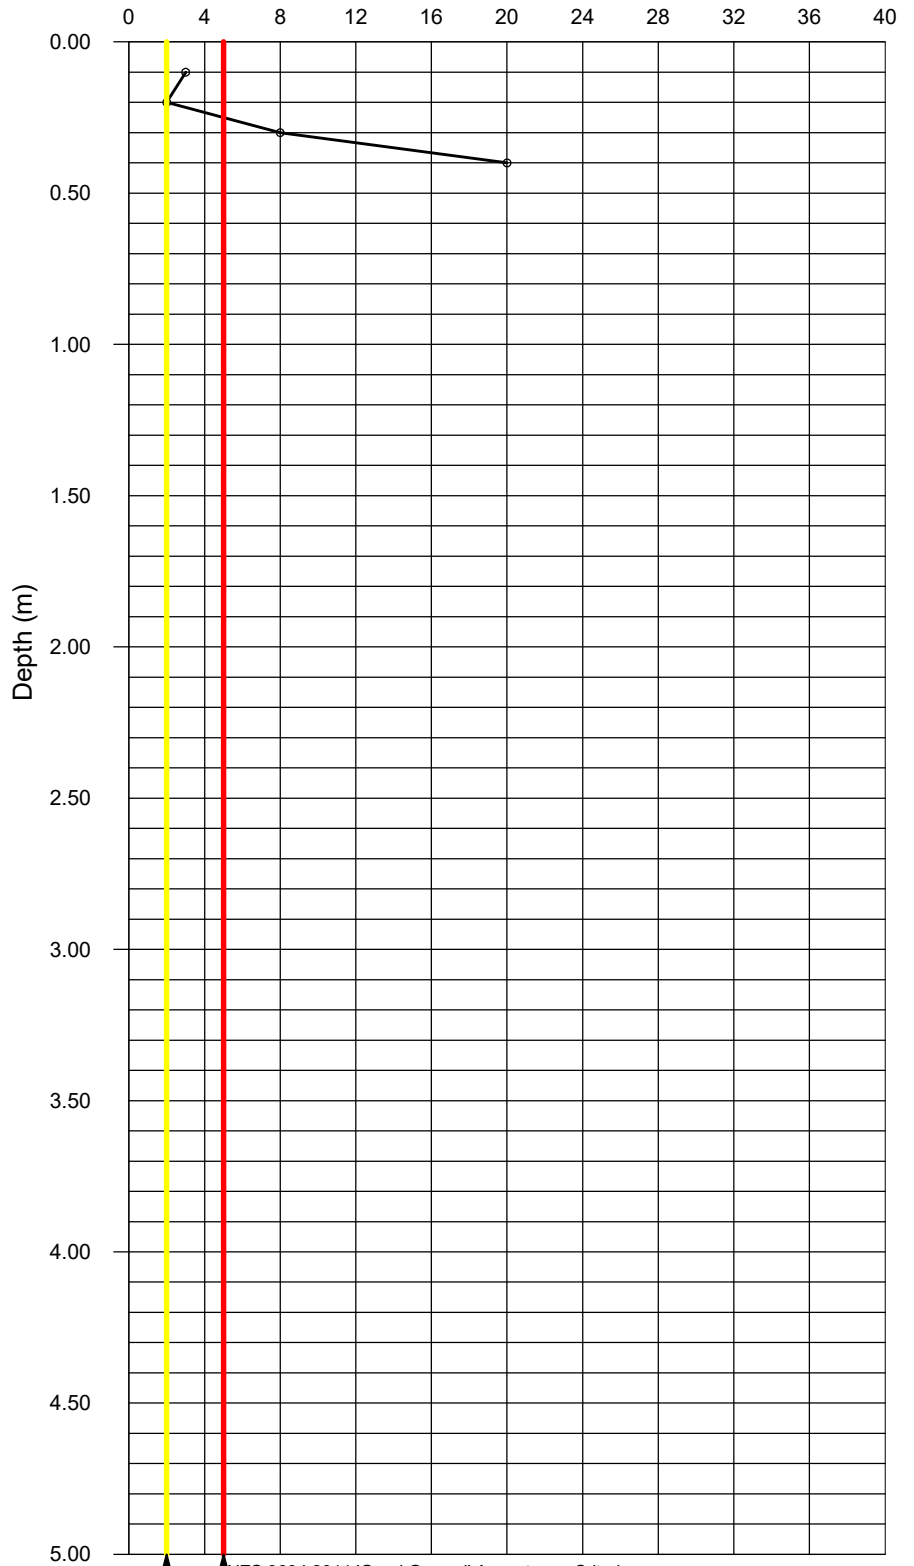
20 blows for 100mm in the last increment.  
Co-ordinates and elevation data from site survey.  
Elevation based on Christchurch Drainage Datum.  
Effective refusal, 20+ blows per 100mm
