**Prestons Park Subdivision**  
**GEOTECHNICAL REPORT FOR LOT 955**  
**CDL Land NZ Limited**

**30 June 2023**  
**Revision: 1**  
**Reference: 235361**

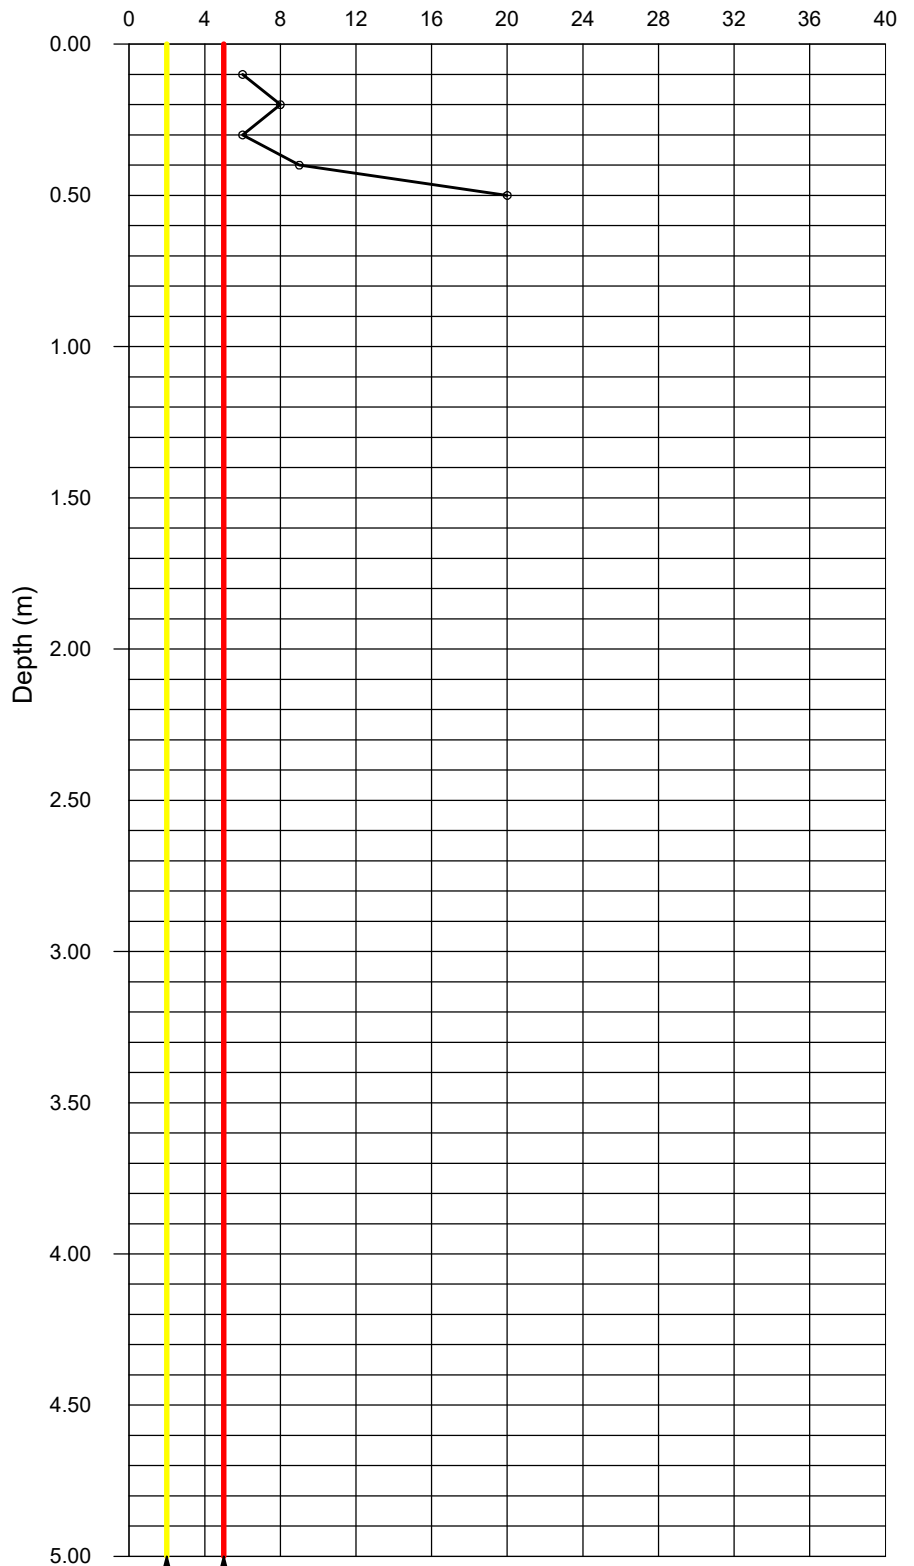
DCP logs indicate 5 blows per 100mm penetration, which is equivalent to an ultimate bearing capacity of 300kPa, was consistently encountered from a shallow depth.

Depth (m)	Blows per 100 mm	Depth (m)	Blows per 100 mm
0.0	6	3.5	
0.1	8		
0.2	6		
0.3	9		
0.4	20	4.0	
0.5			
1.0		4.5	
1.5		5.0	
2.0			
2.5			
3.0			
3.5

20 blows for 100mm in the last increment.  
Co-ordinates and elevation data from site survey.  
Elevation based on Christchurch Drainage Datum.  
Effective refusal, 20+ blows per 100mm.

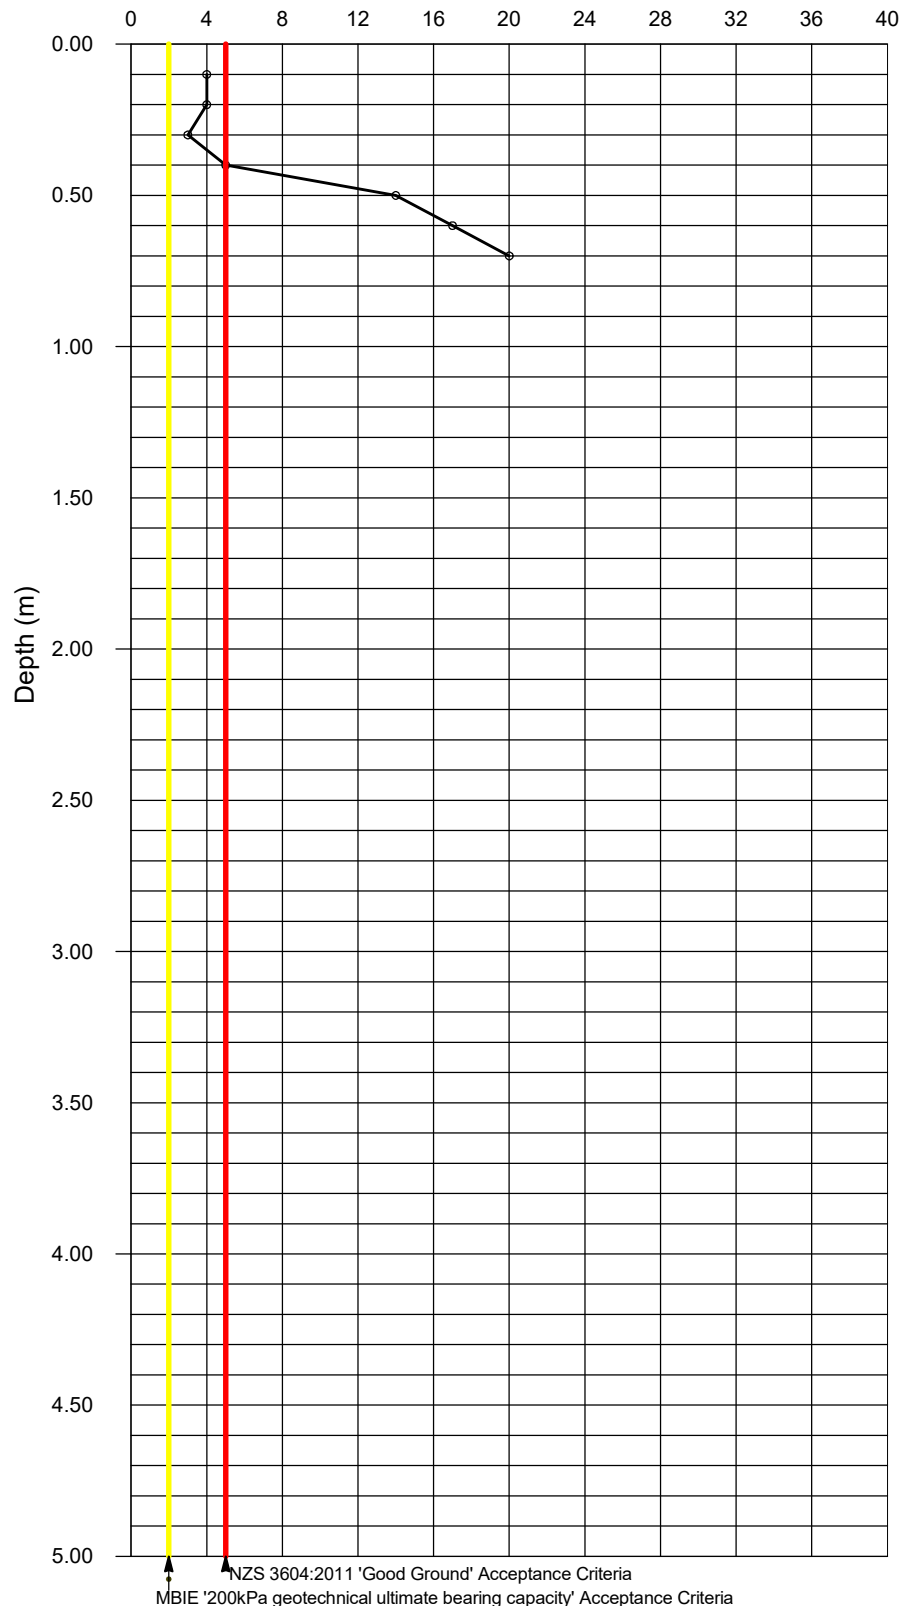
Depth (m)	Blows per 100 mm	Depth (m)	Blows per 100 mm
0.0	4	3.5	
0.1	4		
0.2	3		
0.3	5		
0.4	14	4.0	
0.5	17		
0.6	20		
0.7		4.5	
0.8			
0.9		5.0	
1.0			
1.1			
1.2			
1.3			
1.4			
1.5			
1.6			
1.7			
1.8			
1.9			
2.0			
2.1			
2.2			
2.3			
2.4			
2.5			
2.6			
2.7			
2.8			
2.9			
3.0			
3.1			
3.2			
3.3			
3.4			
3.5
