**Prestons Park Subdivision**  
**GEOTECHNICAL REPORT FOR LOT 958**  
**CDL Land NZ Limited**

**28 June 2023**  
**Revision: 1**  
**Reference: 235361**

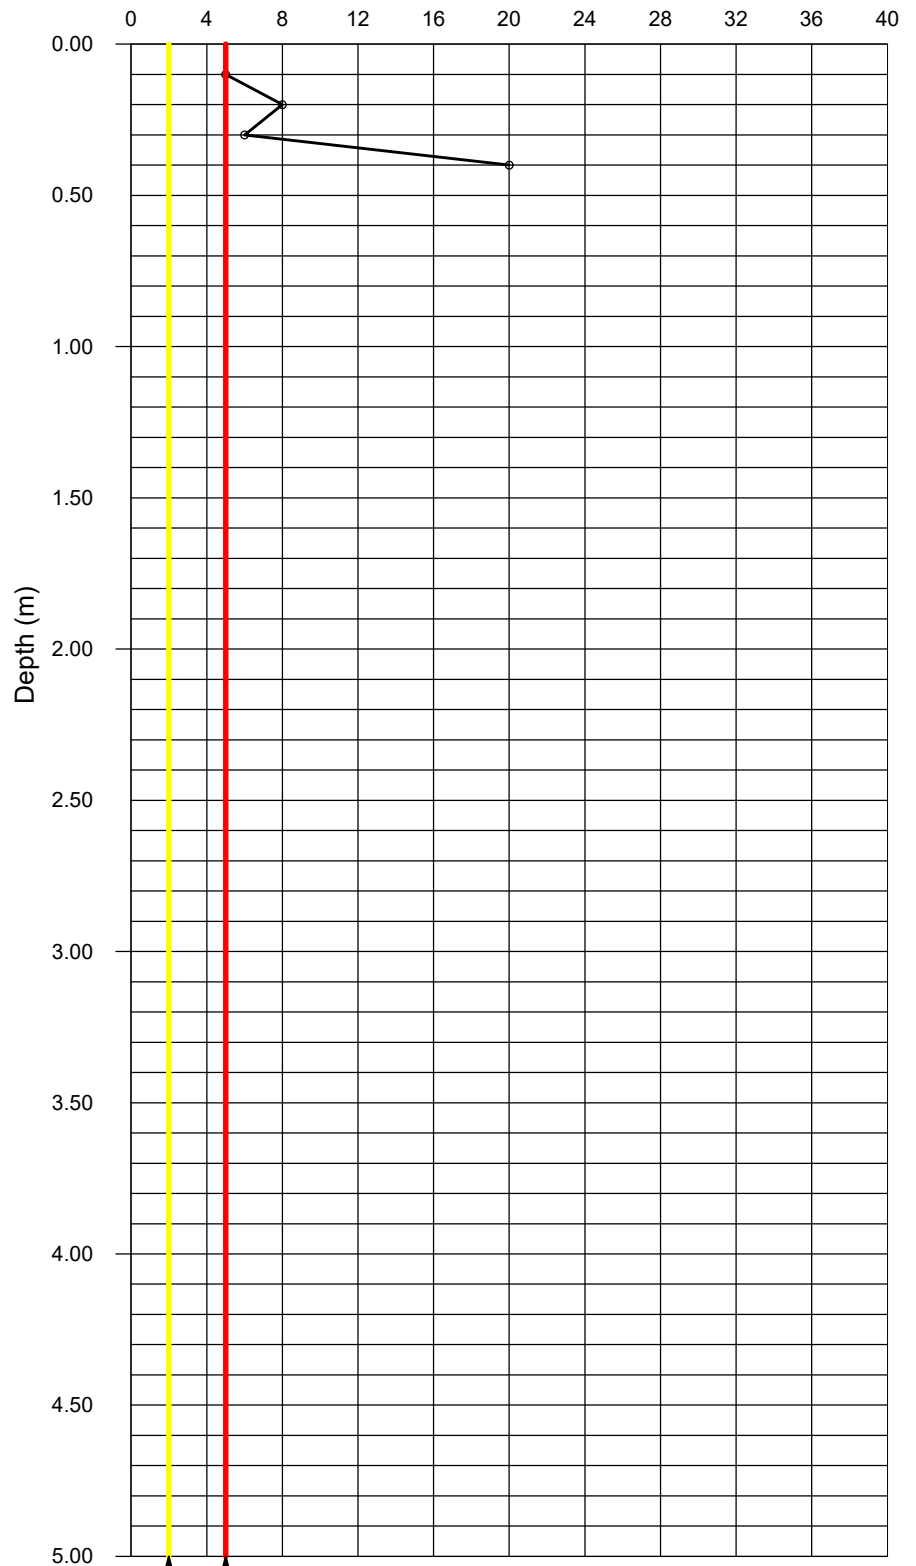
DCP logs indicate 5 blows per 100mm penetration, which is equivalent to an ultimate bearing capacity of 300kPa, was consistently encountered from a shallow depth.

20 blows for 100mm in the last increment.  
Co-ordinates and elevation data from site survey.  
Elevation based on Christchurch Drainage Datum.  
Effective refusal, 20+ blows per 100mm.

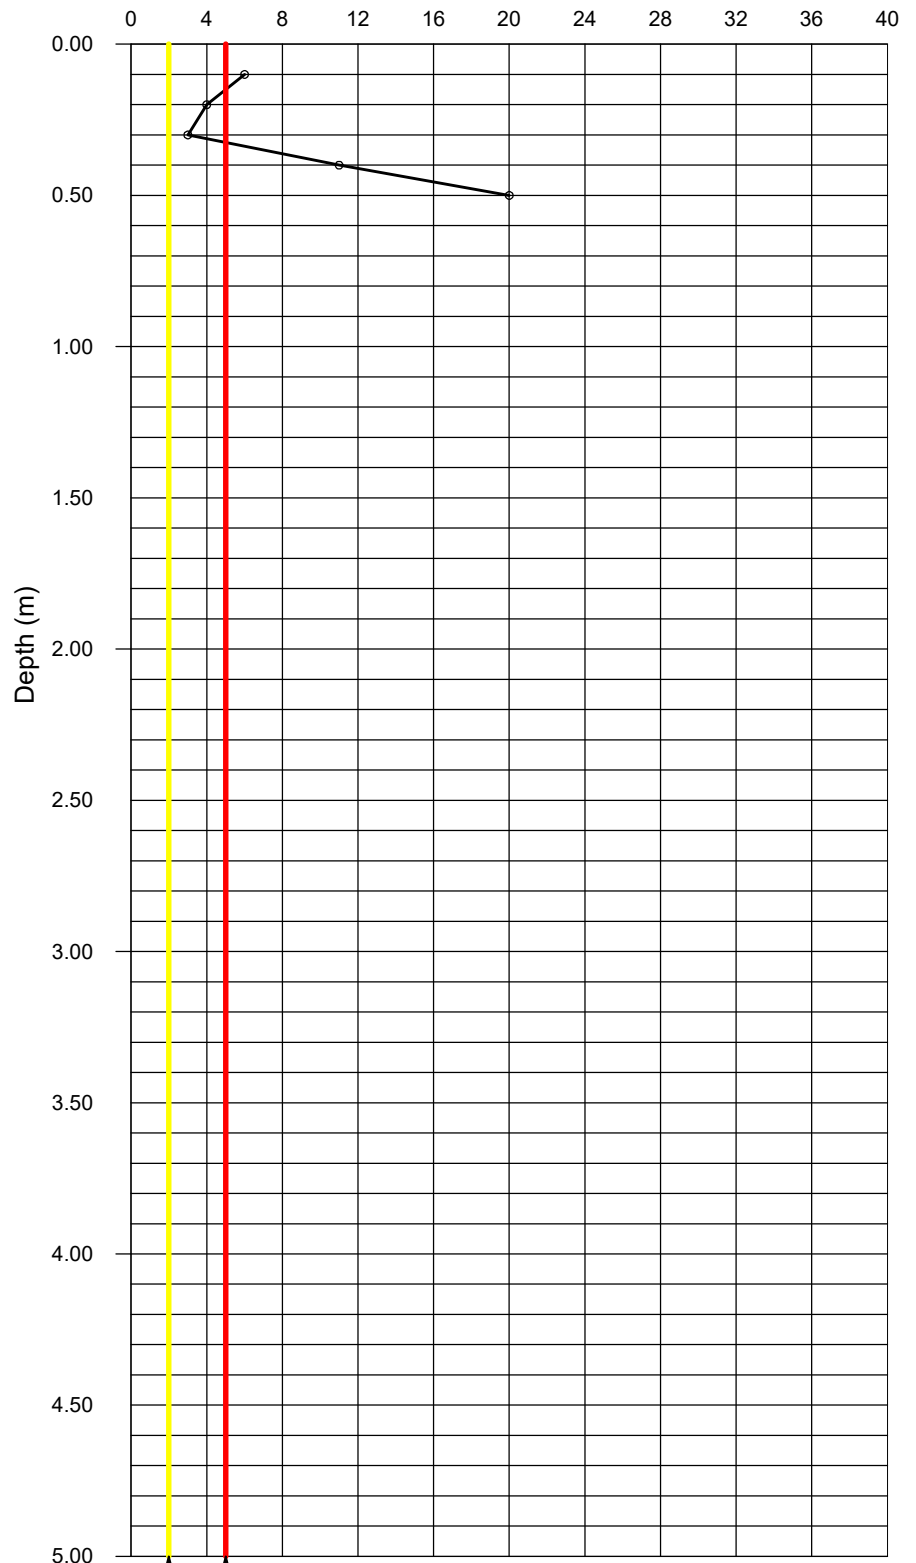
20 blows for 100mm in the last increment.  
Co-ordinates and elevation data from site survey.  
Elevation based on Christchurch Drainage Datum.  
Effective refusal, 20+ blows per 100mm.
