**Prestons Park Subdivision**  
**GEOTECHNICAL REPORT FOR LOT 1012**  
**CDL Land NZ Limited**

**30 June 2023**  
**Revision: 1**  
**Reference: 235361**

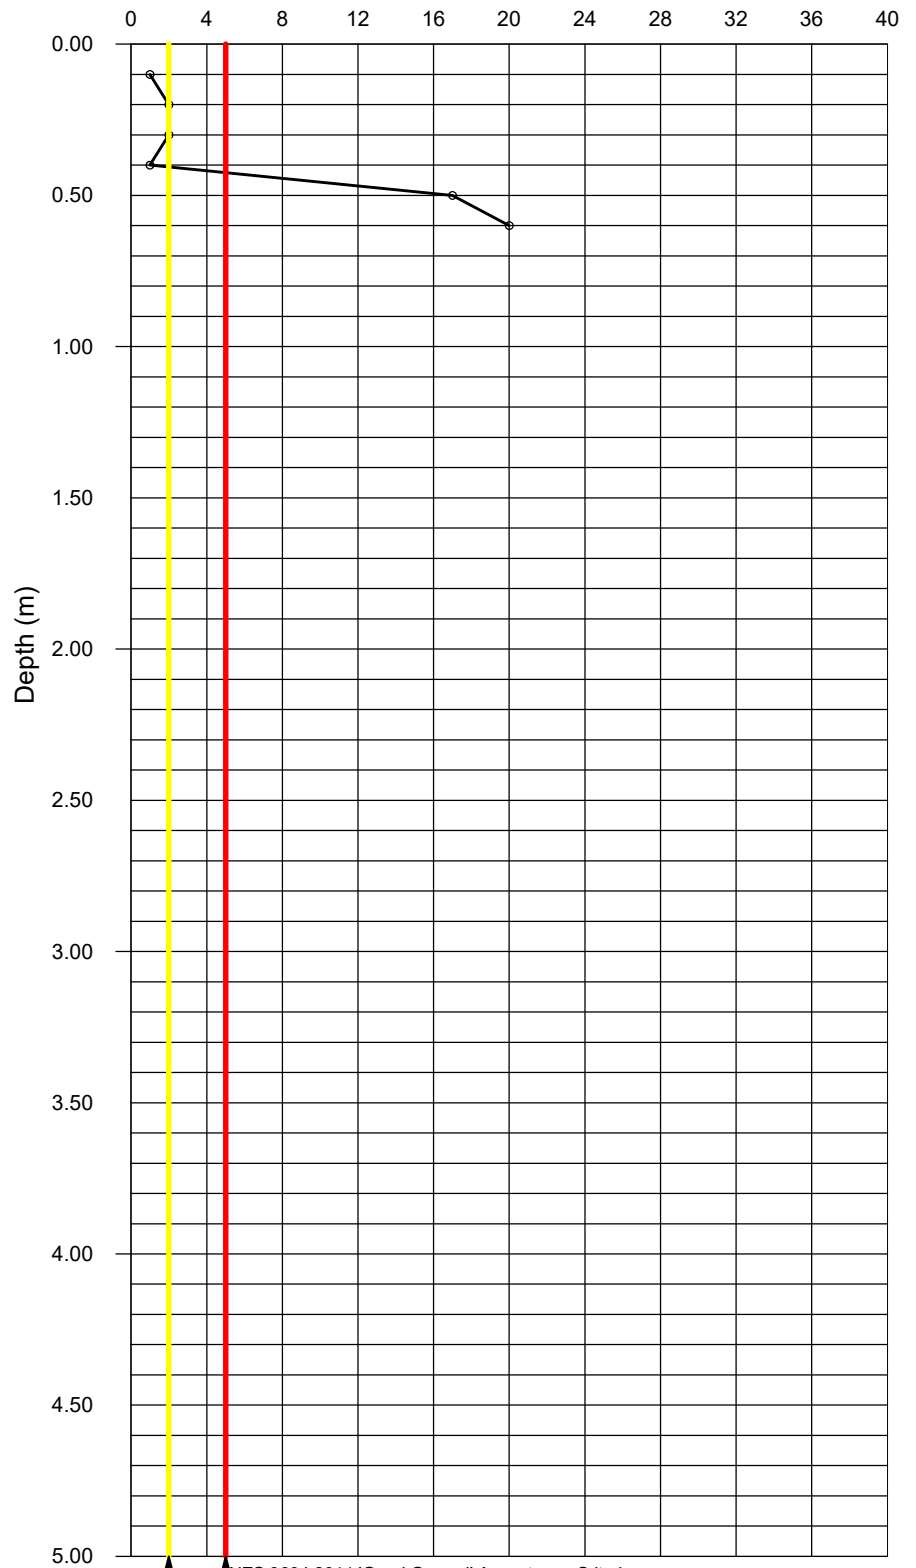
Depth (m)	Blows per 100 mm	Depth (m)	Blows per 100 mm
0.0	1	3.5	
0.1	2		
0.2	2		
0.3	1		
0.4	17		
0.5	20		
0.6			
0.7			
0.8			
0.9			
1.0			
1.1			
1.2			
1.3			
1.4			
1.5			
1.6			
1.7			
1.8			
1.9			
2.0			
2.1			
2.2			
2.3			
2.4			
2.5			
2.6			
2.7			
2.8			
2.9			
3.0			
3.1			
3.2			
3.3			
3.4			
3.5

20 blows for 100mm in the last increment.  
Co-ordinates and elevation data from site survey.  
Elevation based on Christchurch Drainage Datum.  
Effective refusal, 20+ blows per 100mm

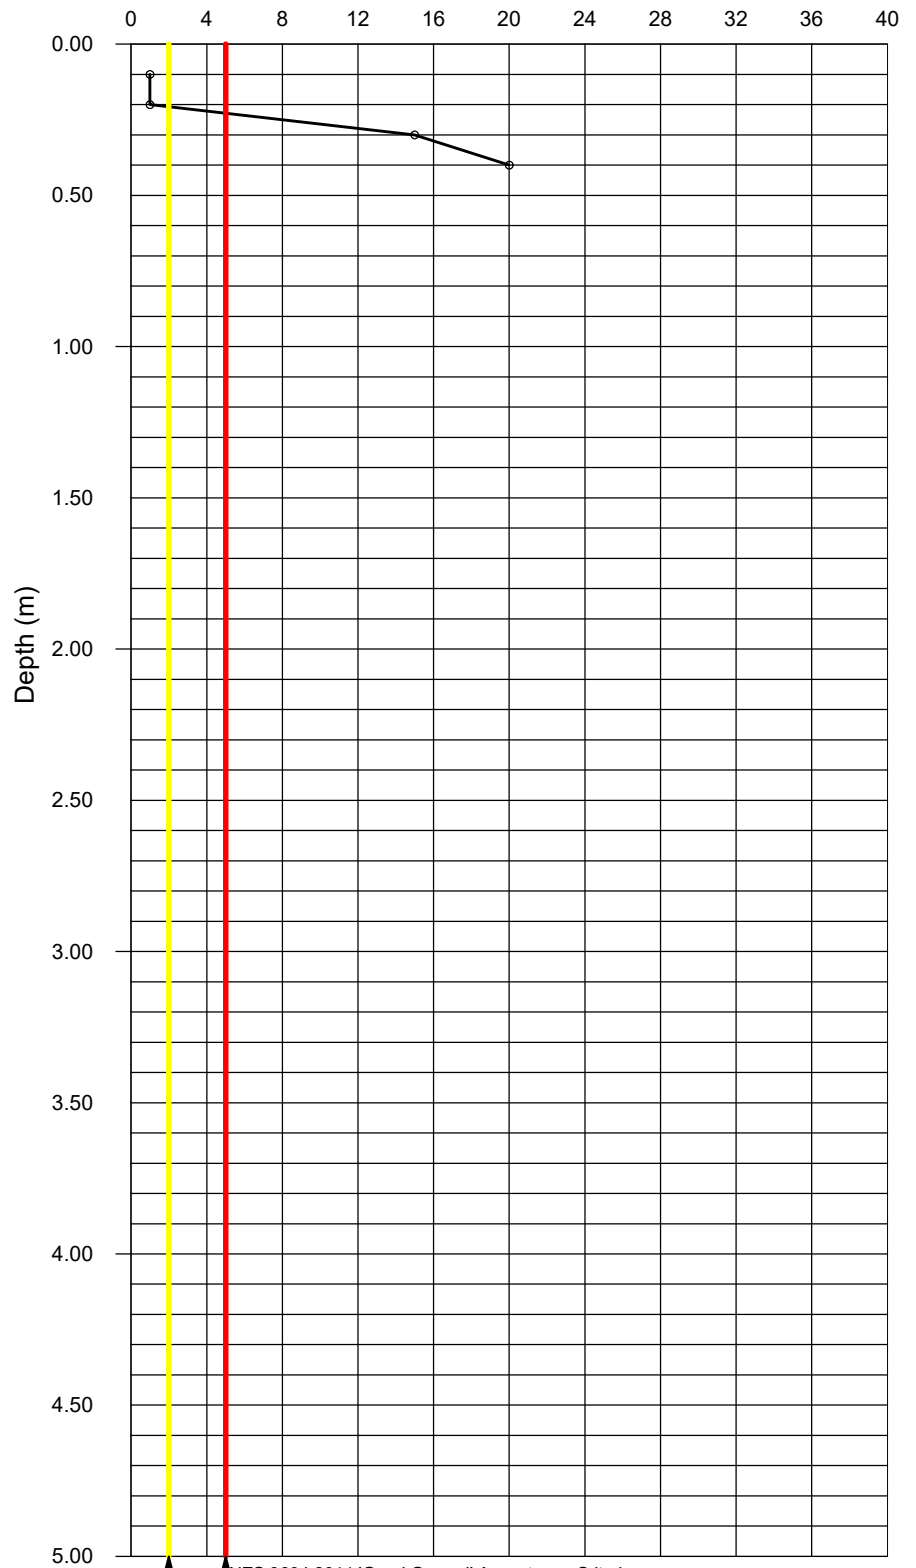
Depth (m)	Blows per 100 mm	Depth (m)	Blows per 100 mm
0.0	1	3.5	
0.1	1		
0.2	15		
0.3	20		
0.4		4.0	
0.5			
1.0		4.5	
1.5		5.0	
2.0			
2.5			
3.0			
3.5

20 blows for 100mm in the last increment.  
Co-ordinates and elevation data from site survey.  
Elevation based on Christchurch Drainage Datum.  
Effective refusal, 20+ blows per 100mm
