**Prestons Park Subdivision**  
**GEOTECHNICAL REPORT FOR LOT 1006**  
**CDL Land NZ Limited**

**8 December 2023**  
**Revision: 1**  
**Reference: 235361**

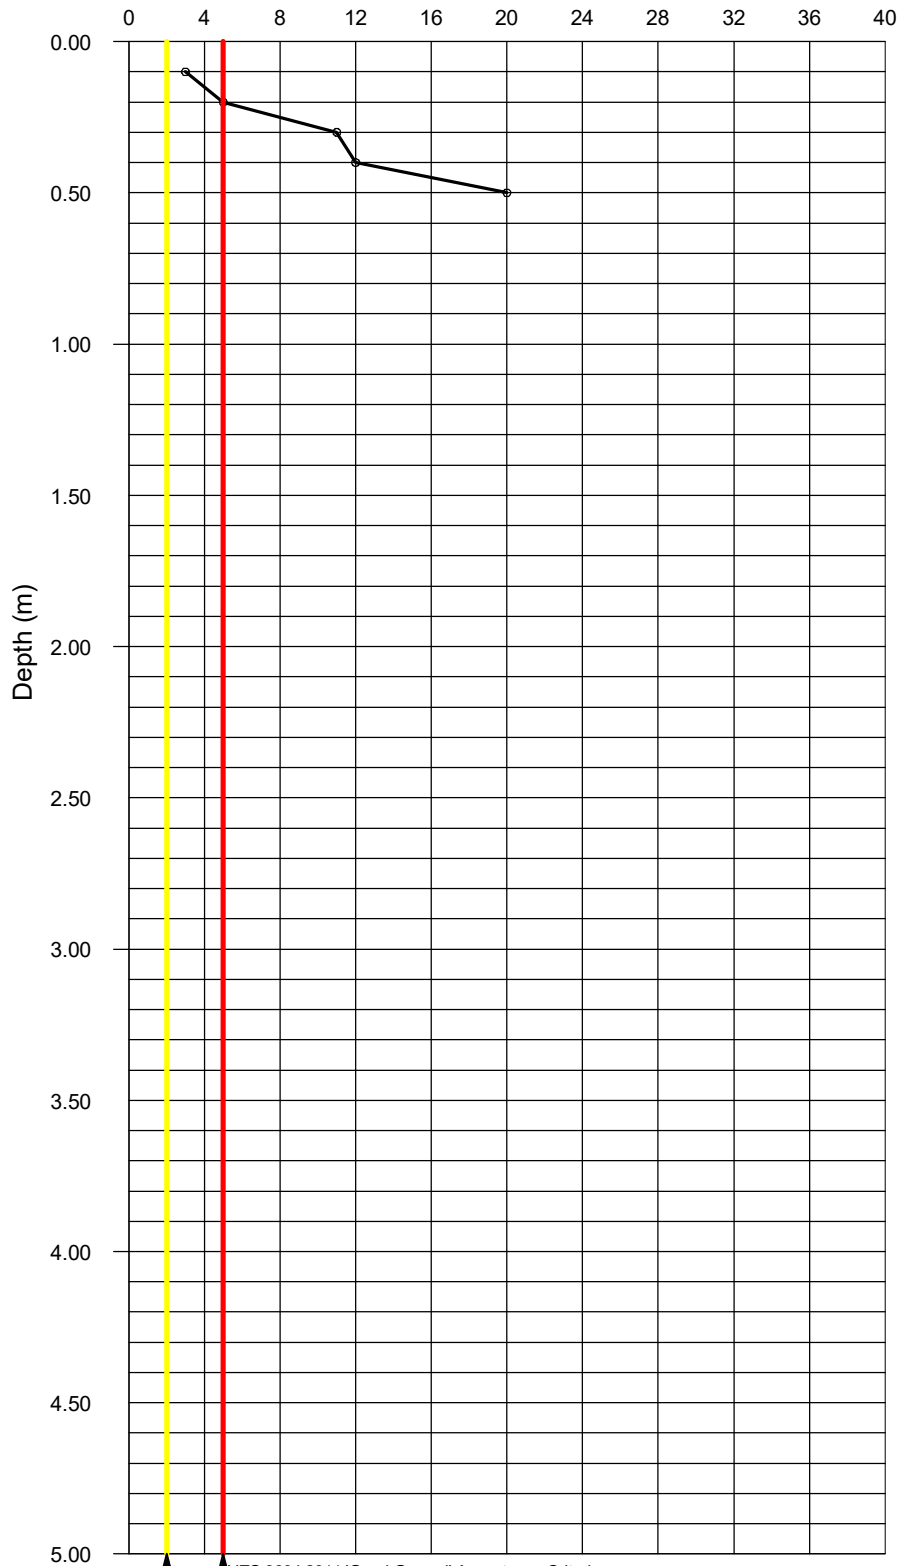
DCP logs indicate two blows per 100mm penetration, which is equivalent to an ultimate bearing capacity of 200kPa, was consistently encountered from shallow depths.

20 blows for 100mm in the last increment.  
Co-ordinates recorded in the field with a mobile device.  
RL from data survey based on design contours (Christchurch drainage datum).  
Effective refusal, 20+ blows per 100mm

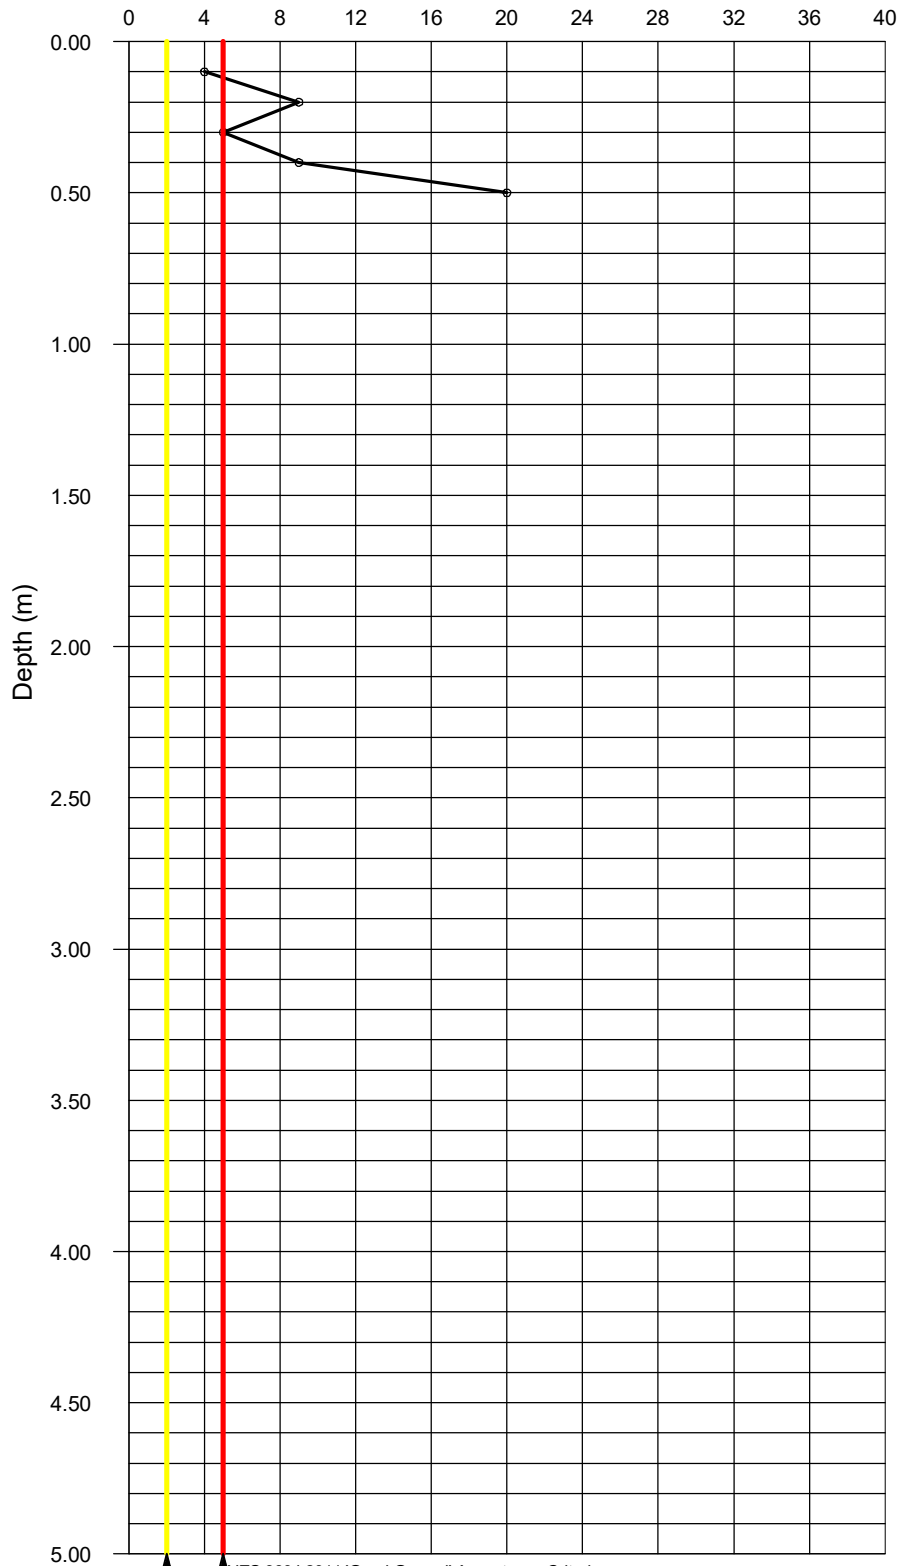
20 blows for 100mm in the last increment.  
Co-ordinates recorded in the field with a mobile device.  
RL from data survey based on design contours (Christchurch drainage datum).  
Effective refusal, 20+ blows per 100mm
