Prestons Park Subdivision
GEOTECHNICAL REPORT FOR LOT 1007
CDL Land NZ Limited

8 December 2023
Revision: 1
Reference: 235361

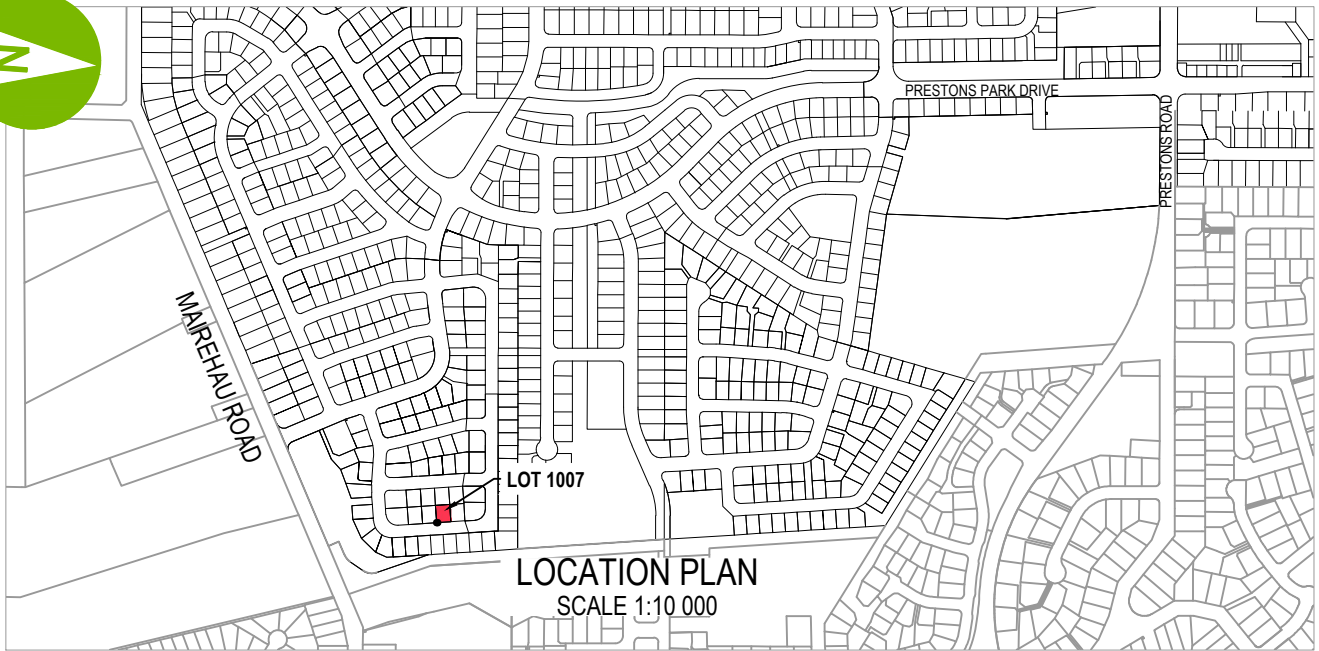
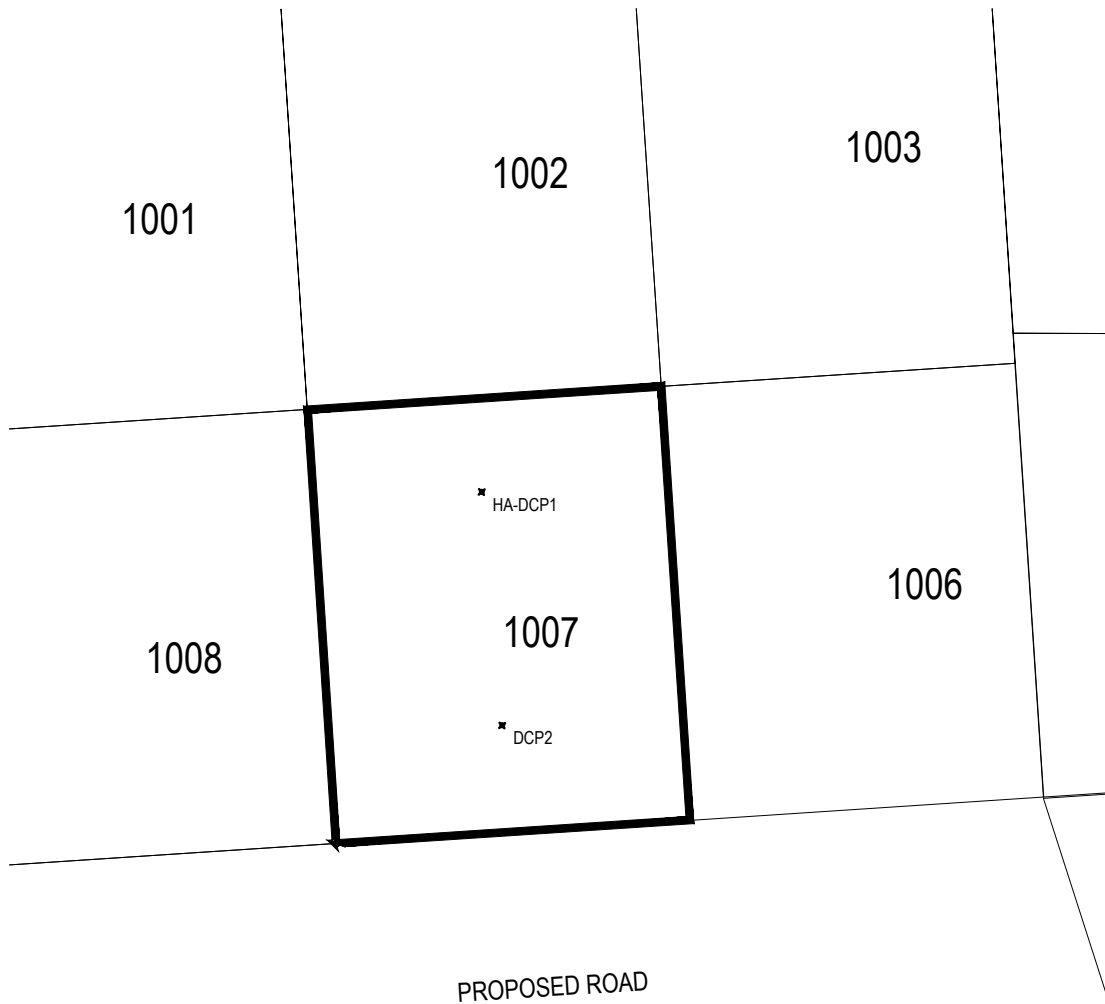
PROJECT	
PRESTONS PARK	
TITLE	
LOT 1007	
SITE LOCATION PLAN	
FIGURE 1

This building consent report is for Lot 1007 which is located in Stage 5 of the Prestons Park Subdivision development (refer Figure 1 in Appendix A). The lot is bordered by residential lots to the north, west and south and an access road to the east.

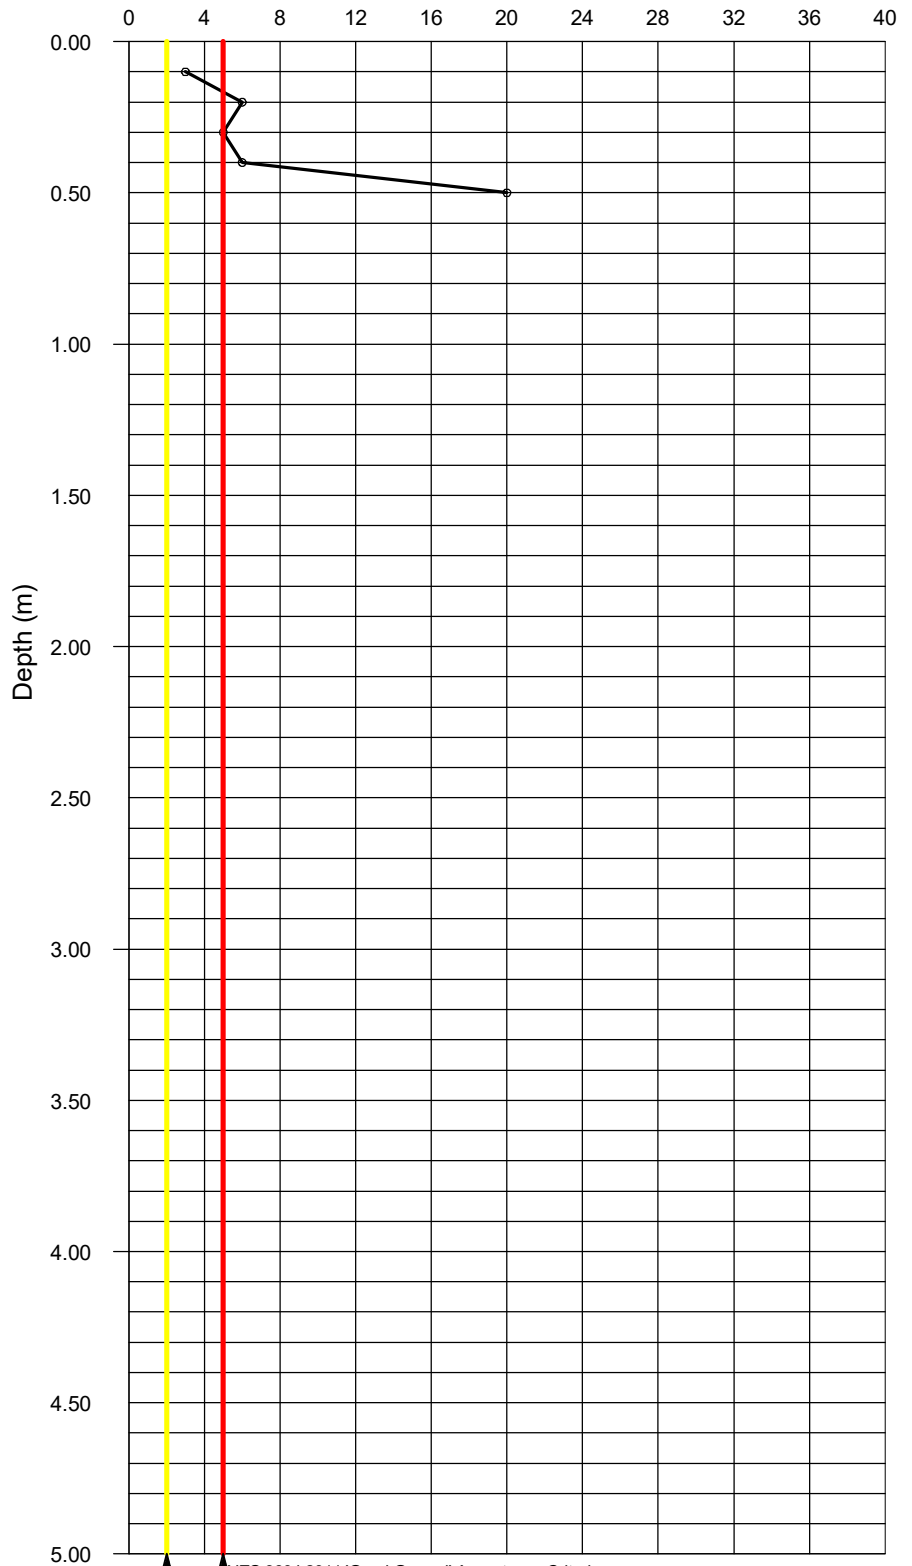
DCP logs indicate two blows per 100mm penetration, which is equivalent to an ultimate bearing capacity of 200kPa, was consistently encountered from shallow depths.

20 blows for 100mm in the last increment.
Co-ordinates recorded in the field with a mobile device.
RL from data survey based on design contours (Christchurch drainage datum).
Effective refusal, 20+ blows per 100mm

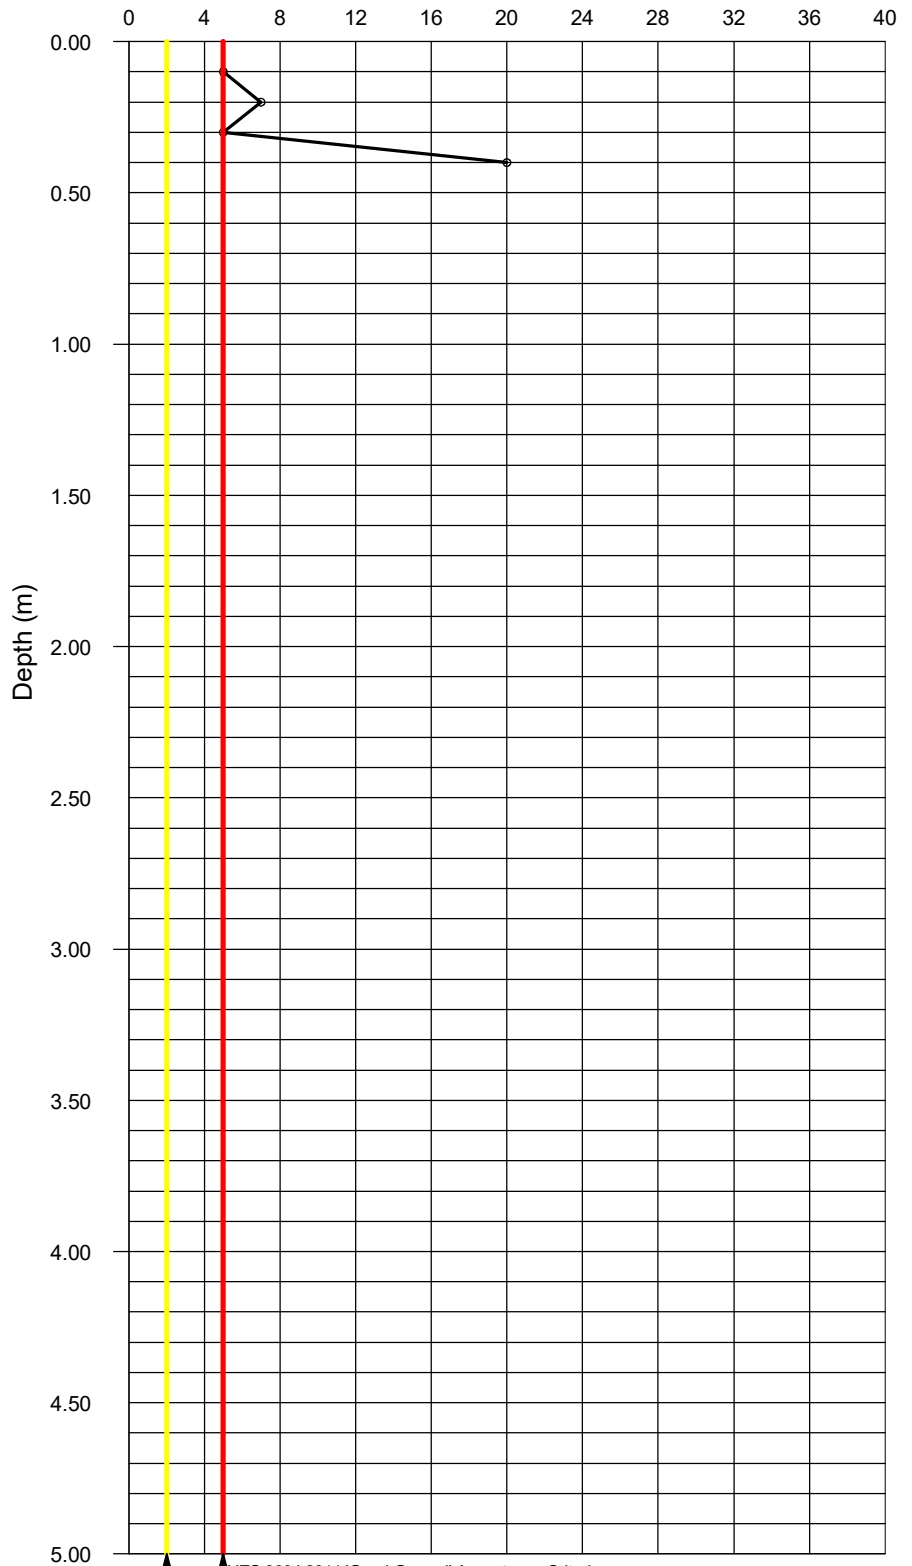
20 blows for 100mm in the last increment.
Co-ordinates recorded in the field with a mobile device.
RL from data survey based on design contours (Christchurch drainage datum).
Effective refusal, 20+ blows per 100mm
