Prestons Park Subdivision
GEOTECHNICAL REPORT FOR LOT 1010
CDL Land NZ Limited

10 January 2024
Revision: 1

Reference: 235361

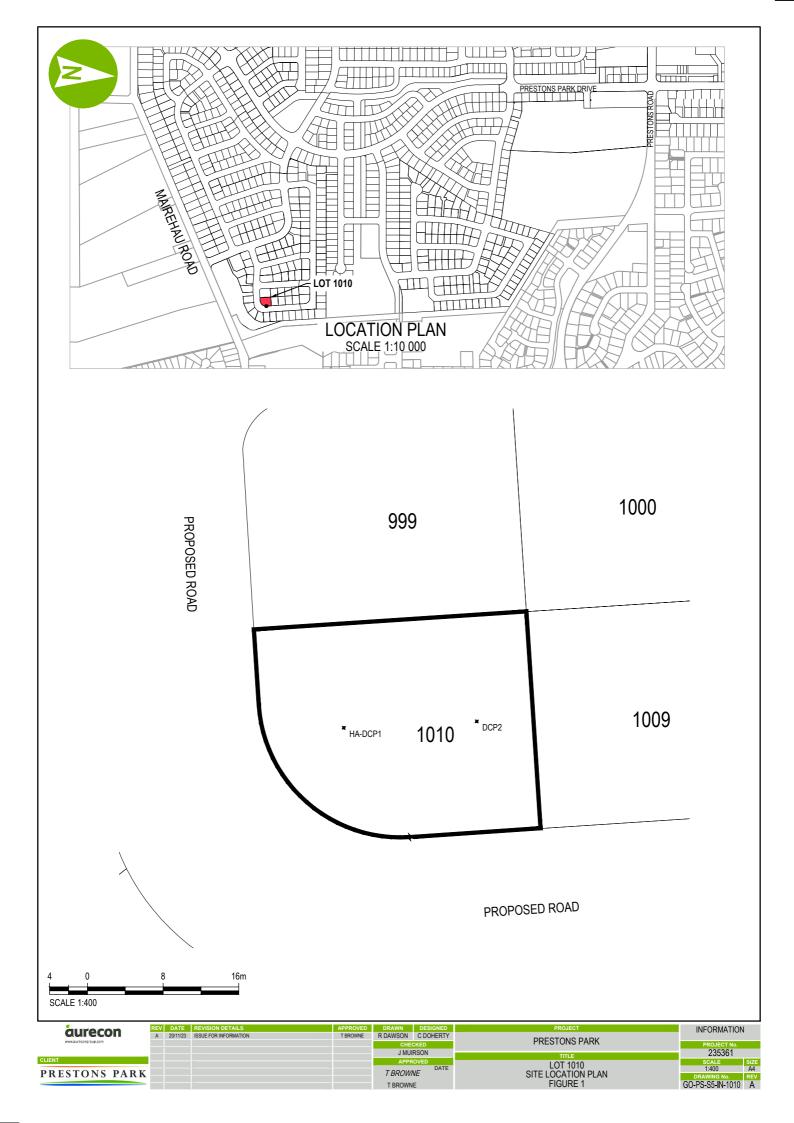
This building consent report is for Lot 1010 which is located in Stage 5 of the Prestons Park Subdivision development (refer Figure 1 in Appendix A). The lot is bordered by residential lots to the north and west and an access road to the east.
