Prestons Park Subdivision
GEOTECHNICAL REPORT FOR LOT 1018
CDL Land NZ Limited

8 December 2023
Revision: 1
Reference: 235361

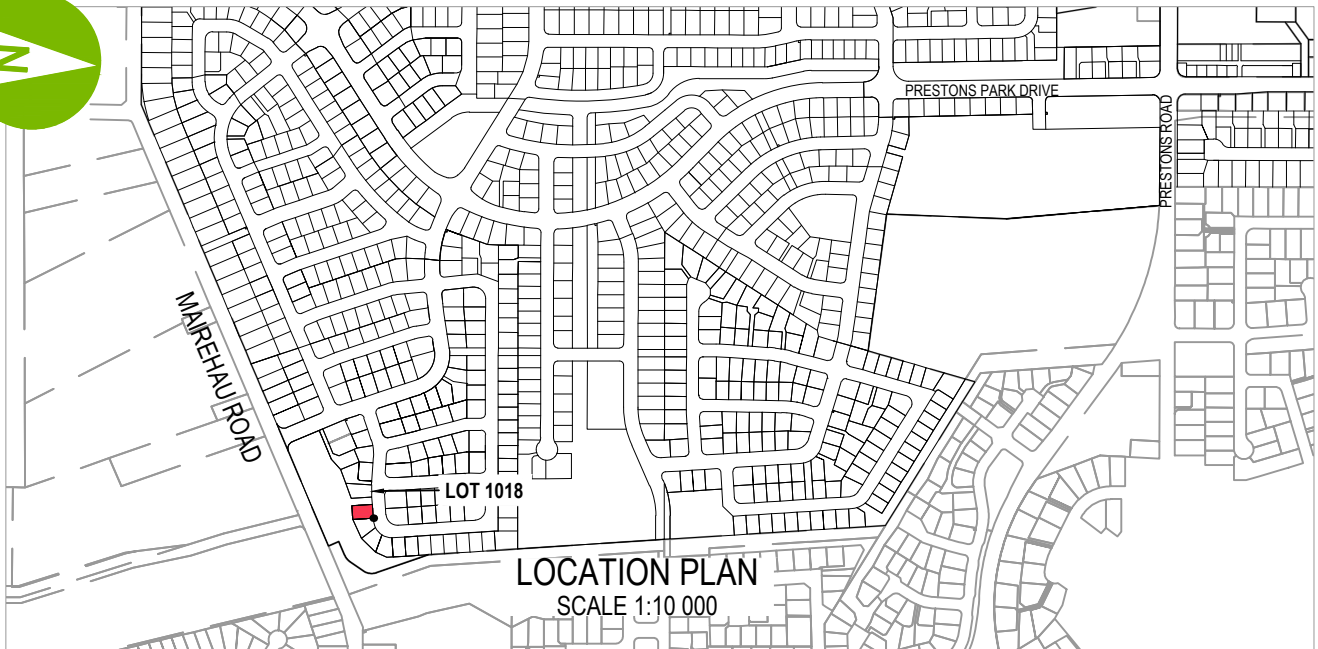
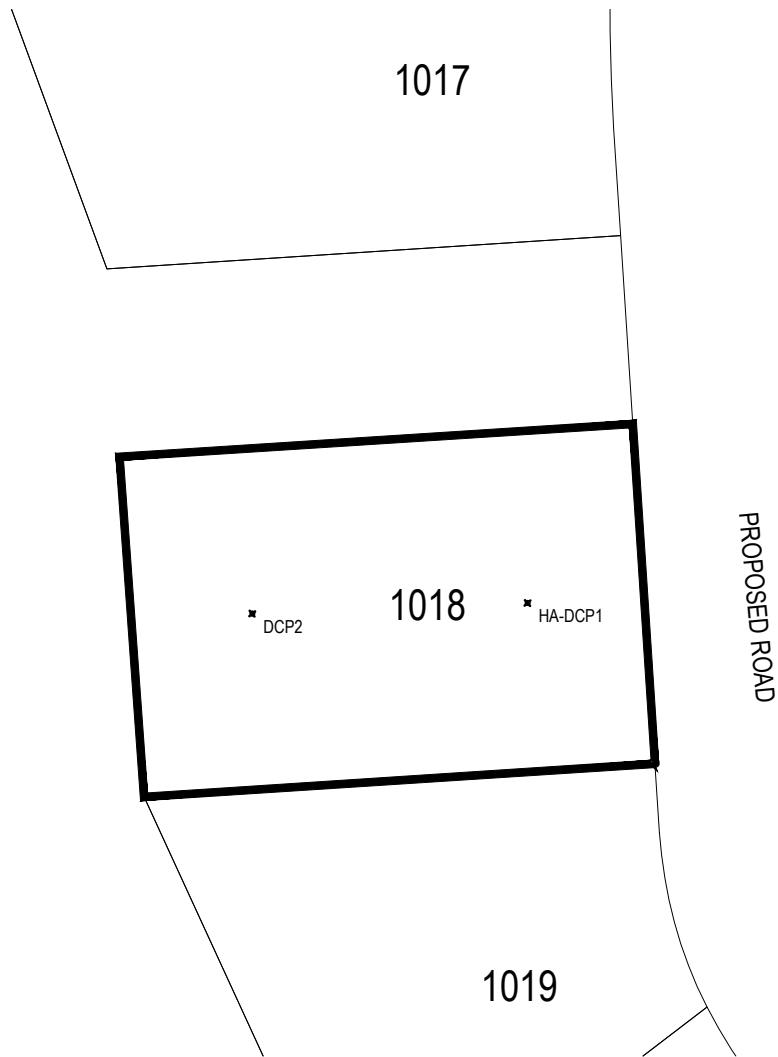
This building consent report is for Lot 1018 which is located in Stage 5 of the Prestons Park Subdivision development (refer Figure 1 in Appendix A). The lot is bordered by residential lots to the west and east and an access road to the north.

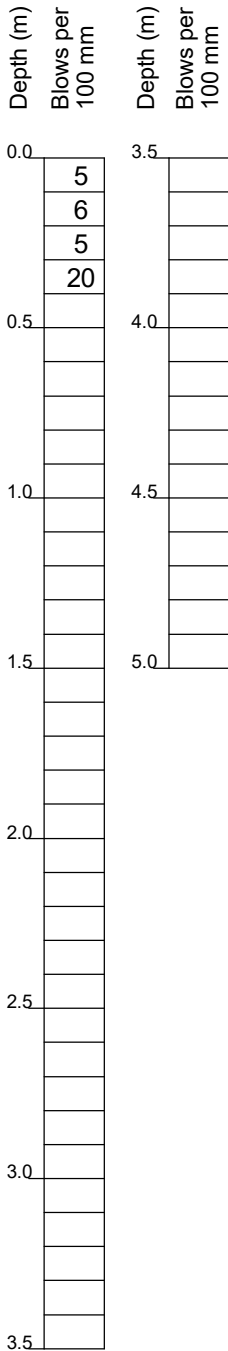
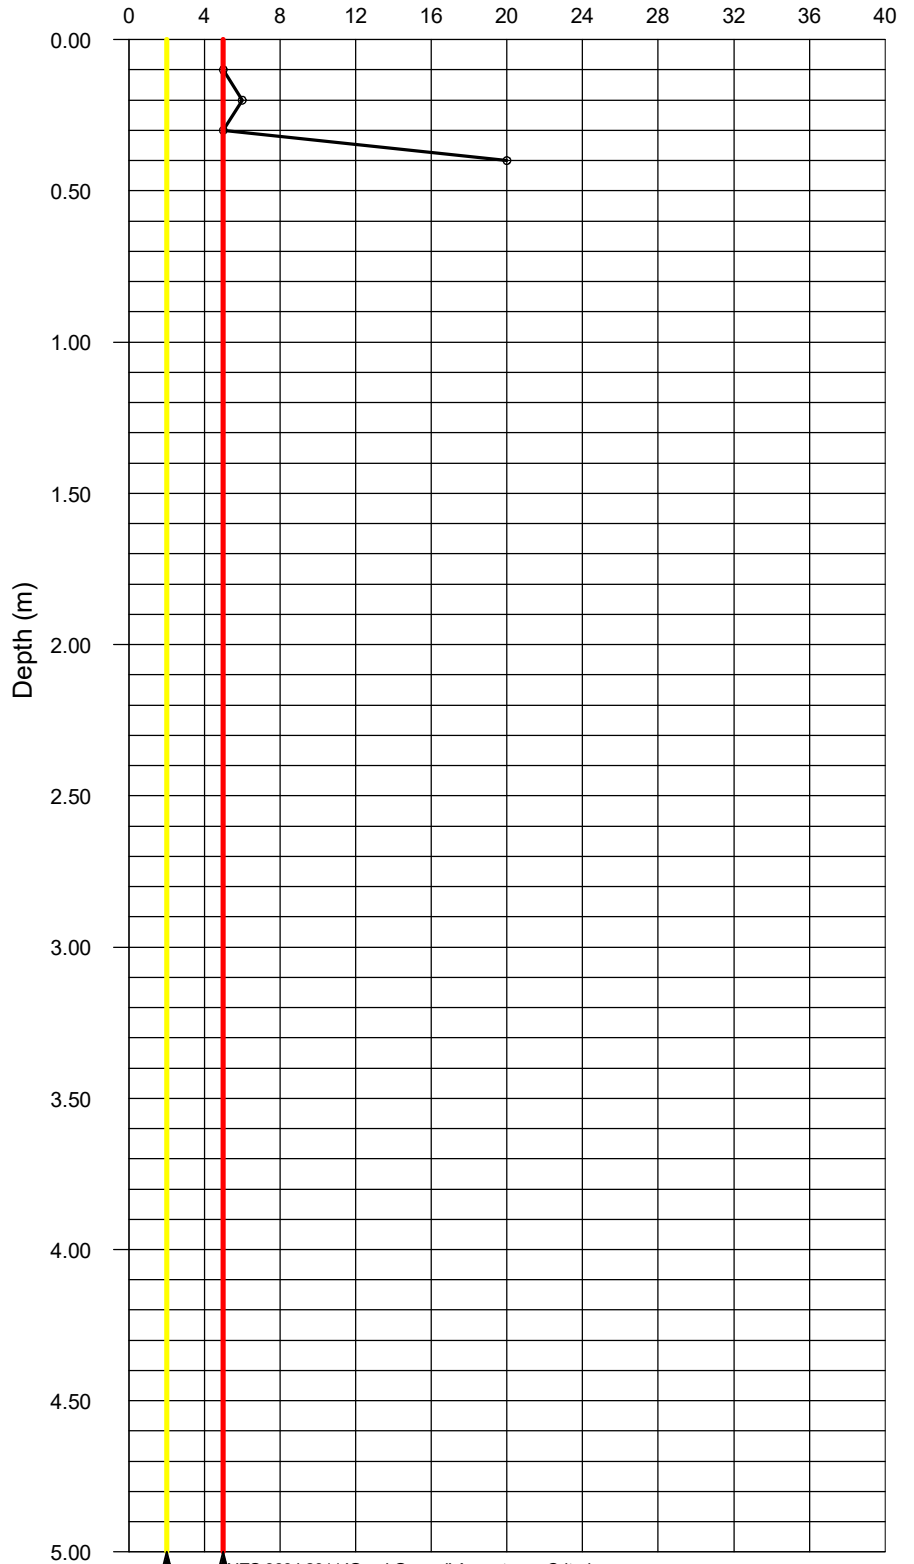
DCP logs indicate two blows per 100mm penetration, which is equivalent to an ultimate bearing capacity of 200kPa, was consistently encountered from shallow depths.

20 blows for 100mm in the last increment.
Co-ordinates recorded in the field with a mobile device.
RL from data survey based on design contours (Christchurch drainage datum).
Effective refusal, 20+ blows per 100mm

Based on our understanding of the site works and the investigation results, we recommend that MBIE Guidelines (2012) Section 5.3.1 compliant foundations are embedded a minimum depth of 0.35m below current ground level.

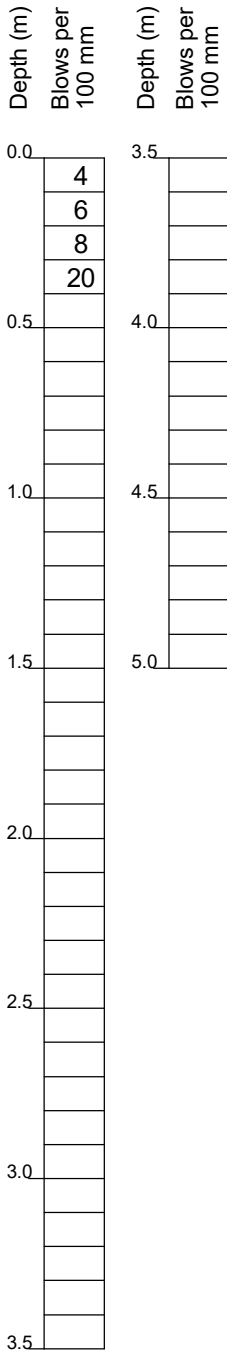
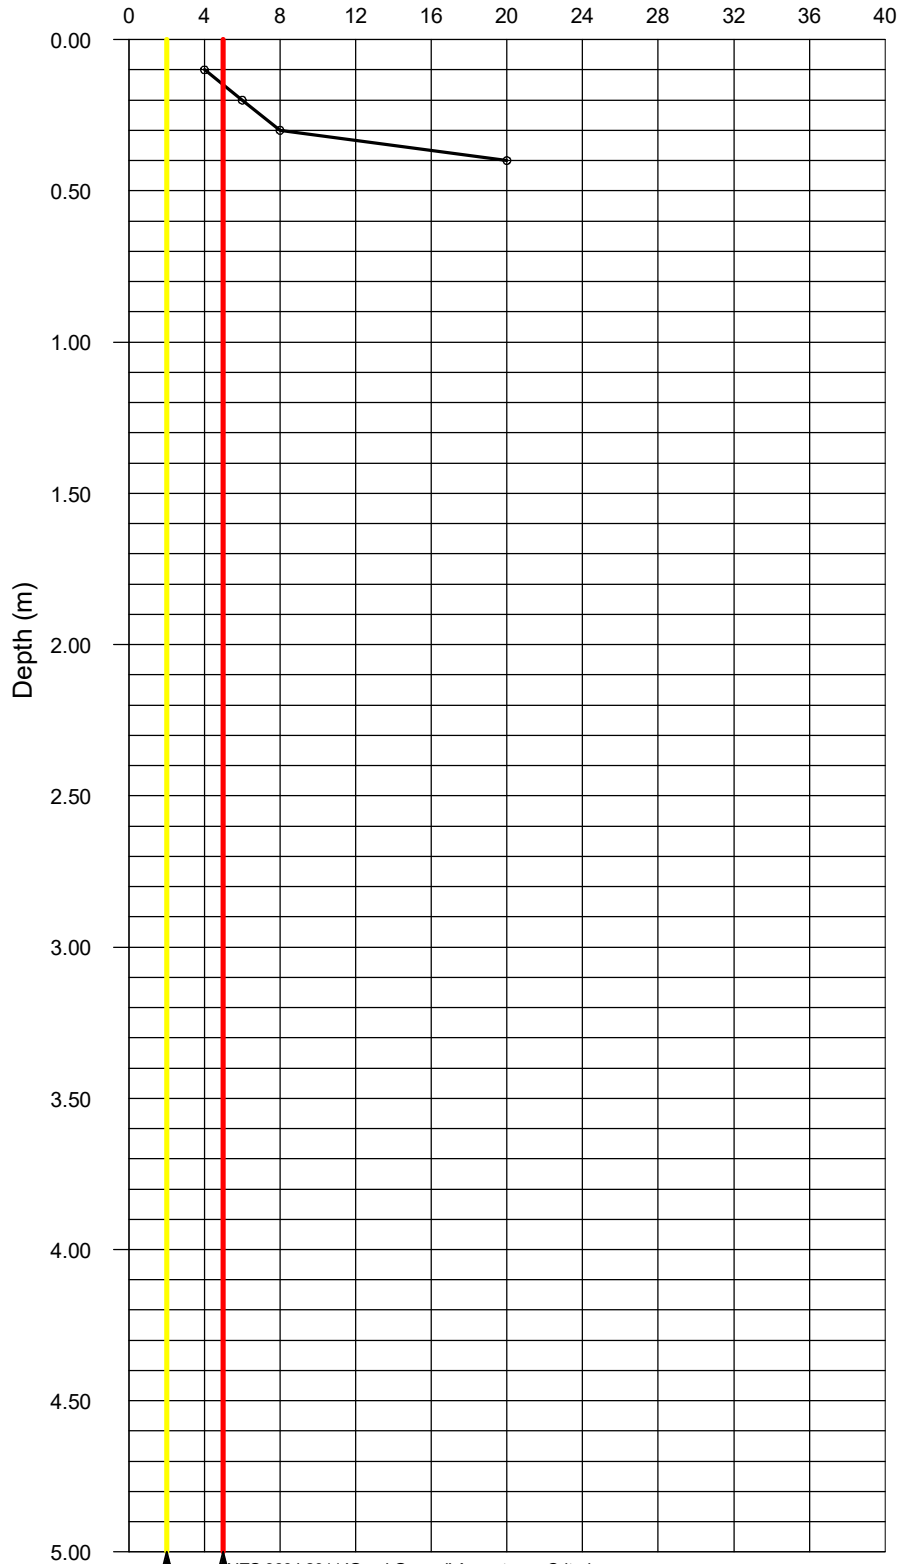
20 blows for 100mm in the last increment.
Co-ordinates recorded in the field with a mobile device.
RL from data survey based on design contours (Christchurch drainage datum).
Effective refusal, 20+ blows per 100mm
