**Prestons Park Subdivision**  
**GEOTECHNICAL REPORT FOR LOT 1019**  
**CDL Land NZ Limited**

**8 December 2023**  
**Revision: 1**  
**Reference: 235361**

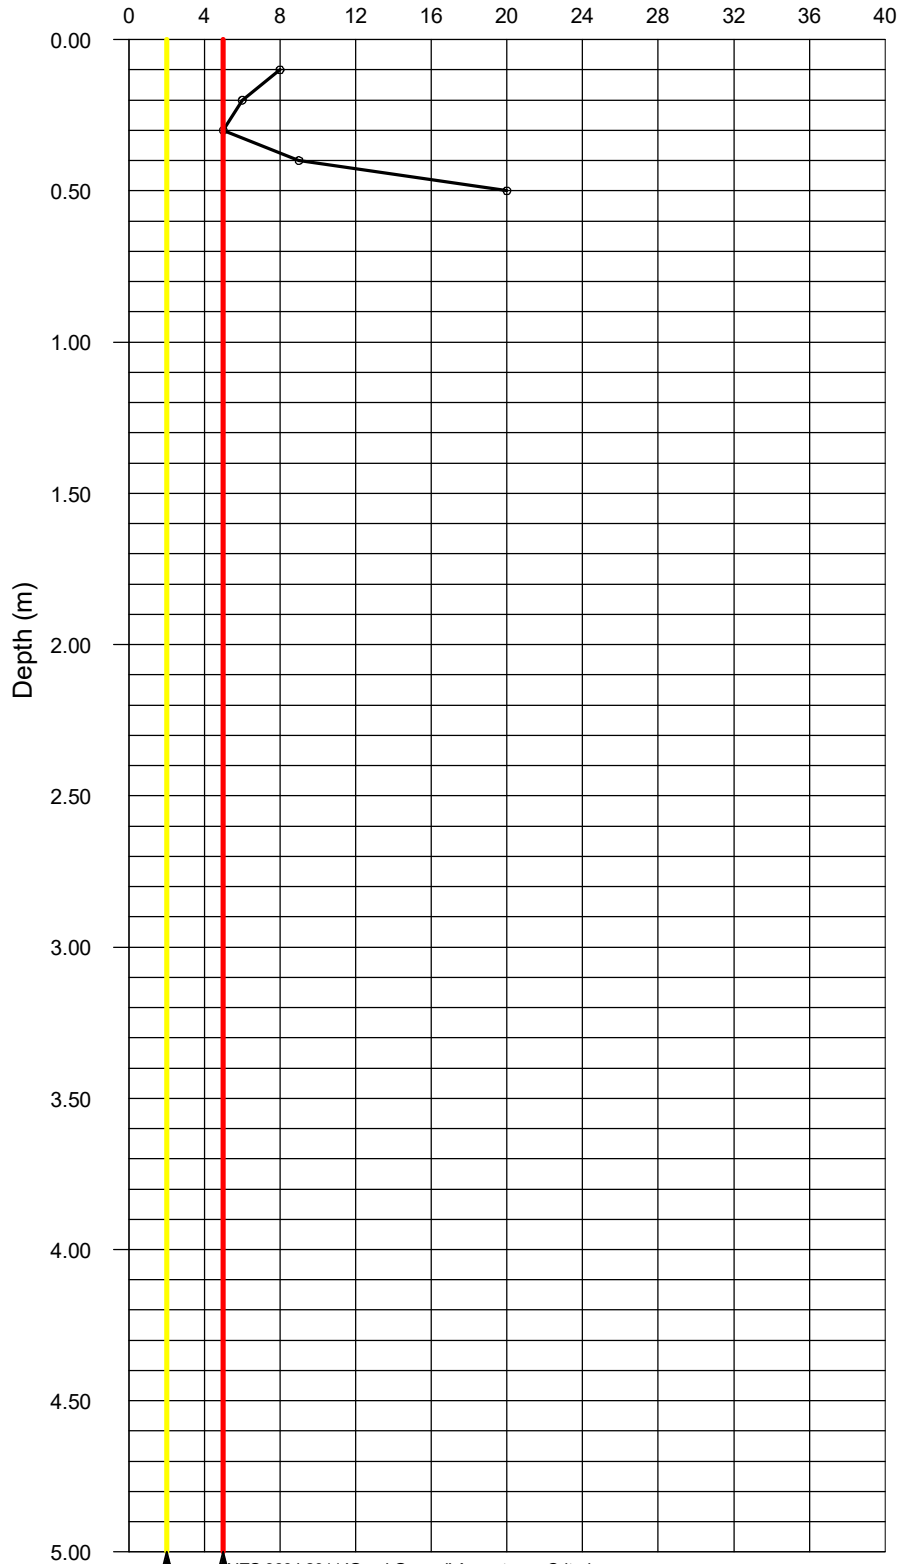
DCP logs indicate two blows per 100mm penetration, which is equivalent to an ultimate bearing capacity of 200kPa, was consistently encountered from shallow depths.

20 blows for 100mm in the last increment.  
Co-ordinates recorded in the field with a mobile device.  
RL from data survey based on design contours (Christchurch drainage datum).  
Effective refusal, 20+ blows per 100mm

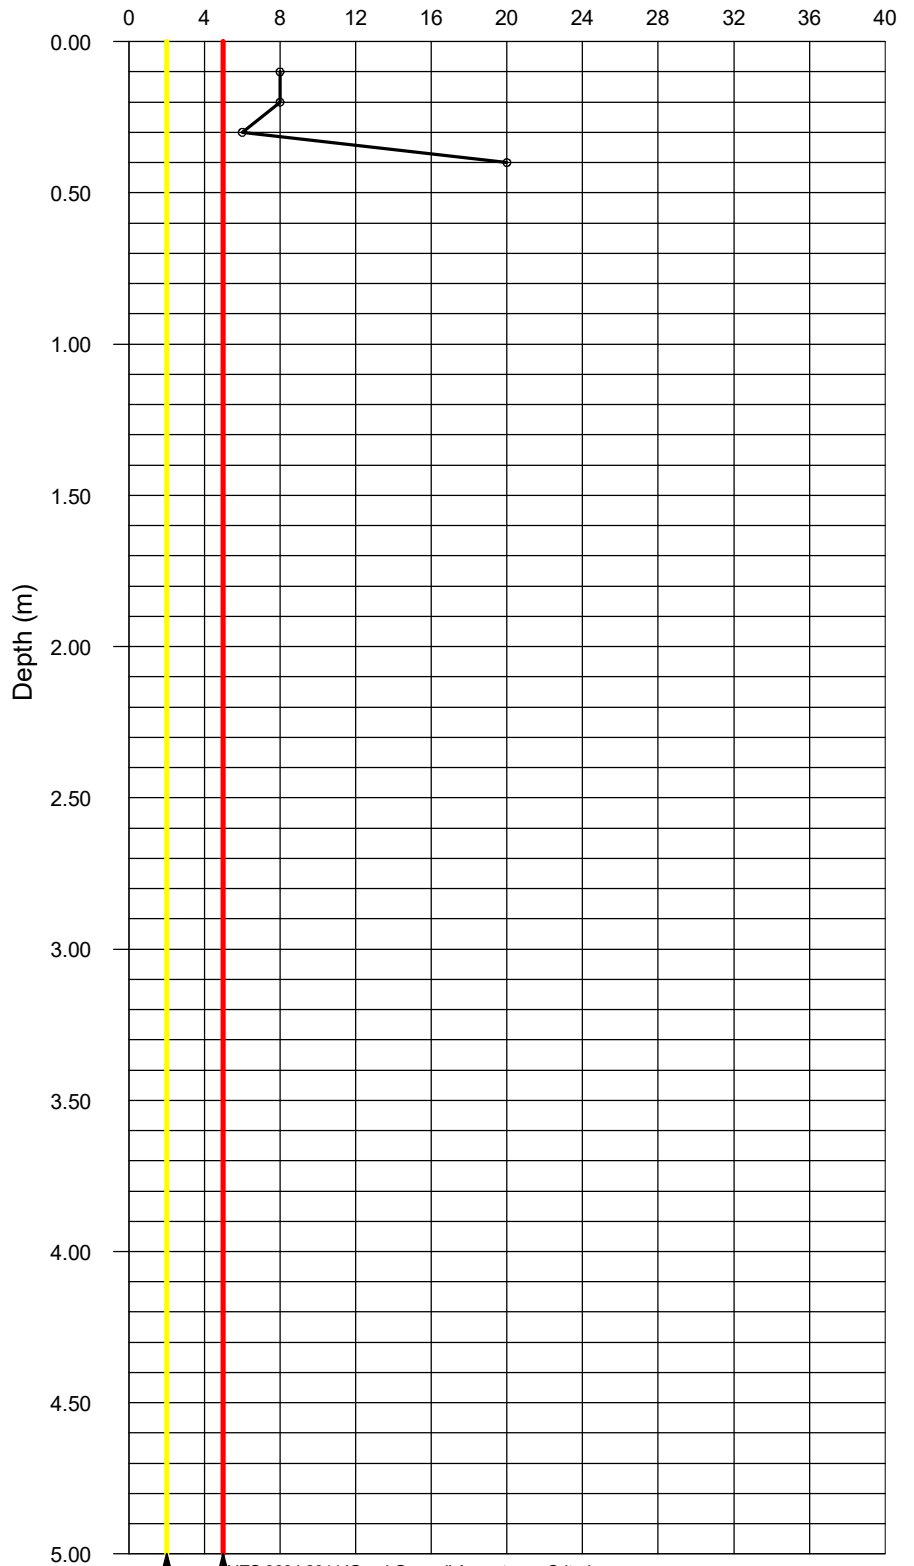
20 blows for 100mm in the last increment.  
Co-ordinates recorded in the field with a mobile device.  
RL from data survey based on design contours (Christchurch drainage datum).  
Effective refusal, 20+ blows per 100mm
