**Prestons Park Subdivision**  
**GEOTECHNICAL REPORT FOR LOT 1020**  
**CDL Land NZ Limited**

**8 December 2023**  
**Revision: 1**  
**Reference: 235361**

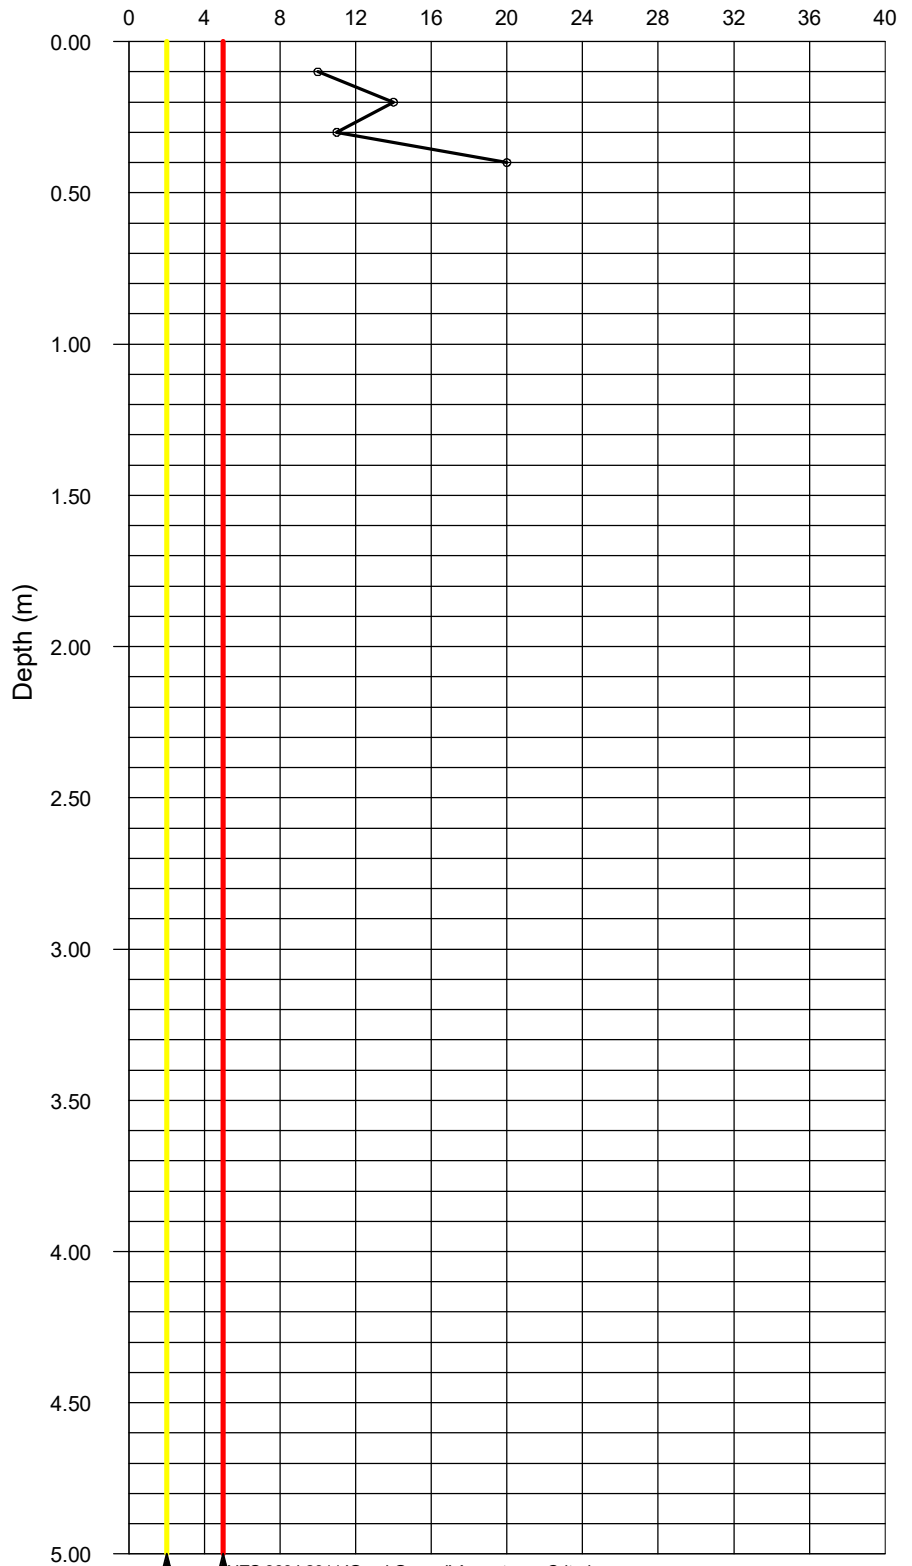
20 blows for 100mm in the last increment.  
Co-ordinates recorded in the field with a mobile device.  
RL from data survey based on design contours (Christchurch drainage datum).  
Effective refusal, 20+ blows per 100mm

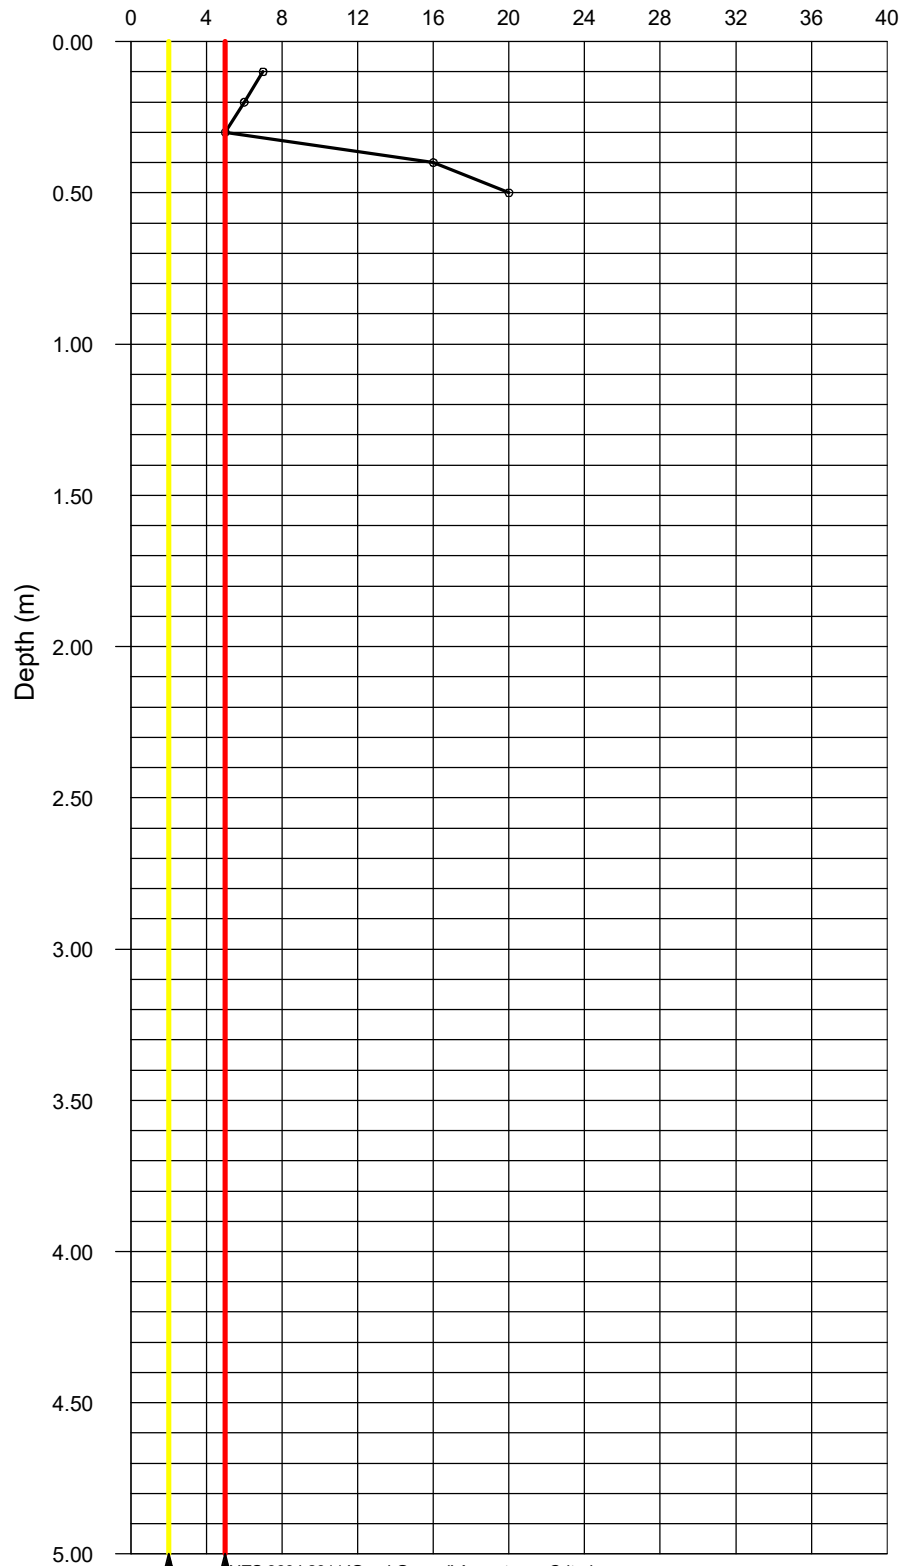
20 blows for 100mm in the last increment.  
Co-ordinates recorded in the field with a mobile device.  
RL from data survey based on design contours (Christchurch drainage datum).  
Effective refusal, 20+ blows per 100mm
